Subject: Modine e-fan Harness Rework			
Field Change Program: Field Campaign	FCP Number: 480	Revision: A	Date: 07/21/2020
Coach Section: 06-Cooling	P/N: 06-01-1648, 06-01-1655		Type: Product Integrity

1.0 Description

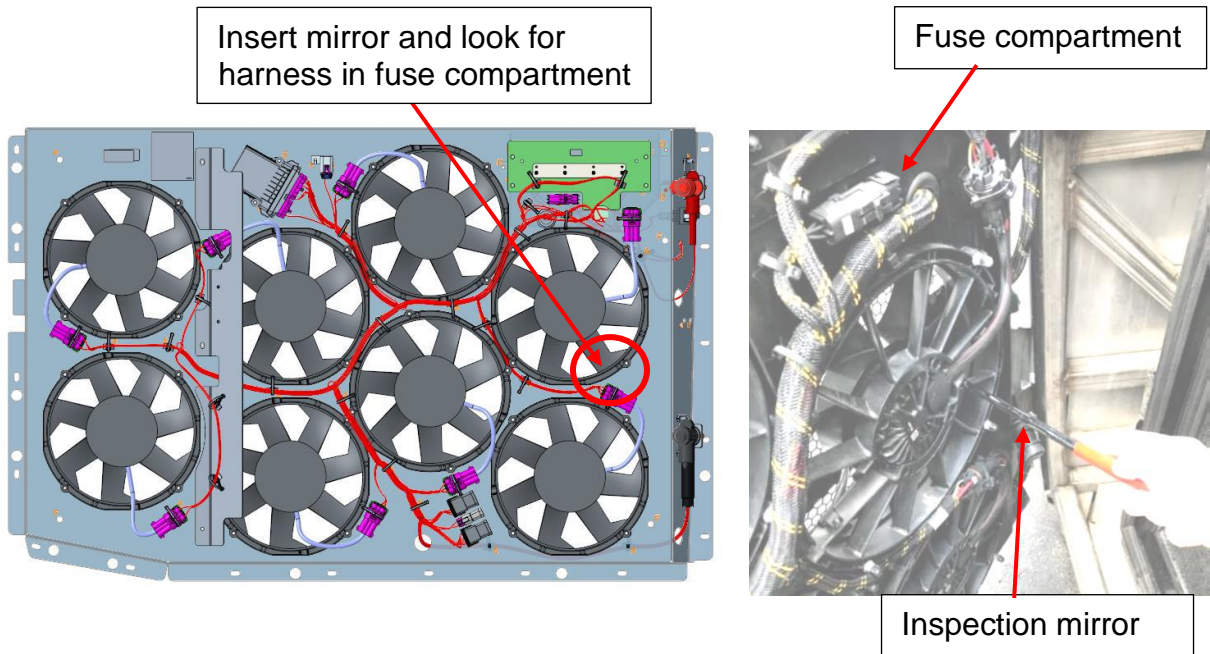
Insert inspection mirror through the fan, as shown below, and look for harness in the fuse compartment.

If there is any visible red wire resting on the fuse compartment edge as shown below, continue to Section 5.0. Otherwise, continue to Section 6.0.

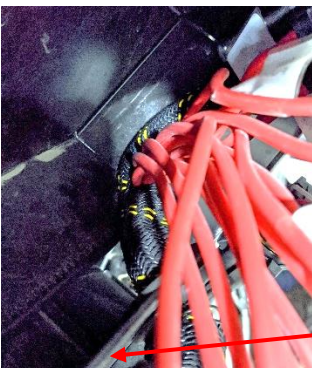
Remove and discard the edge grip

Remove and discard the edge grip in the fuse compartment.
