Service Action – USA Only

Code: 91X9

Subject Car-Net® Button Array

Release Date July 29, 2020

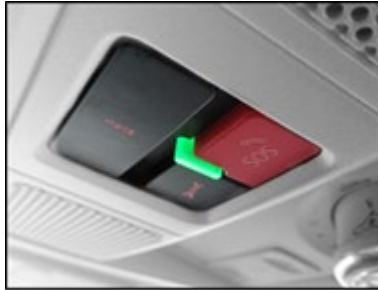
What is the issue? On certain vehicles, the Car-Net button array was not enabled at the factory.

What will we do? Your authorized Volkswagen dealer will enable the Car-Net button array. This work will take about an hour to complete and will be performed for you free of charge. Please keep in mind that your dealer may need additional time for the preparation of the repair, as well as to accommodate their daily workshop schedule.
