July 27, 2020

Version 1

2018-20 Odyssey: Popping or Crackling from the Speakers; No Sound from the Audio System; *Network Loss* Message

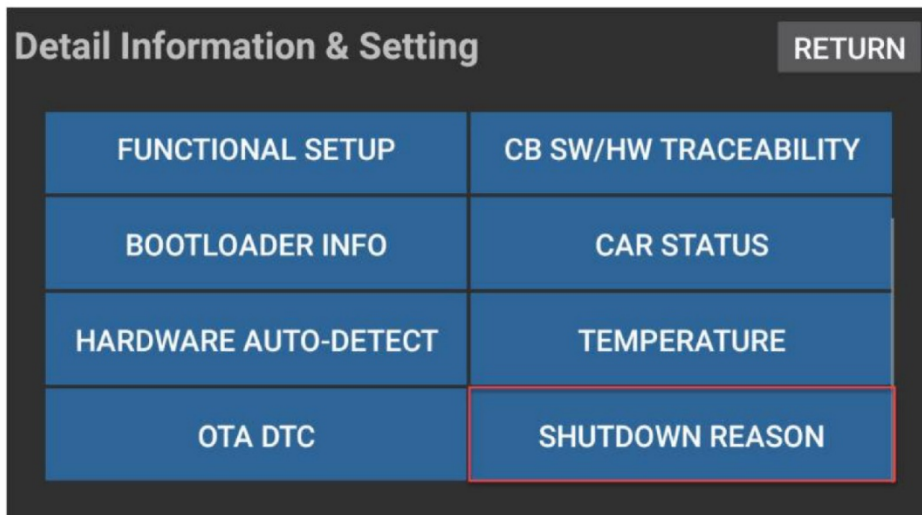
4. Scroll down the menu, and select **SHUTDOWN REASON**.

In this example, the cause of the failure can be identified as **Meter:SUDDEN_SIGNAL_OFF**.

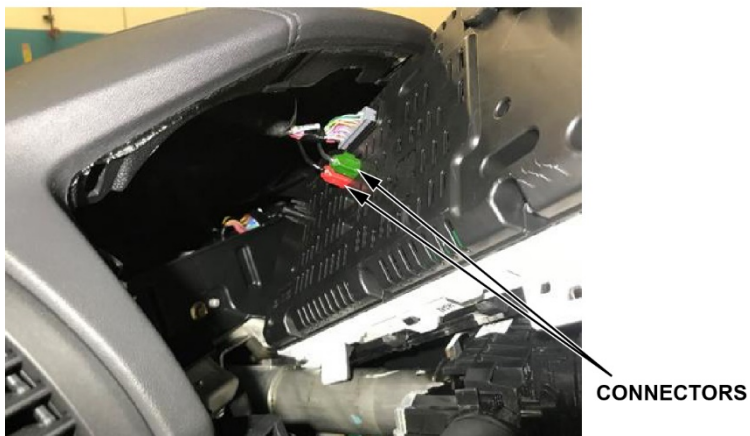
5. Turn the gauge control module to access the rear connectors. Then, using the straight FAKRA tool, disconnect the red and green FAKRA connectors, and remove them from the gauge control module.
