Preliminary Information

PIP5495M Check Engine Light On With P0299 Or P0234

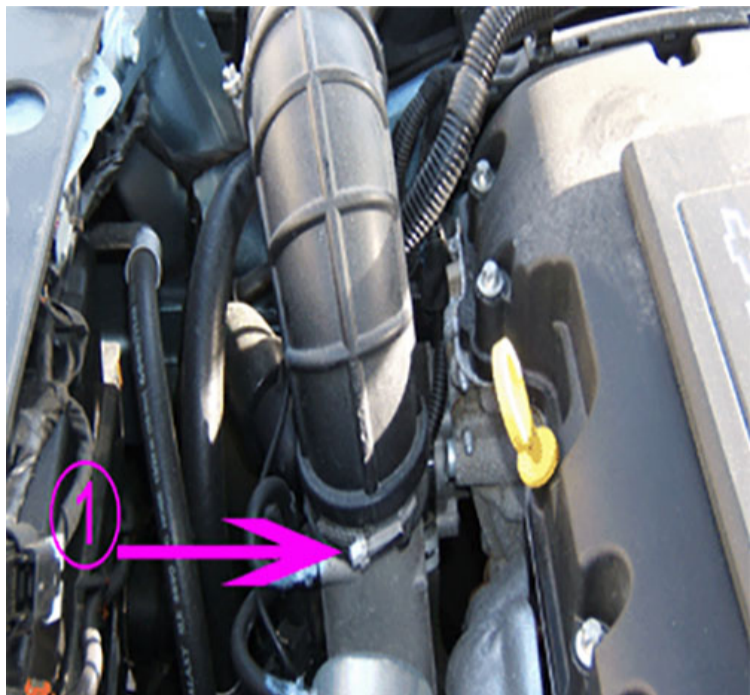
Remove the turbocharger rubber outside air inlet duct.

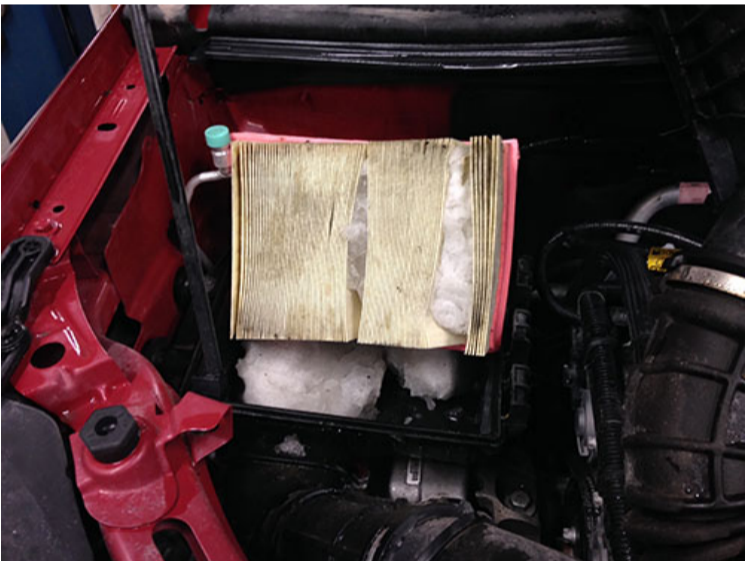
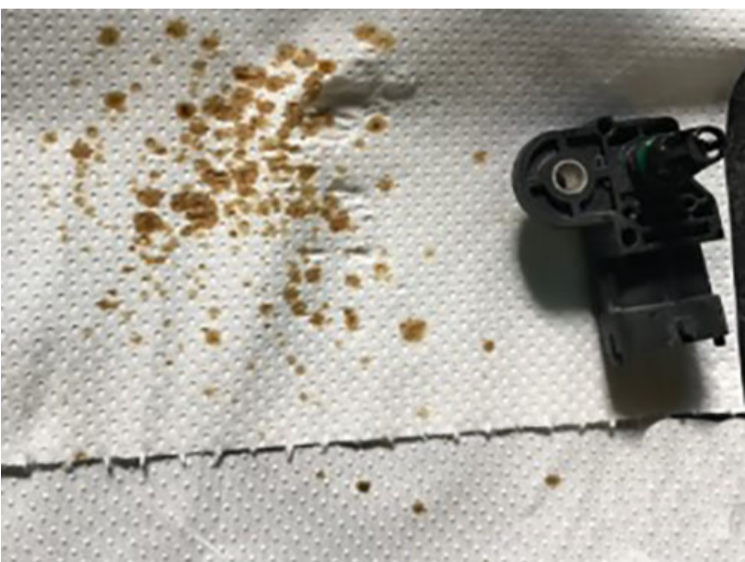
P0299 could set as a result of ice buildup in the Induction system, Charge Air Cooler (CAC) and/or the Boost Pressure sensor.

For Encore and Trax refer to the latest version of [16-NA-405](#) ; (Poor Engine Performance in Extremely Cold Weather Conditions, PCV Bypass Hose and Charge Air Cooler Icing - Malfunction Indicator Lamp (MIL) Illuminated, DTC P0299, P0236, P2227, and P00C7 Set)
