Subject: N202300240 - Customer Satisfaction Program  
Transfer Case Leak

Models: 2019 Chevrolet Silverado 4500 HD / 5500 HD / 6500 HD

# Customer Satisfaction Program

## N202300240 Transfer Case Leak

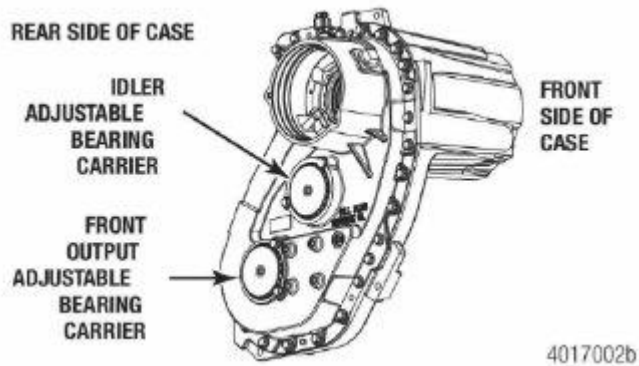
5600859

This bulletin provides instructions for identifying and replacing the adjustable bearing carrier O-rings on MTC-3203-AD02-100-300 model transfer cases. These procedures apply only to the forward output and idler adjustable bearing carriers. These procedures apply only to MTC-3203-AD02-100-300 model transfer cases. Refer to TSB #16-NA-158: U.S. Dealer Special Tool Loan Program for information on how to obtain the *Front Output / Idler Bearing Adjusting Ring Tool 13-191-01-02*.

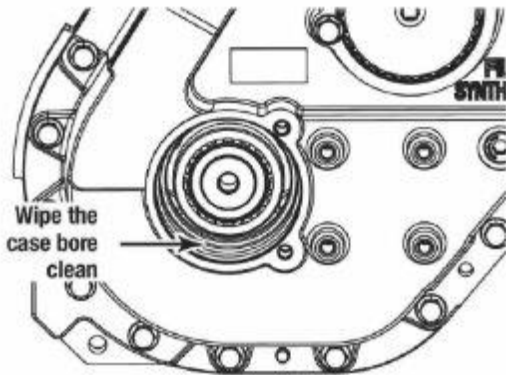
5600932

11. With a clean cloth, clean and inspect the case bore and adjustable bearing carrier for any damage from corrosion or debris.
