Technical Journal

Panoramic sunroof, roller blind hanging loose

REF NO: TJ 35583.1.0	ISSUING DEPARTMENT: Technical Service	CAR MARKET: United States and Canada	
PARTNER: 3 US 7510 Volvo Car USA		ISSUE DATE: 2020-07-06	STATUS DATE: 2020-07-13
FUNC GROUP: 8369	FUNC DESC: Miscellaneous	Page 1 of 4

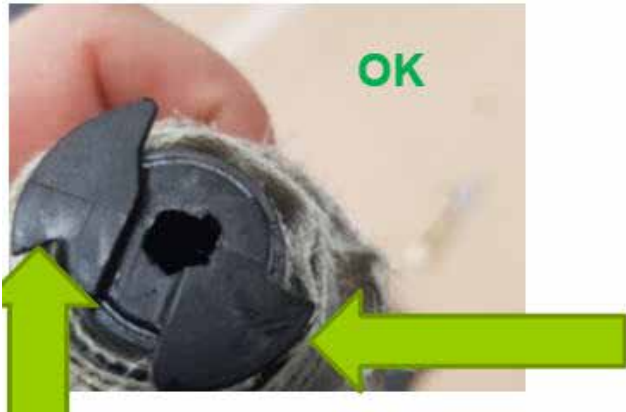
- A. Rollo tube pinching. There should be 6 separated pinchings in the tube, check each pinch that the depth is good. If possible, measure the depth using a caliper.
- B. Socket for rollo fixator. Check if any cracks or imperfections in the plastic.
- C. Roller blind fixator. Check the wings to see if there are any cracks or imperfections in the plastic.

If any problems are found, please replace the roller blind according to VIDA method (search for VCC ID: VCC-371003-6) and send a Vehicle Report with the findings including some photos.

If no abnormalities / damages could be found, repair the car by rolling back the roller blind to the correct position.
