Technical Journal

Plug-in hybrid electric vehicle high voltage battery repairs

REF NO: TJ 34295.5.0	ISSUING DEPARTMENT: Technical Service	CAR MARKET: United States and Canada		
3 US 7	PARTNER: '510 Volvo Car USA	ISSUE DATE: 2020-06-24	STATUS DATE: 2020-07-13	
FUNC GROUP: 3113	FUNC DESC: Battery, high voltage	Page	1 of 9

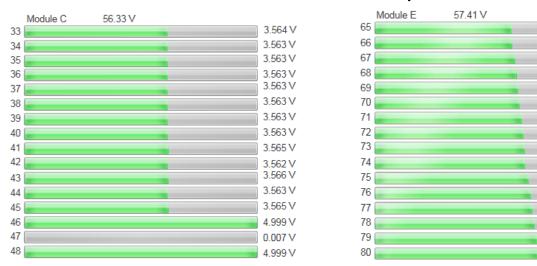
Cell Module: This part is most often used when one cell is defective. The most common cell defects are seen as one cell having a lower Open Circuit Voltage (OCV) and State of Charge (SoC) than all other cells. Normal SOC deviation is less than 5%, more than 10% is a fault. The cell module is delivered complete with temperature sensors and a Cell Voltage and Temperature Node. Examples is attached in "HVB - Cell Voltage Overview"
