Abnormal Buzz/Groan Noise at 20 - 30 mph From Front Transfer Case

YEAR(S)	MODEL(S)	ADDITIONAL INFORMATION
2019	RAV4

The information contained in this bulletin supersedes Service Bulletin No. T-SB-0065-19.

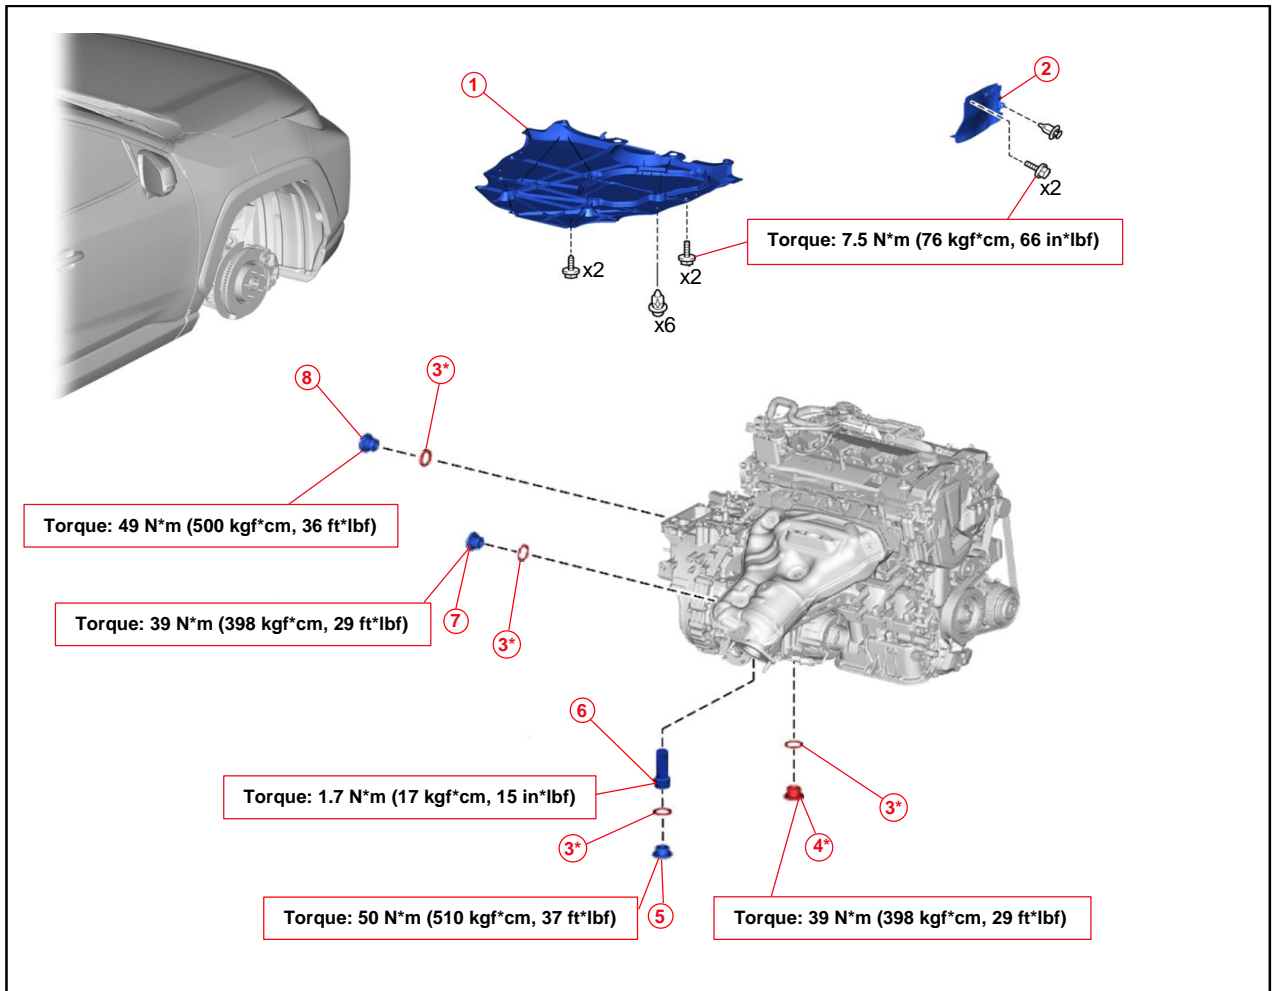
Figure 1. Component Overview 1 of 2

*Component to be replaced.

- **YES** — Review Figure 1 and Figure 2 (pgs. 6 and 7) and complete the rest of the Repair Procedure in this bulletin.
- **NO** — This bulletin does NOT apply. Continue diagnosis using the applicable Repair Manual.

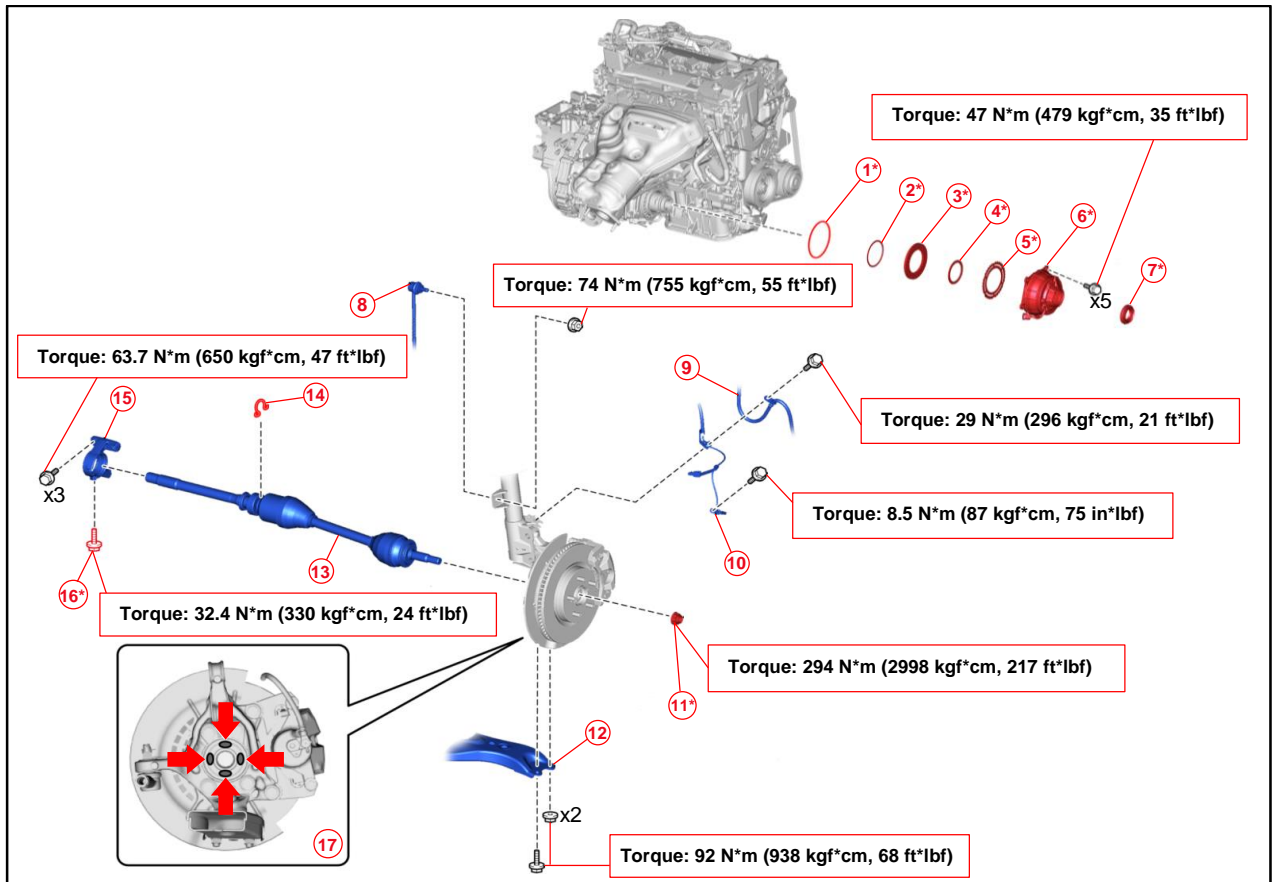
Figure 2. Component Overview 2 of 2

*Component to be replaced. (Component is part of the front transfer case electro-magnetic clutch assembly.)
