NUMBER: 08-007-20 REV. A

GROUP: 08 - Electrical

DATE: July 17, 2020

UAQ and UCQ Radio Enhancements

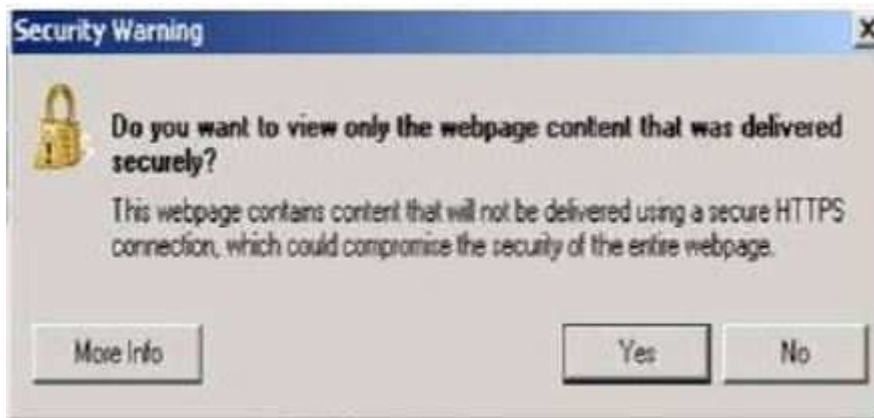
Fig. 2
Pop-Up Security Message

1. Has a **16GB** USB flash drive been created?
 - YES >>> Proceed to [Step 10](#).
 - NO >>> Proceed to [Step 2](#).
2. Go to DealerCONNECT>Service>Uconnect Command Center>Uconnect>More Information >Dealer software downloads to download the files.
3. If a security message appears “Do you want to view only the web page content that was delivered securely?” ([Fig. 2](#)) . Press “No” to continue.

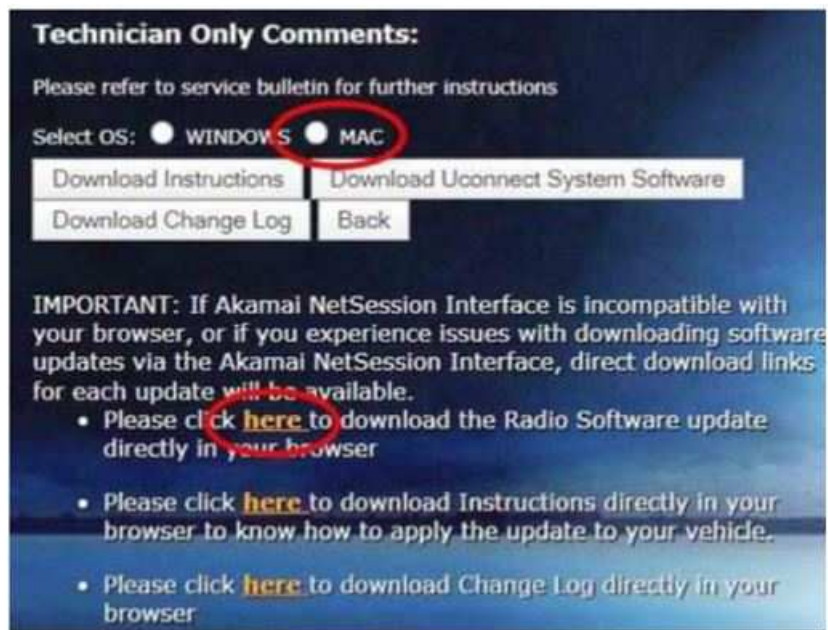
Fig. 3
MAC Download Steps

5. Download the software update file to your local PC's desktop. Make sure to select the "MAC" radial button for all downloads (Fig. 3) .

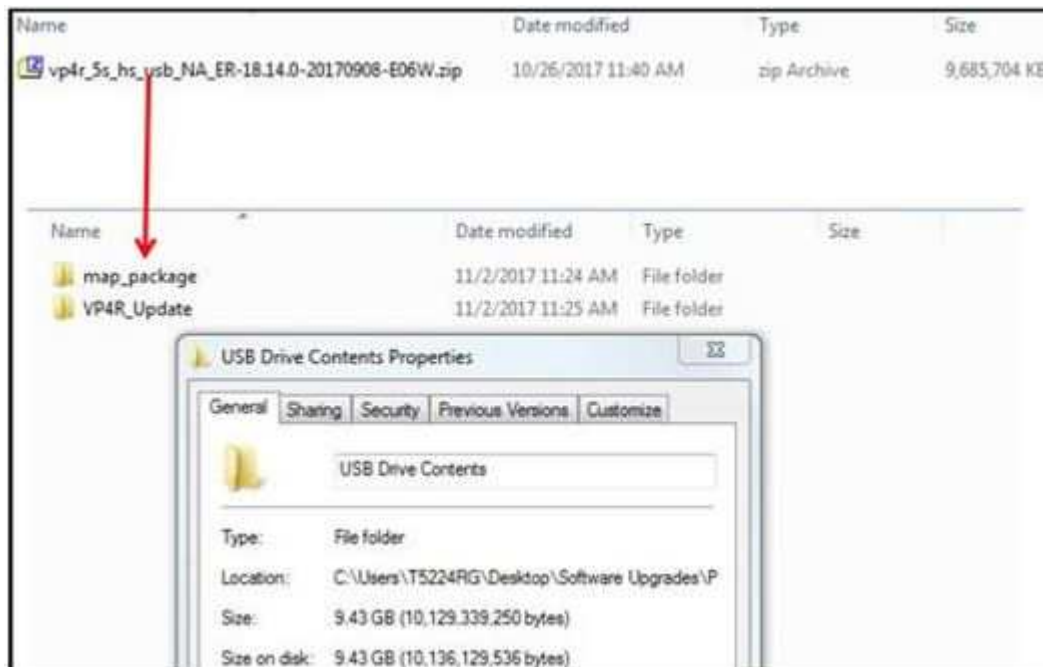
Fig. 4
Files/Folders In The USB Flash Drive

6. Be sure to download the file to your designated folder before extracting the zip file to the blank USB flash drive.
7. A blank USB flash drive will be needed for each radio update, additional updates can not be on the same USB flash drive.
8. Unzip all the files to the root folder of USB flash drive. Files should not be within a zip folder. Your USB files should look like (Fig. 4) when you open it, displaying multiple files/folders.

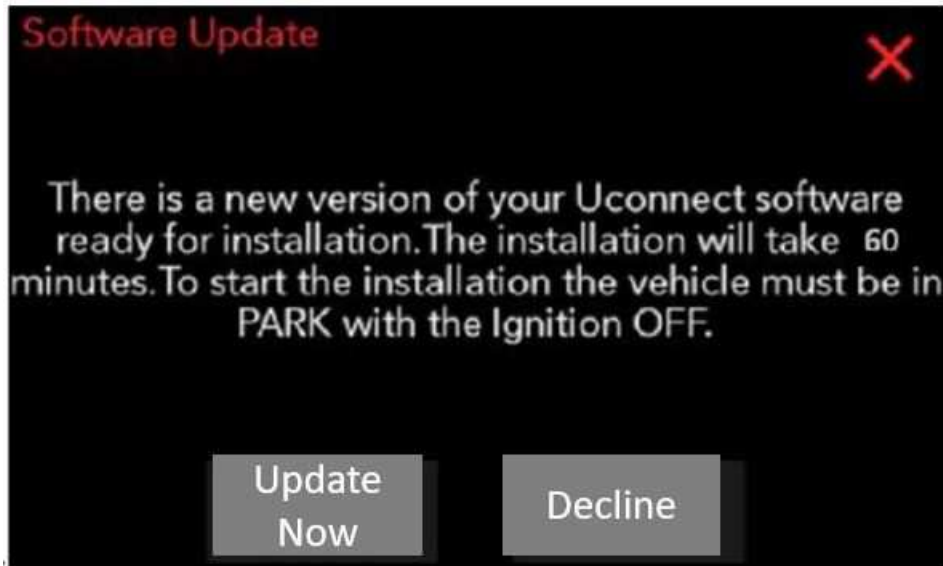
Fig. 7

13. Once the system has verified there is an available update, touch the “Update Now” button. Make sure the vehicle is in park, **do NOT turn off the ignition at this point, (Fig. 7) .**

Software Update is Available

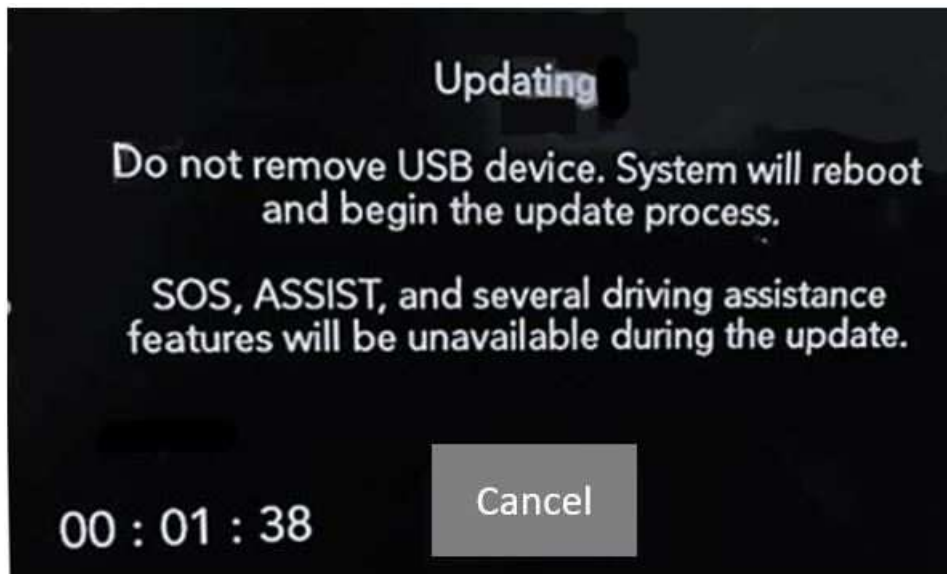
Fig. 8

NOTE: Do not turn off the ignition until the two minute timer has expired, as seen in (Fig. 8) .

14. If the ignition is turned to the off position **before** the two minute timer has expired, the update will be canceled, The ignition does **not** have to be turn off to perform this radio update. (Fig. 8) .

Radio Update Process Begins

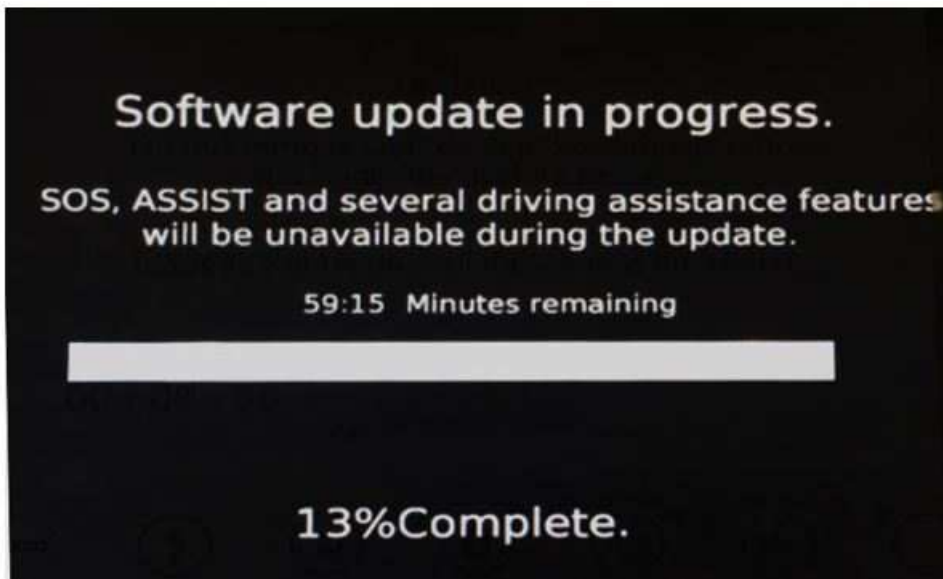
15. The radio will reboot and the update will begin. The update should only take 20 minutes, the timer on the screen may display the incorrect time remaining, (Fig. 9) .

Fig. 9
Software Update In Progress

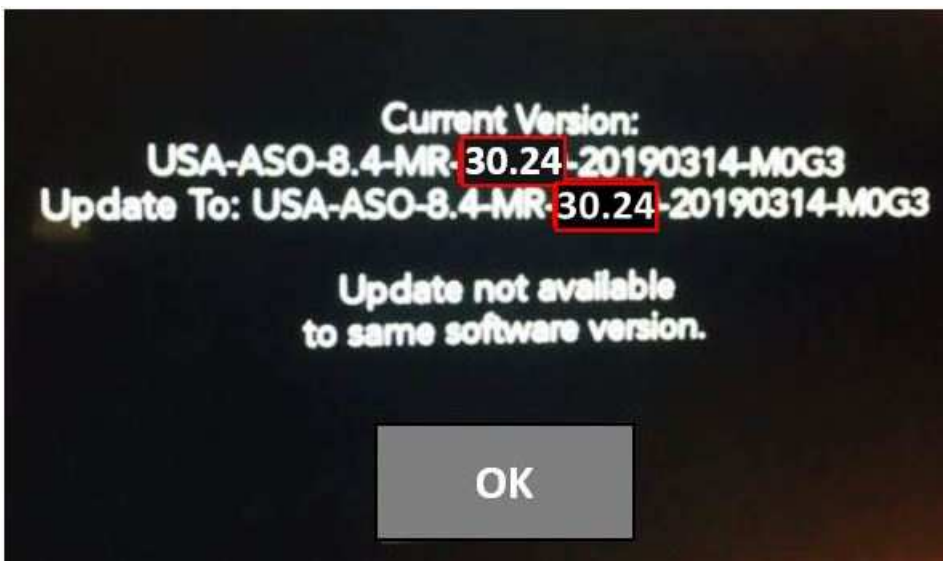
16. After the update has completed, the radio will shut down. With the USB flash drive still inserted in the USB port, turn the ignition back to the run position. If the radio has been updated correctly, the screen in (Fig. 10) will be displayed. Press "OK" and remove the USB flash drive.

Fig. 10
Radio Software has been Updated
