# Service Bulletin

Bulletin No.: 20-NA-126

**Subject: Water Leak in Rear Compartment**

Brand:	Model:	Model Year:		Engine:	Transmission:
		from	to		
Chevrolet	Malibu (VIN Z)	2016	2016	All	All
	Malibu	2017	2020

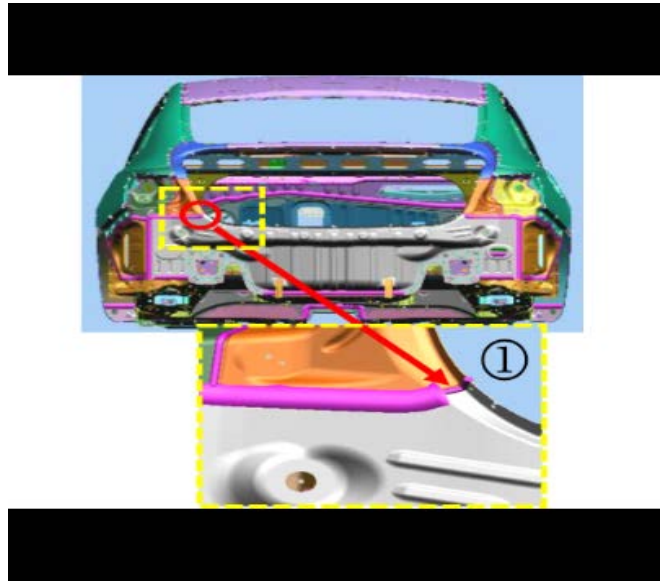
5610533

**Note:** The areas noted by callout (1) are body seams that are more commonly known to be missing sealer. The areas noted by callout (2) are areas where the rear compartment lid weatherstrip is more commonly found to be not fully seated.

1. Water Test the rear compartment, specifically addressing the possible leak path areas noted above.
  - If NO water leaks are evident, NO further repairs specified in this bulletin should be completed. Further discussion should take place with the customer regarding the possible source of the original water found, or further testing may be necessary.
  - If water leaks ARE evident AND the vehicle was built prior to VIN # G1ZB5ST6LF077651 continue ahead to **step #2** and complete the body sealer repairs and the weatherstrip replacement.
  - If water leaks ARE evident AND if vehicle was build VIN # G1ZB5ST6LF077651, or after, body sealer repairs won't be necessary. Jump ahead to **step #9** and install the NEW rear compartment lid weatherstrip.

2. Remove the rear compartment lid weatherstrip (1). Refer to *Rear Compartment Lid Weatherstrip Replacement* in SI.

3. Locate the misapplied sealer at the left tail lamp pocket. The location is shown in the graphic above.
4. If necessary to access the sealer area, remove the left rear tail lamp. Refer to *Rear Body Structure Stop Lamp Replacement* in SI.

6. Locate the improperly skived sealer along the left flange of the deck lid opening. The location is shown in the graphic above.
7. Also apply a generous bead of sealer to close the skive void along the left flange of the deck lid opening.
8. If removed, reinstall the left rear tail lamp. Refer to *Rear Body Structure Stop Lamp Replacement* in SI.

9. Remove the rear compartment lid weatherstrip (1), if not yet removed. Install the NEW rear compartment lid weatherstrip. Refer to *Rear Compartment Lid Weatherstrip Replacement* in SI.
