MODEL
2021MY
K5 (DL3A)

NUMBER
092

TECHNICAL SERVICE BULLETIN

SUBJECT: SERVICE ACTION: HOOD RELEASE CABLE, INTERCOOLER CLAMP AND WINDSHIELD SIDE MOLDING (SA431)

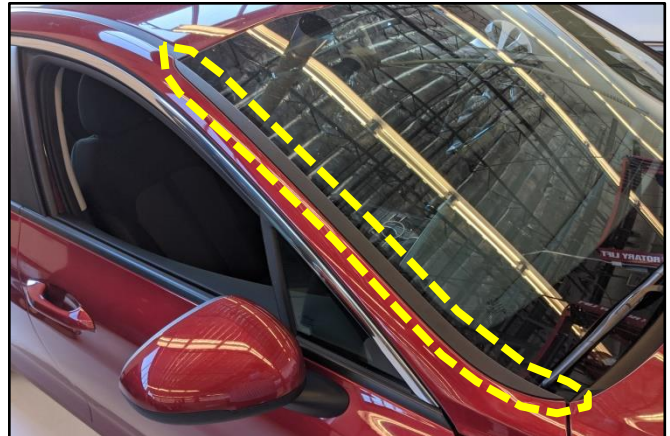
- 2a. Check if the windshield trim molding is not flush to the A-pillar or is loose. Lightly pull on the following areas shown.

- Top
- Middle
- Bottom

If any area is not flush or is loose, apply pressure in the needed area to engage retaining clip and secure.

- 2b. Confirm that the windshield trim molding is flush with A-pillar and not loose. This action is now complete.
