MODEL  
2021MY  
K5 (DL3A)

NUMBER  
092 (Rev 1, 08/12/2020)

## TECHNICAL SERVICE BULLETIN

**SUBJECT: SERVICE ACTION: HOOD RELEASE CABLE, INTERCOOLER CLAMP AND WINDSHIELD SIDE MOLDING (SA431)**

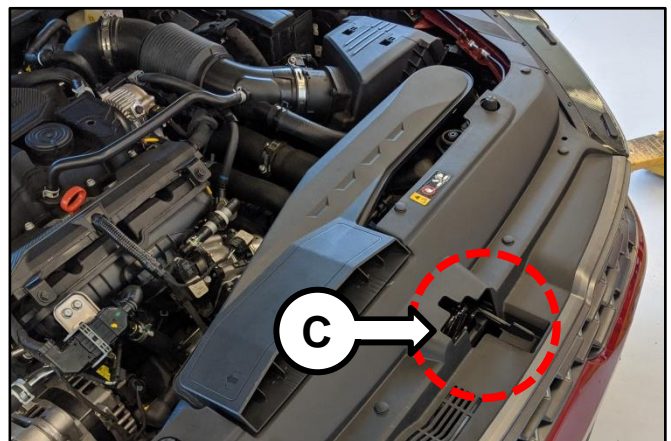
- 2b. If the hood **does not** open, proceed to step 3 to repair this concern.

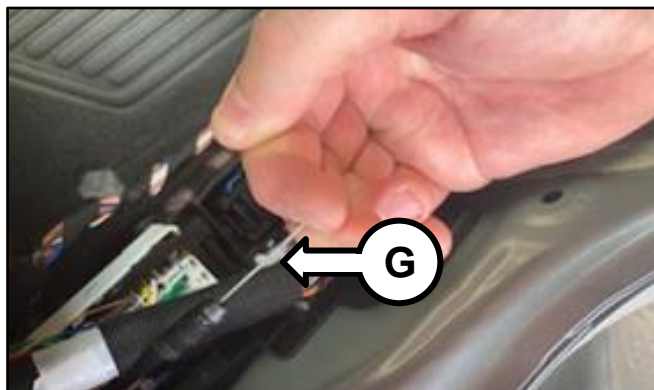
- 7a. Check the hood release cable coupler is attached properly and that the two cable attachments (black and white ends) are fully inserted into the mounting bracket(s).

Photo sample is OK.

- 7b. If the cable is not fully inserted into the bracket (NG), be sure to align and press down firmly.

**Note:** Listen for click to confirm it is secured in place, OK. (Refer image shown on step 7a).

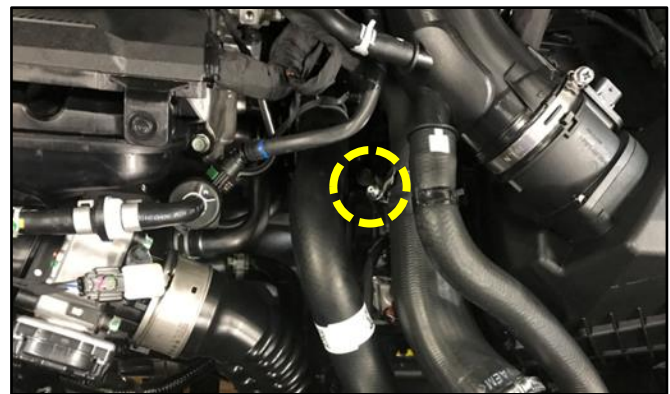
A loose intercooler hose connection may trigger a MIL ON with DTC P017200 - System too rich (Bank 1).

- 1b. Inspect the intercooler hose clamp (A) to intercooler tube connection. Ensure the hose is properly installed to the locating dimple and the hose clamp is squarely positioned around the hose.

- If the hose clamp or hose is NOT positioned as described, proceed to Step 1c/d.
- If the hose is properly installed, proceed to Step 2a.

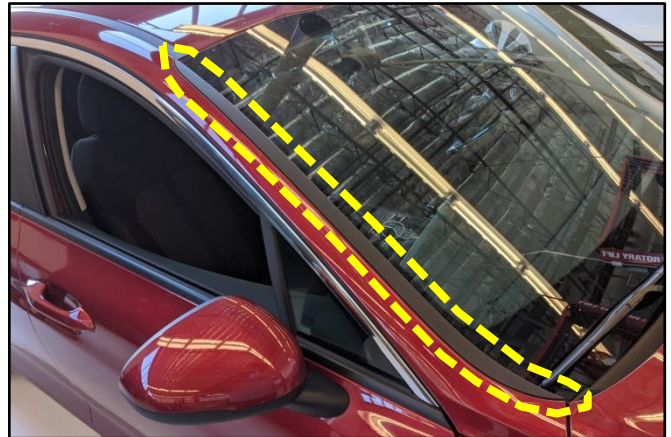
- 2a. Check if the windshield trim molding is not flush to the A-pillar or is loose. Lightly pull on the following areas shown.

- Top
- Middle
- Bottom

If any area is not flush or is loose, apply pressure in the needed area to engage retaining clip and secure.

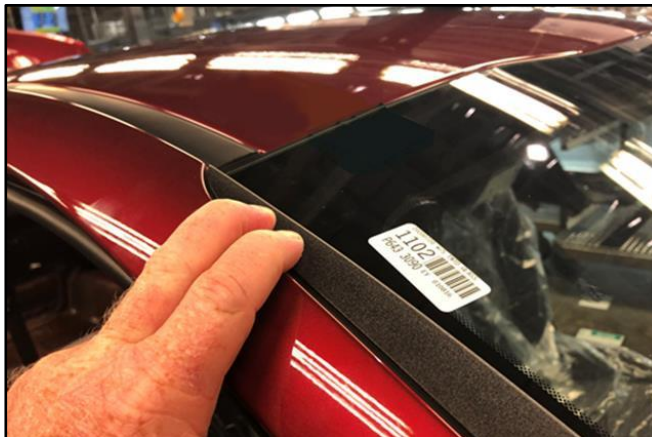
- 2b. Confirm that the windshield trim molding is flush with A-pillar and not loose. This action is now complete.

If windshield molding clips are defective replace the windshield molding trim under normal Warranty claim.
