SERVICE BULLETIN

APPLICABILITY: 2019-20MY Impreza
 2019-20MY Crosstrek (Including Hybrid Model)
 2019-20MY Forester
 2019MY Legacy/ Outback
 2019-20MY WRX
 2019-20MY BRZ- Navigation -equipped ONLY
 2019-20MY Ascent

NUMBER: 15-236-18R

SUBJECT: Reprogramming File Availability for Optimization of Harman Gen 3.1 Audio and Navigation Head Units

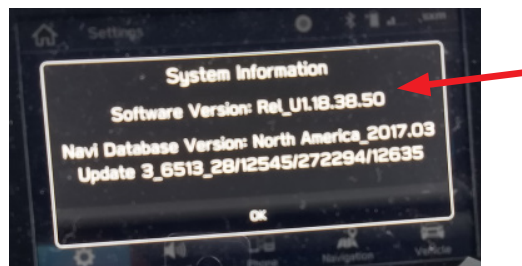
- The currently installed software version will be displayed. If the Software Version is **Rel_UE 19.22.70 or Rel_UE 19.25.70** (or before), proceed to **Step 2**. This version number is the same for all 4 levels of head unit.

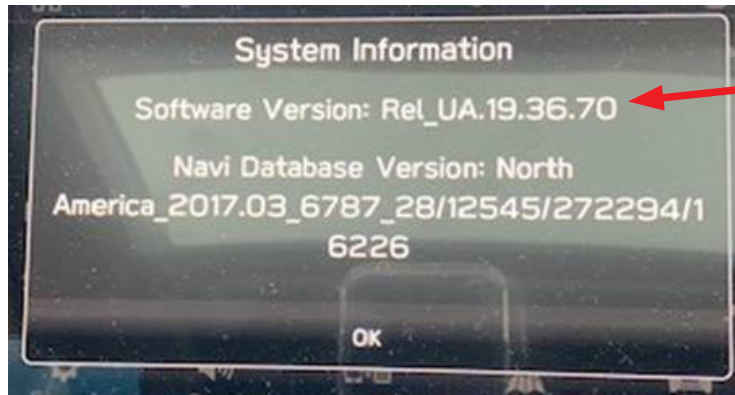
- Confirm Software Version is now “**Rel_UA.19.36.70**”.
