N472NAS1

TECHNICAL BULLETIN

Service Action: Windshield Molding Tapping Noise

| MODEL: | MODEL YEAR: | VIN: |
|---|---|---|
| Defender (LE) | 2020 | 000584-008252 |

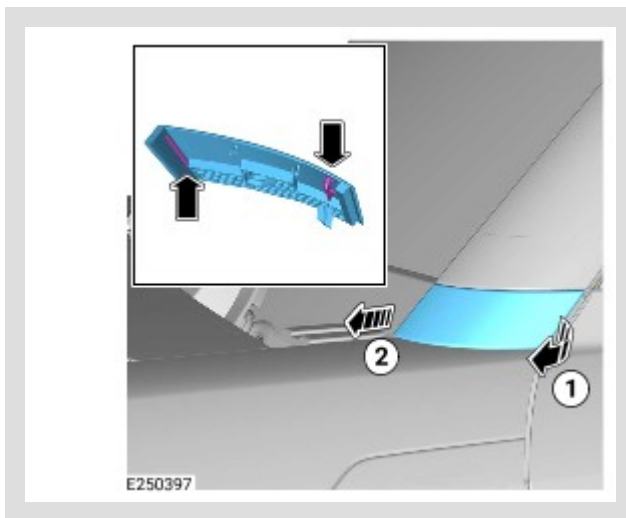
Right windshield molding bolt cover shown; left windshield molding bolt cover similar.

View the video and then remove the left windshield molding bolt cover.

1. Release clip closest to the door first in the direction shown.
2. Release second clip by pulling the bolt cover away from the vehicle in a forward direction.
