N472NAS2

# TECHNICAL BULLETIN

Service Action: Windshield Molding Tapping Noise

MODEL:	MODEL YEAR:	VIN:
Defender (LE)	2020	000584-008252

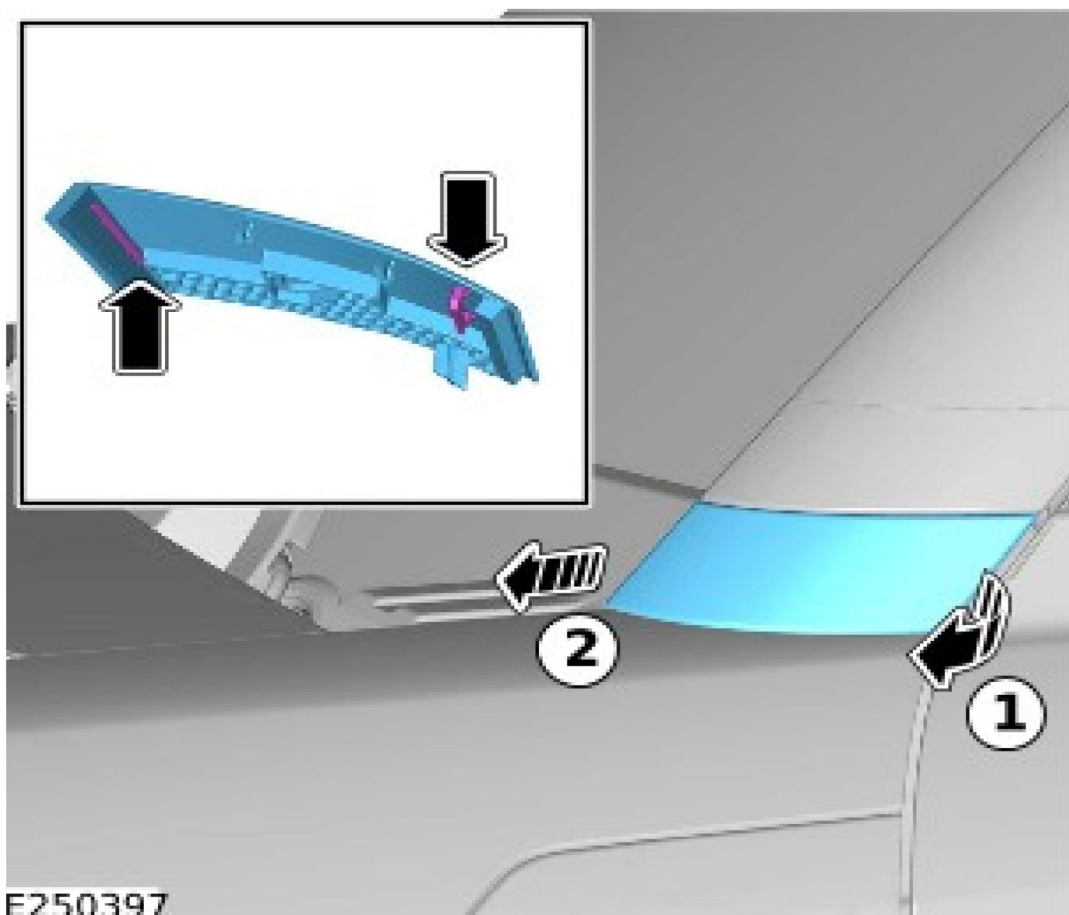
Right windshield molding bolt cover shown; left windshield molding bolt cover similar.

View the video and then remove the left windshield molding bolt cover.

- 1. Release clip closest to the door first in the direction shown.
- 2. Release second clip by pulling the bolt cover away from the vehicle in a forward direction.

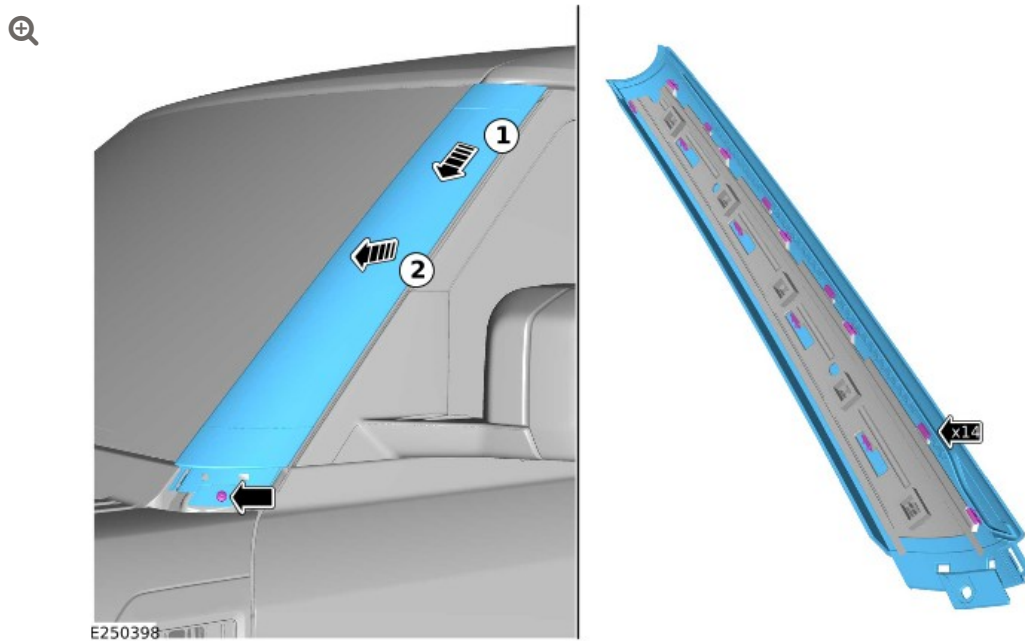
- Extra care must be taken not to damage the windshield molding.
- Do not use tools during this operation; removal of the component must be completed by hand.

Remove the retaining bolt and then remove the left windshield molding.

- 1. Pull the windshield molding down in the direction shown.
- 2. Release the windshield molding from the vehicle by pulling in a forward direction.
