Title: Base Line 1020 update

Applicability: MY20 Revero GT

CC-20-00-02

Type: Baseline Release

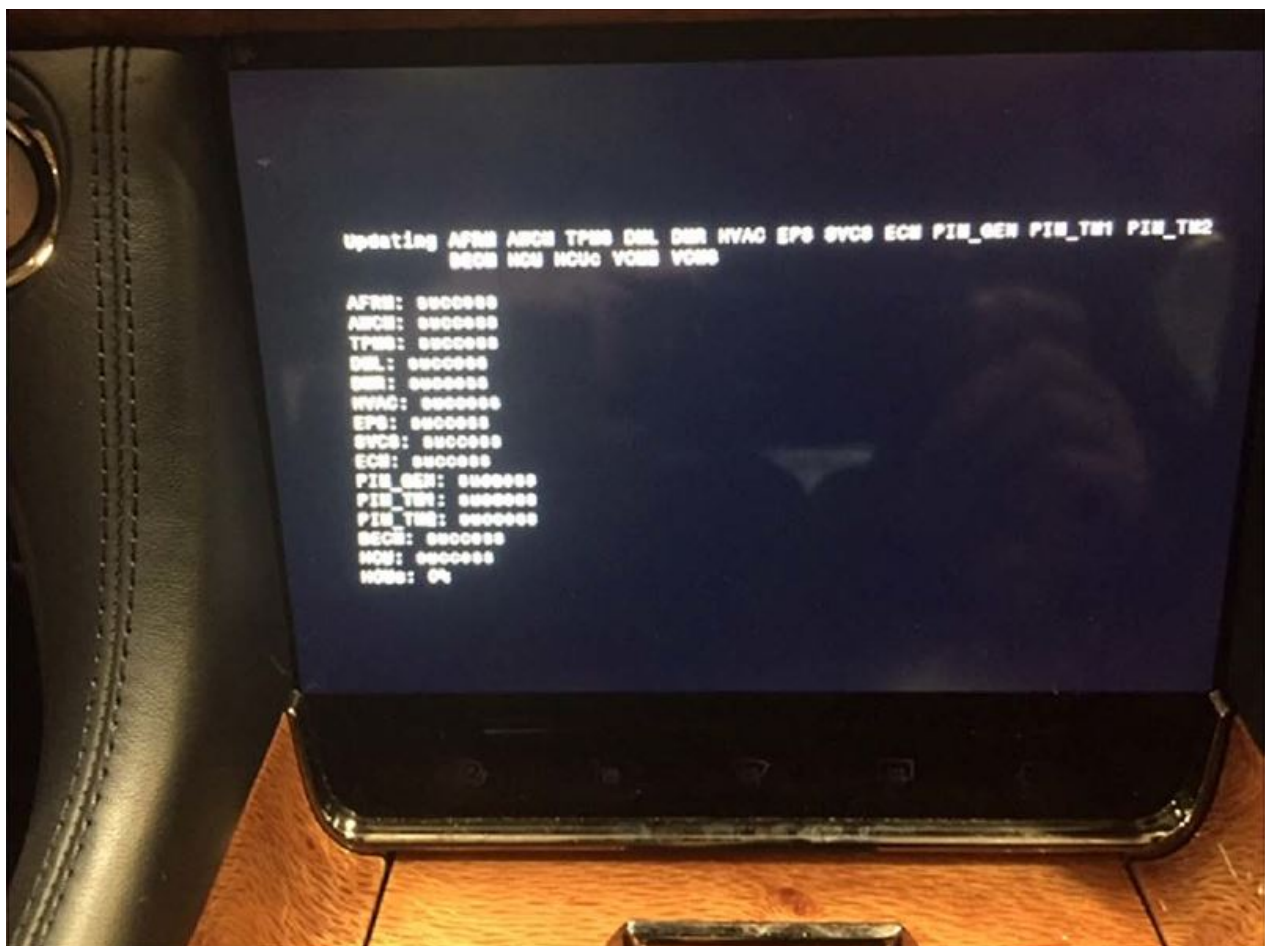
Note: Once completed with Karma Sync a secondary FOTA install prompt will appear. Please accept this prompt as it will override the existing s/w with the same version. This is FOTA stage 2. This is normal operation for BL1020.

- Proceed to full vehicle update
- Select the modules that are mismatched (Should be four modules)
 - HCUc
 - VCMS
 - VCMB
 - EBCM
- Please make sure the front right, rear right, rear left, and the hood are closed
- Close the striker/ latch on the left front door as you will need to be in the vehicle to follow Karma Sync prompts
- Continue with the update
