TECHNICAL INSTRUCTIONS
FOR
LIMITED SERVICE CAMPAIGN KLG
CUSTOMER SUPPORT PROGRAM 19LE05

SAFETY CONNECT SYSTEM – VEHICLE LOCATION INACCURATE
CERTAIN

**2011 – 2017 MODEL YEAR LS, 2013 – 2016 MODEL YEAR LS Hybrid,
2011 – 2017 MODEL YEAR GS, 2016 – 2017 MODEL YEAR GS-F,
2013 – 2017 MODEL YEAR GS Hybrid, 2010 – 2017 MODEL YEAR IS,
2011 – 2015 MODEL YEAR IS-C, 2013 – 2014 MODEL YEAR IS-F,
2015 – 2017 MODEL YEAR RC, 2015 – 2017 MODEL YEAR RC-F,
2011 – 2017 MODEL YEAR CT, 2010 – 2017 MODEL YEAR RX,
2010 – 2017 MODEL YEAR RX Hybrid, 2015 – 2017 MODEL YEAR NX,
2015 – 2017 MODEL YEAR NX Hybrid, 2013 – 2017 MODEL YEAR LX,
2013 – 2018 MODEL YEAR GX, 2010 – 2017 MODEL YEAR ES,
2013 – 2017 MODEL YEAR ES Hybrid**

Updated 08/24/2020

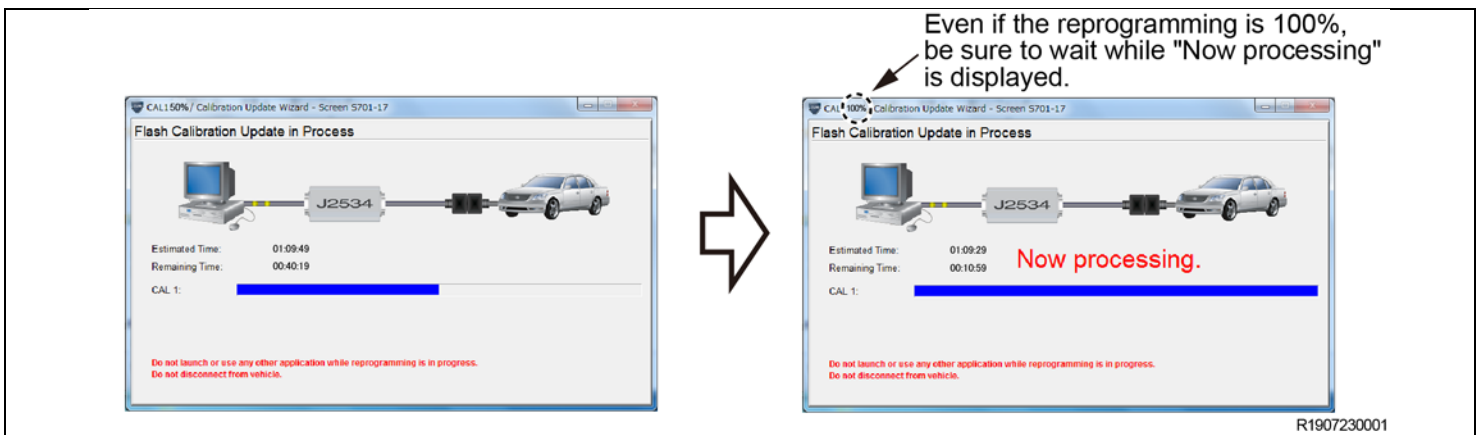
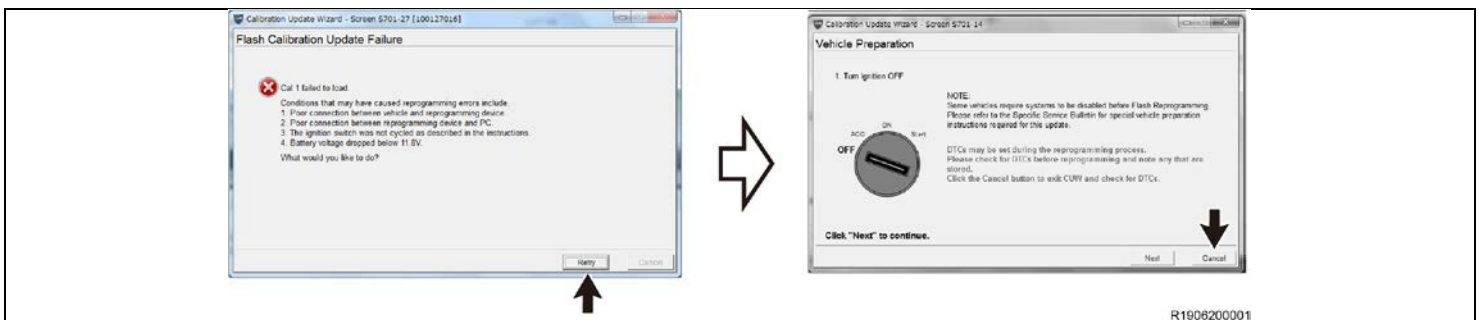
If the following window is displayed and the reprogramming has failed, click on "Retry" and then "Cancel" to finish the reprogramming process. Remove the DCM (telematics transceiver) from the vehicle and perform the reprogramming procedure again only to the DCM (telematics transceiver). Refer to Section XIII

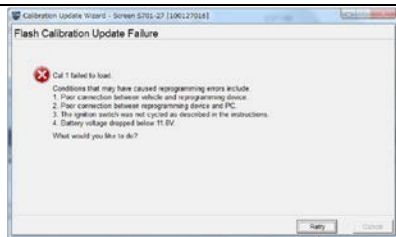
R1906200001

If the following window is displayed and the reprogramming has failed, click on "Retry" and then "Cancel" to finish the reprogramming process. Remove the DCM (telematics transceiver) from the vehicle and perform the reprogramming procedure again only to the DCM (telematics transceiver). Refer to Section XIII
