SS 1034348 New Cascadia Unintended 4-way Flashers Activation

This solution applies to all New Cascadia (P4) vehicles.

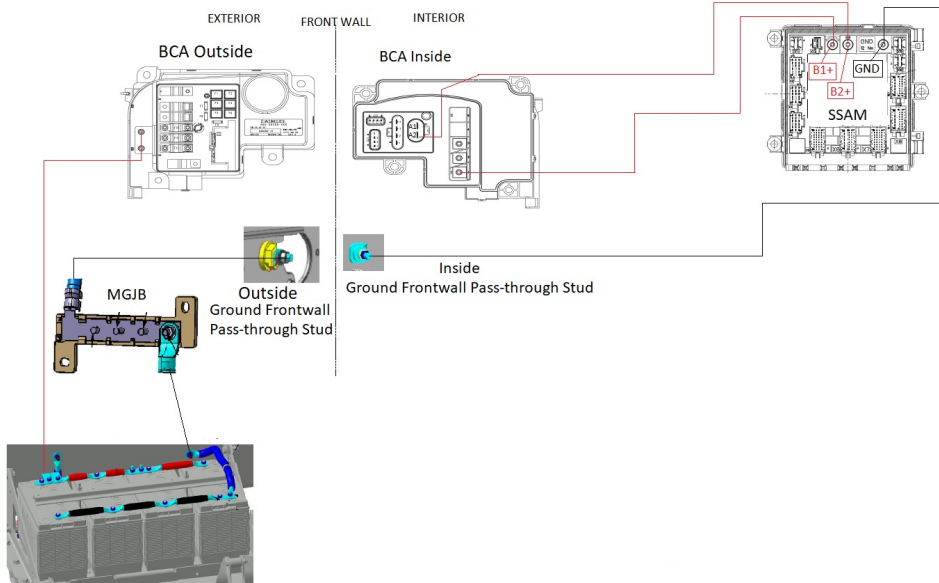
The figure below of the power supply path to the SSAM is being supplied as a reference. The figure can be referenced when tracing out voltage drops if needed.

Prior to running voltage drop tests, inspect the power and ground cables to the SSAM:

Prior to inspecting the power and ground cables to the SSAM, make sure to unhook the ground cable to the Batteries, eliminating any power to the vehicle.

- Remove the Bat 1, Bat 2 and the ground cable from the SSAM. When removing the cables from the SSAM studs, make sure to inspect the cables for any excessive Loctite or glue that may be present on the ring eye terminals (See photos below). Make sure to document any material that is found on these connections.
- Clean the SSAM studs, cable ring eye connections and all of the mounting hardware, so that all connection surfaces are clean and free of foreign material.
- The reason for this inspection and cleaning of the connections, is to ensure that no voltage drop occurs between the cable ring eyes and the studs located on the SSAM. Note: Locking nuts for the power and ground connections were installed starting 5/20/2019, eliminating the need for any Loctite. The new locking nut P/N is 23-14592-008 - NUT-HEX,SST,8M,W/ PATCH LOCK.
