9/11/2020
CAL FTL 35001

Subject: Inspection of ConMet Disc Brake Rotor to Hub Fastener

Models Affected: All Business Class M2, New Cascadia, and Coronado vehicles built from June 1, 2020 through August 24, 2020

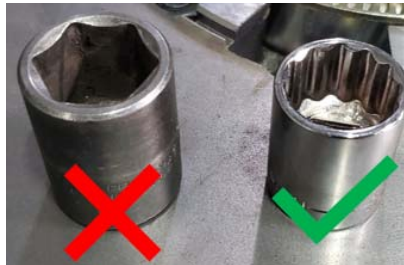
1. Support the hub in a way that allows up to **40 ft-lb** of torque to be applied to the rotor mounting nuts. Potential methods include setting in an upside down drum or wheel or other fixture or held by a second person.
2. Torque all ten (10) rotor attachment nuts in the tightening direction to **40 ft-lb** (or practical equivalent). If the nut turns, continue to tighten the nut to verify that the stud is being pulled out of the hub. **This is a reject condition.** Note: due to the length of the stud shank and friction between the stud shank and the hub it may not be easy to remove the stud by hand even after the stud rotates freely.

3. Mark rejected hubs as “RS NG” and reserve for ConMet. Replace with a new hub assembly.
4. Mark certified hubs with a “RS OK” on the top of the flat pads on the rotor.
5. If the inspected hub was removed from an axle, replace the seal before reassembling on to the axle.

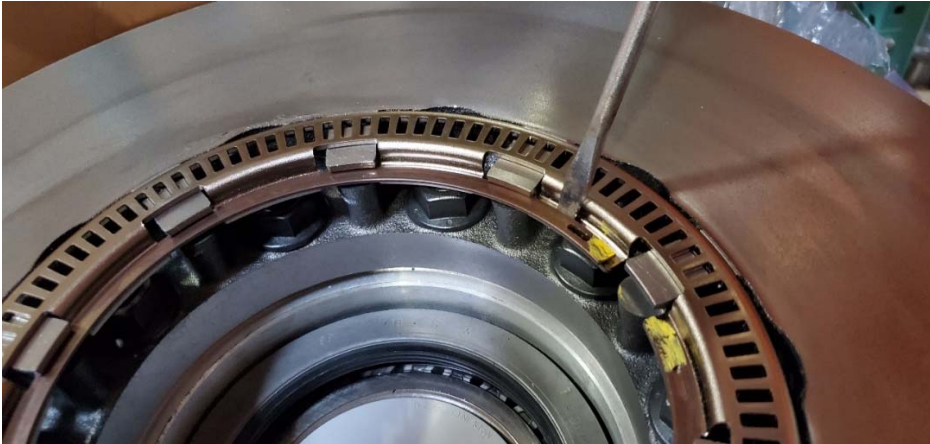
3. Remove the ABS ring from the rotor.
4. Torque all ten (10) rotor attachment nuts in the tightening direction to **40 ft-lb** (or practical equivalent). If the nut turns, continue to tighten the nut to verify that the stud is being pulled out of the hub. **This is a reject condition.** Note: due to the length of the stud shank and friction between the stud shank and the hub it may not be easy to remove the stud by hand even after the stud rotates freely.

5. Mark rejected hubs as "RS NG" and reserve for ConMet. Replace with a new hub assembly.
6. Mark certified hubs with a "RS OK".

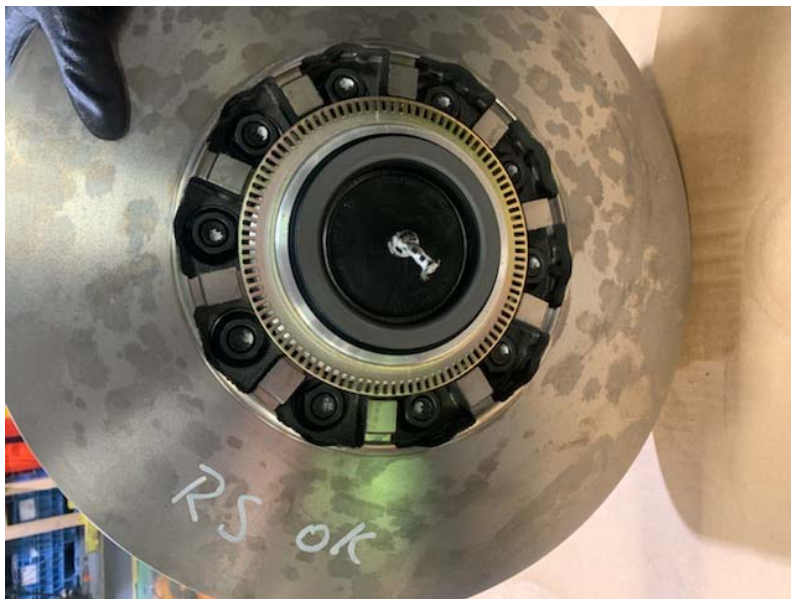
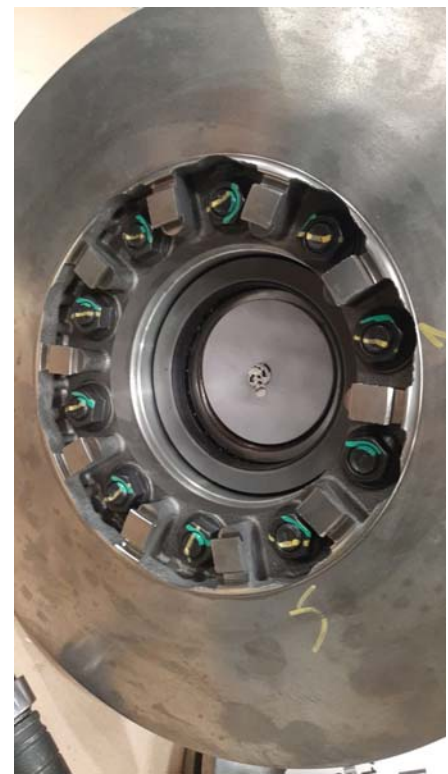
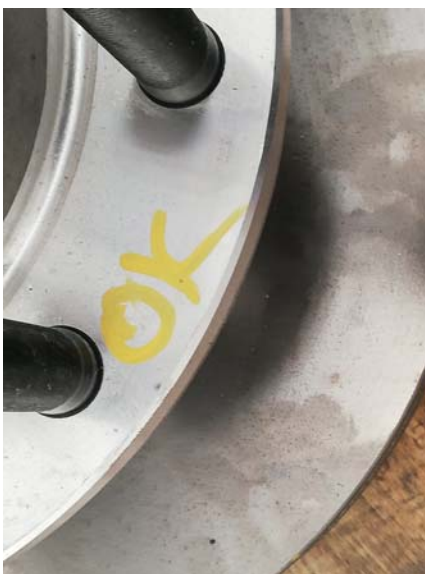
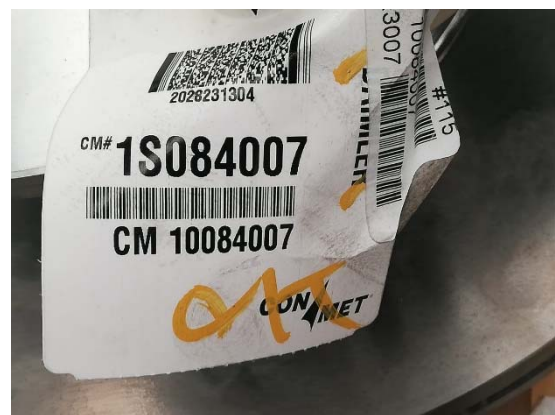
Below images are previous examples of certified inspected hub marking.
