Mack Chassis - Rear Drive, Transverse Torque Rod Bracket Failure

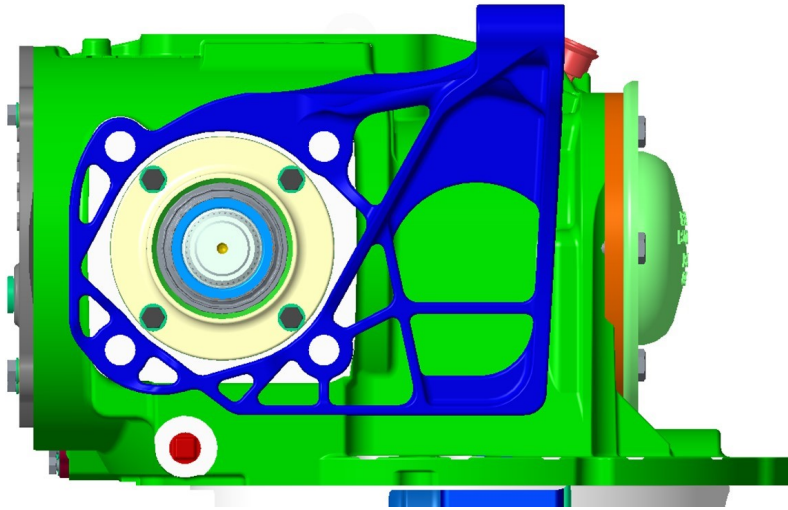
Bracket 22539545

Mack Trucks has seen an increase in Mack rear drive, transverse torque rod bracket failures.

Failures happen after the studs loosen on the rear of the carrier or when the bracket does not sit flat on the carrier housing to the torque rod bracket.

Inspect for a raised boss area on the carrier
Inspect for bracket not being seated flush with the carrier housing
Remove studs
If applicable grind smooth to match the flat surface for the bracket (be careful to grind smooth so no cracks form)
Clean and install the studs with Loctite 263. Torque to 225-275 lb-ft.
