Popping/Crackling from the Speakers; Display Blank

Supersedes 20-031, dated June 18, 2020, to revise the information highlighted in yellow.

Year	Model	Trim Level	VIN Range
2019-20	RDX	ALL	ALL

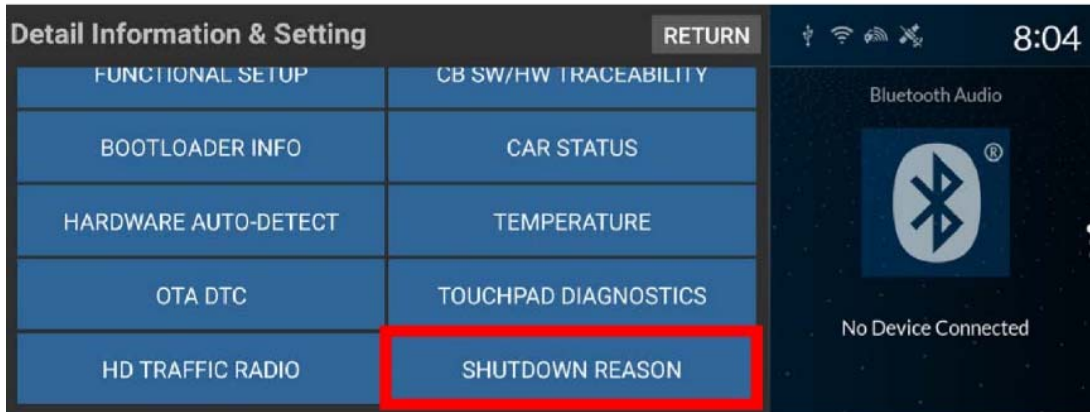
3. Scroll down the menu, and select **SHUTDOWN REASON**.

In this example, the cause of the failure can be identified as **Meter:SUDDEN_SIGNAL_OFF**.

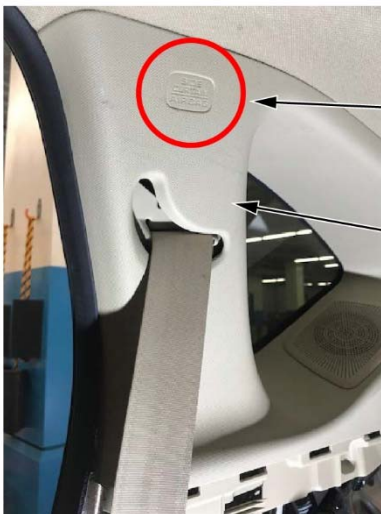
**QUARTER
PILLAR TRIM**

Lightly tap this area
with a rubber mallet.

17. Using a rubber mallet, apply a light blow to disengage the quarter pillar trim clip (a must-replace part). Then, remove the quarter pillar trim. Once it is removed, install a new quarter pillar trim clip.
