GROUP	MODEL
ELE	2021MY K5 (DL3a)
NUMBER	DATE
207	September 2020

TECHNICAL SERVICE BULLETIN

SERVICE ACTION: FRONT PASSENGER VENTILATED SEAT HARNESS INSPECTION AND REPLACEMENT (SA434)

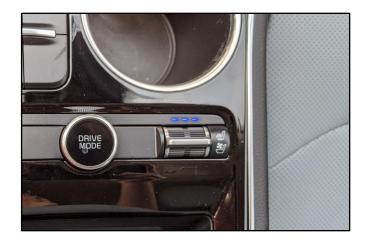
This bulletin provides information regarding the front passenger seat harness on some 2021MY K5 (DL3a) vehicles produced from March 27, 2020 through June 19, 2020, which may have had an incorrect passenger seat harness installed during assembly. The incorrect seat harness may cause the front passenger ventilated seat feature to timeout after a short period of time. Before conducting the procedure, verify the vehicle is included in the list of affected VINs.
