MODEL  
2021MY  
K5 (DL3A)

NUMBER  
092 (Rev 2, 09/03/2020)

## TECHNICAL SERVICE BULLETIN

SUBJECT: **SERVICE ACTION: HOOD RELEASE CABLE,  
INTERCOOLER CLAMP AND WINDSHIELD SIDE MOLDING (SA431)**

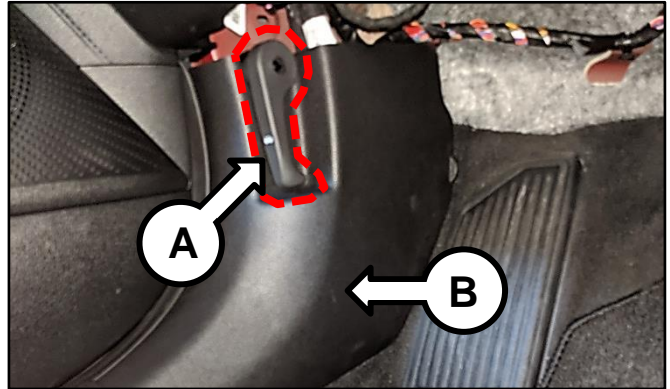
1. Pull the hood release lever (A) located on the lower left kick panel (B).

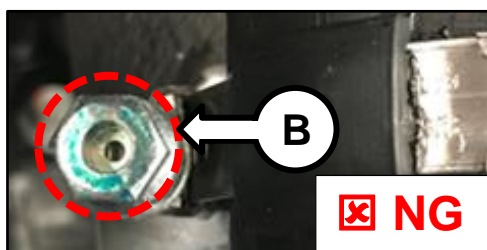
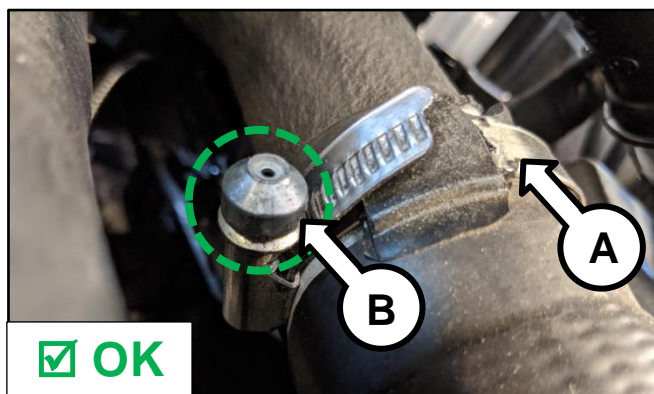
- 2a. Confirm that the hose clamp (A) break away nut head (B) is not present. If so, this action is complete.

- 2b. If the hose clamp (A) break away nut head (B) is present:

- Tighten the hose clamp break away nut (B) until the nut head breaks off the clamp
- Pull on the intercooler hose to verify that the hose is secure. This action is now complete.

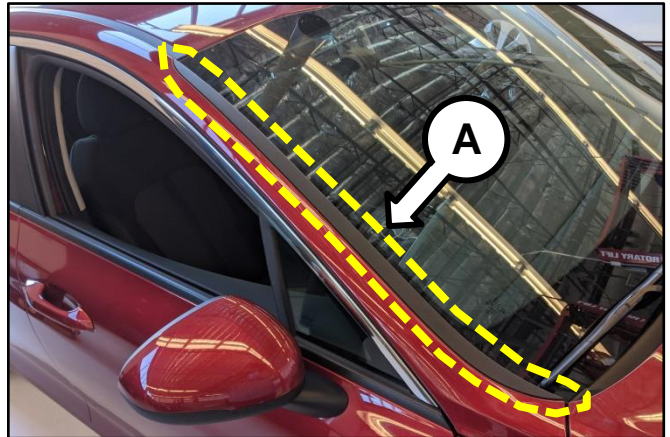
- 2a. Check if the windshield trim molding is not flush to the A-pillar or is loose. Lightly pull on the following areas shown.

1. Locate the left or right side windshield trim molding (A).
