**SERVICE BULLETIN**

**APPLICABILITY:** 2020MY Legacy and Outback Models      **NUMBER:** 15-261-20R  
**SUBJECT:** Reprogramming File Availability for Optimization of Gen 4 Denso CP1 Infotainment Systems      **DATE:** 03/10/20  
**REVISED:** 09/09/20

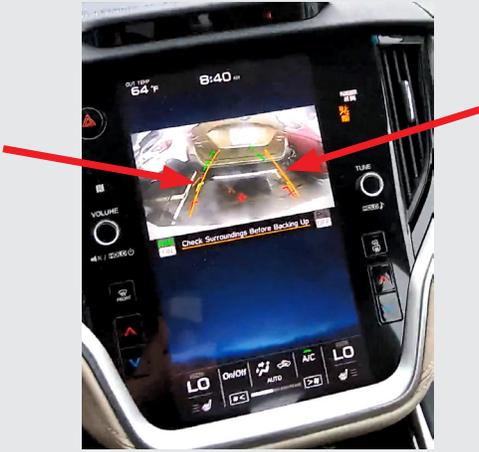
</div> <p><b>**NOTE:</b> After switching the ignition off and leaving the driver’s door open more than 70 seconds, the system <i>may</i> recover after switching the ignition back on.</p>
<b>2</b>	<p>Delayed response of rear view camera guide lines. When the rear view camera is activated and the steering wheel is turned, there is a delay before the steering-responsive guide lines respond to the steering wheel input.</p> <div style="text-align: center;">
