# HYUNDAI Technical Service Bulletin

| GROUP<br><b>STEERING</b> | NUMBER<br><b>20-ST-002H-2</b> |
| DATE<br><b>SEPTEMBER, 2020</b> | MODEL(S)<br><b>ELANTRA (ADa)</b> |

**SUBJECT:** C-MDPS WORM SHAFT ASSEMBLY BEARING NOISE

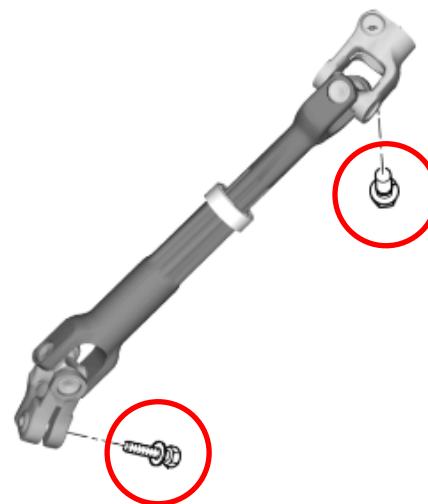
If the pinch bolts on either end of the steering universal joint assembly are removed, the bolts **cannot** be reused during reassembly.

3. Remove the C-MPDS assembly and universal joint according to the applicable vehicle shop manual.
