Technical Service Bulletin

GROUP STEERING	NUMBER 20-ST-003H-1
DATE SEPTEMBER, 2020	MODEL(S) Multiple

SUBJECT: C-MDPS WORM SHAFT BEARING NOISE

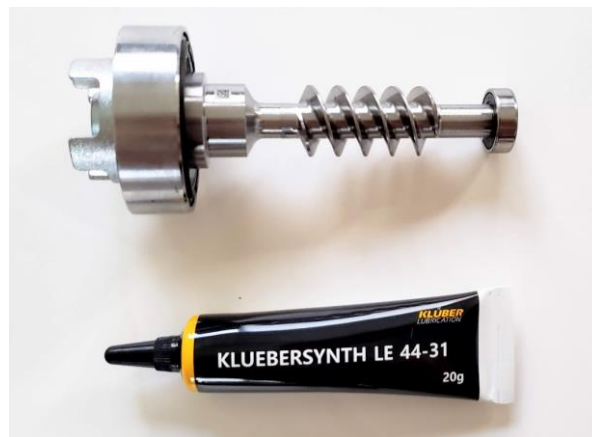
Description: Certain vehicles may develop a bearing noise within the Motor Driven Power Steering (MDPS) column worm shaft assembly. If bearing noise is heard, follow the procedure in this bulletin to replace the worm shaft assembly.

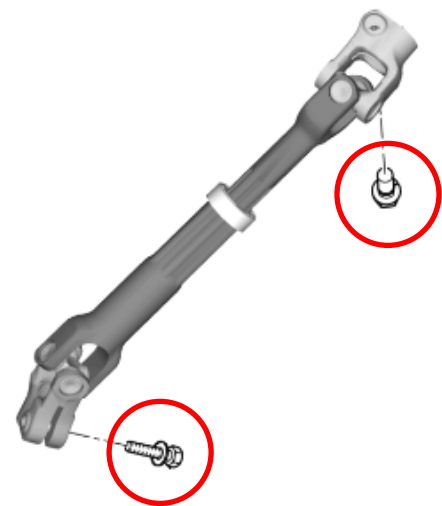
If the pinch bolts on either end of the steering universal joint assembly are removed, the bolts **cannot** be reused during reassembly.

- Remove the C-MDPS assembly and universal joint according to the applicable vehicle shop manual.
