2019FA07, Rev. E  
September 16, 2020  
Product Code(s): 65, 66  
Page 1 of 15

**SUBJECT:** Special Coverage for TIDB Aluminum Main Valve Body – Reactive

**MODELS AFFECTED:** 3000 Series™, 4000 Series™, B200™, B300™, B3400 xFE™, B400™, B500™, T200™, T300™, T400™, T500™ Models

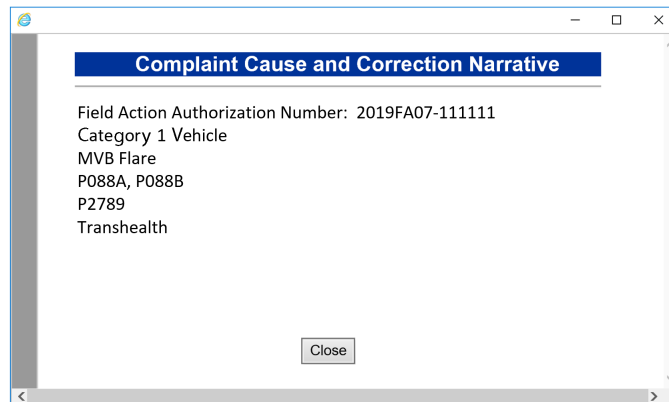
**Figure 4. Claim Narrative Example**

- Include the 2019FA07 authorization number in the first line of the AWAARE Claim Narrative
- Indicate the Vehicle Category (1 or 2) in the second line of the AWAARE Claim Narrative
- For a harsh upshift when C2 clutch is oncoming, include “MVB Flare” in the next line of the Claim Narrative
- For a P088A and/or P088B DTCs, include the applicable DTCs in the next line of the Claim Narrative separated by a comma and single space as required
- For a P2789 DTC, include “P2789” in the next line of the Claim Narrative
- For a TRANSHEALTH Red failure, include “Transhealth” in the next line of the Claim Narrative
