Popping/Crackling from the Speakers; Display Blank

Supersedes 20-031, dated September 25, 2020, to revise the information highlighted in **yellow**.

AFFECTED VEHICLES

Year	Model	Trim Level	VIN Range
2019-20	RDX	ALL	ALL

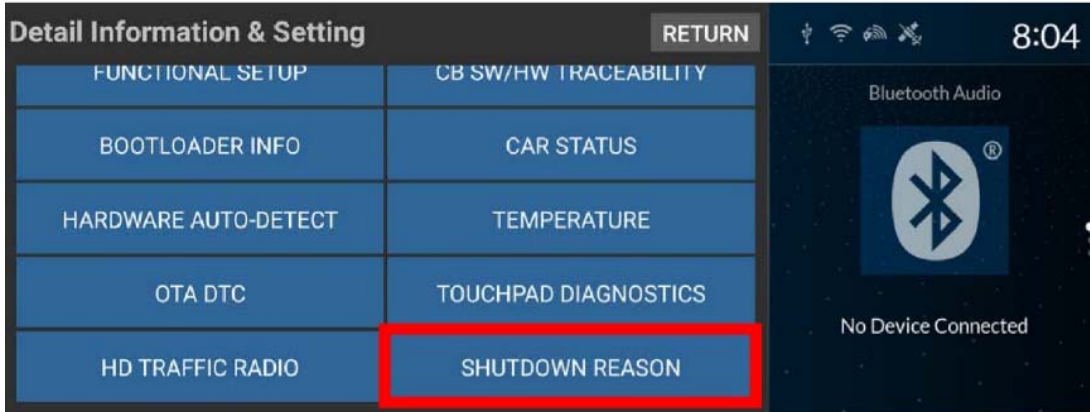
3. Scroll down the menu, and select **SHUTDOWN REASON**.

In this example, the cause of the failure can be identified as **Meter:SUDDEN_SIGNAL_OFF**.

4. Write down any failures as they will be collected on the warranty claim. Then, clear the data.
