SIB 52 05 20

BACKREST MISALIGNMENT OF 60/40 SECOND ROW SEAT

2020-09-09

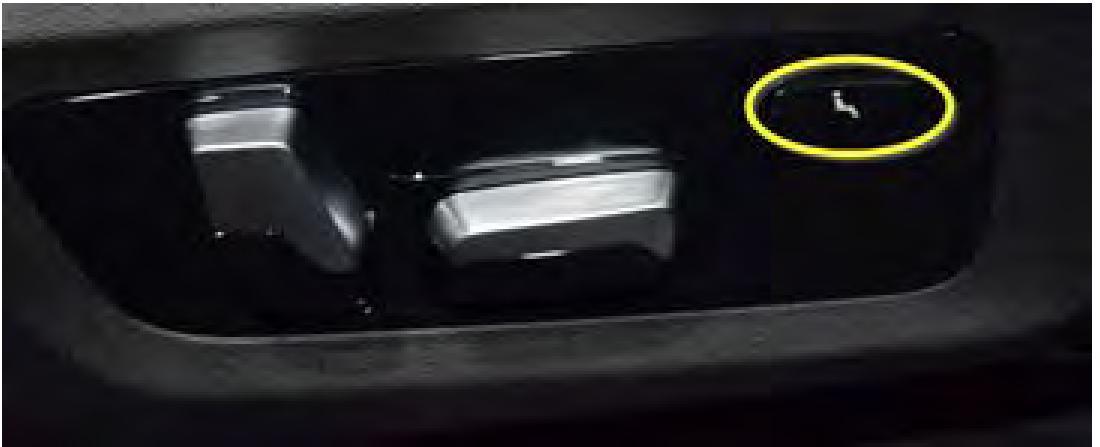
When seats are in the COMFORT position, use the backrest button on the side of the seat to recline the seat back further. If the seat is able to move beyond that stop then the seats must be initialized to learn full travel.

If there are no stored faults (*except for seat initialization*) then perform the seat initialization test plan in ISTA: Under VEHICLE MANAGEMENT

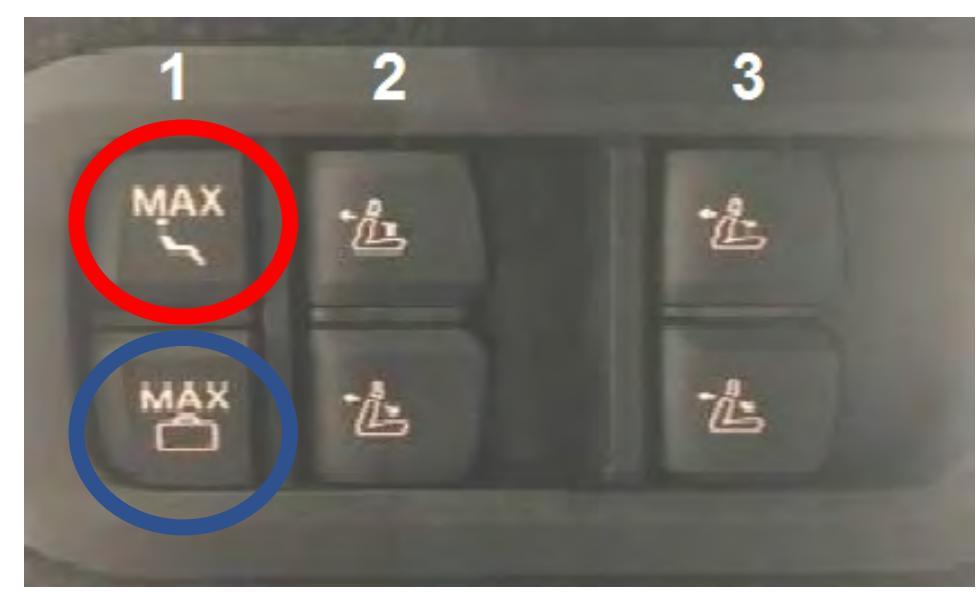
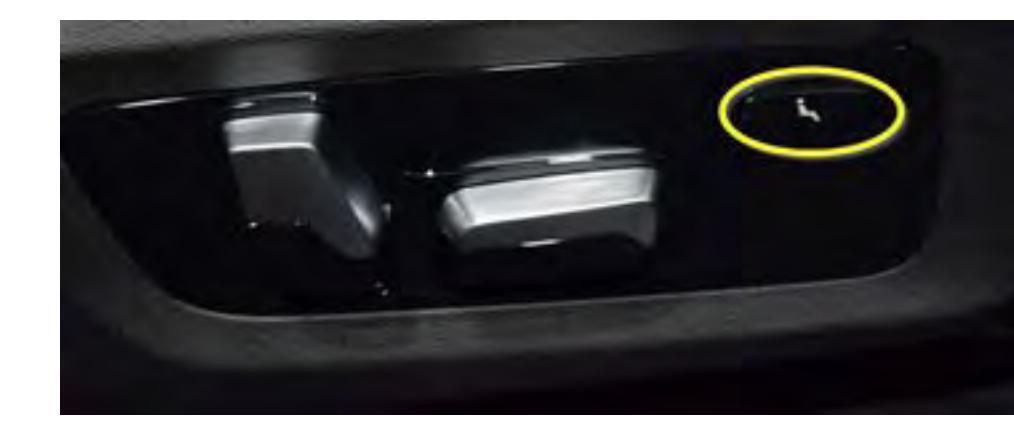
- A large misalignment can indicate the seats have not gone full travel during the previous movement, that the frame is bent or that there is an obstruction within the seat mechanism.
- Check for obstructions.
- Manually operate the seat controls (side of seat) to see if the backrest can be moved any further back.
- Repeat seat initialization test plan for 2nd row seats only.

- Cycle the 2nd row seat backrest to the MAX SEATING button, row 1 top button. (button circled in red)
- Once the seats have completed travel move seats to the COMFORT position by pressing the "Home" button on both sides of the seat (button circled in yellow).

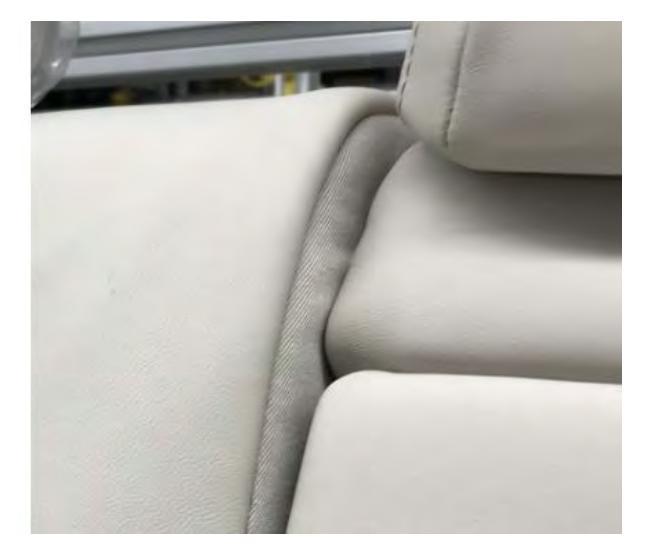
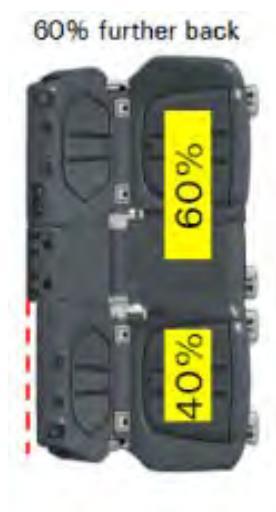
Rework 40% Seat

So we will be modifying the seat that's backrest sits further forward.

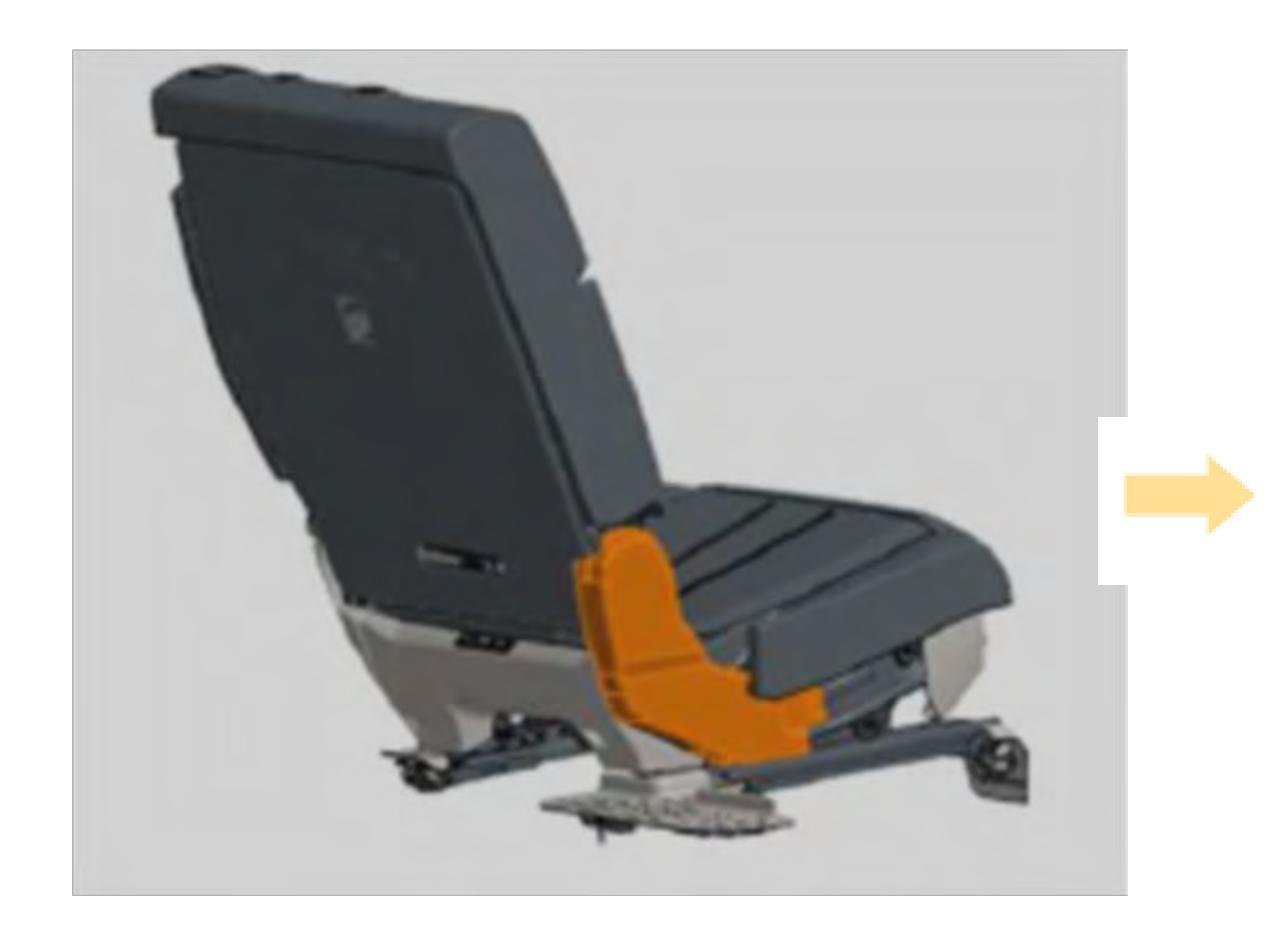
Before doing any rework of the end stop, check to ensure one end stop is making contact.

If they are not making contact on either side then the seat is not initialized, or the seat frame could be bent.

DO NOT rework the end stop until it is contacting the seat backrest.

If performing these modifications with seat installed in vehicle, move the 60% seat to EZ access position for more working room.

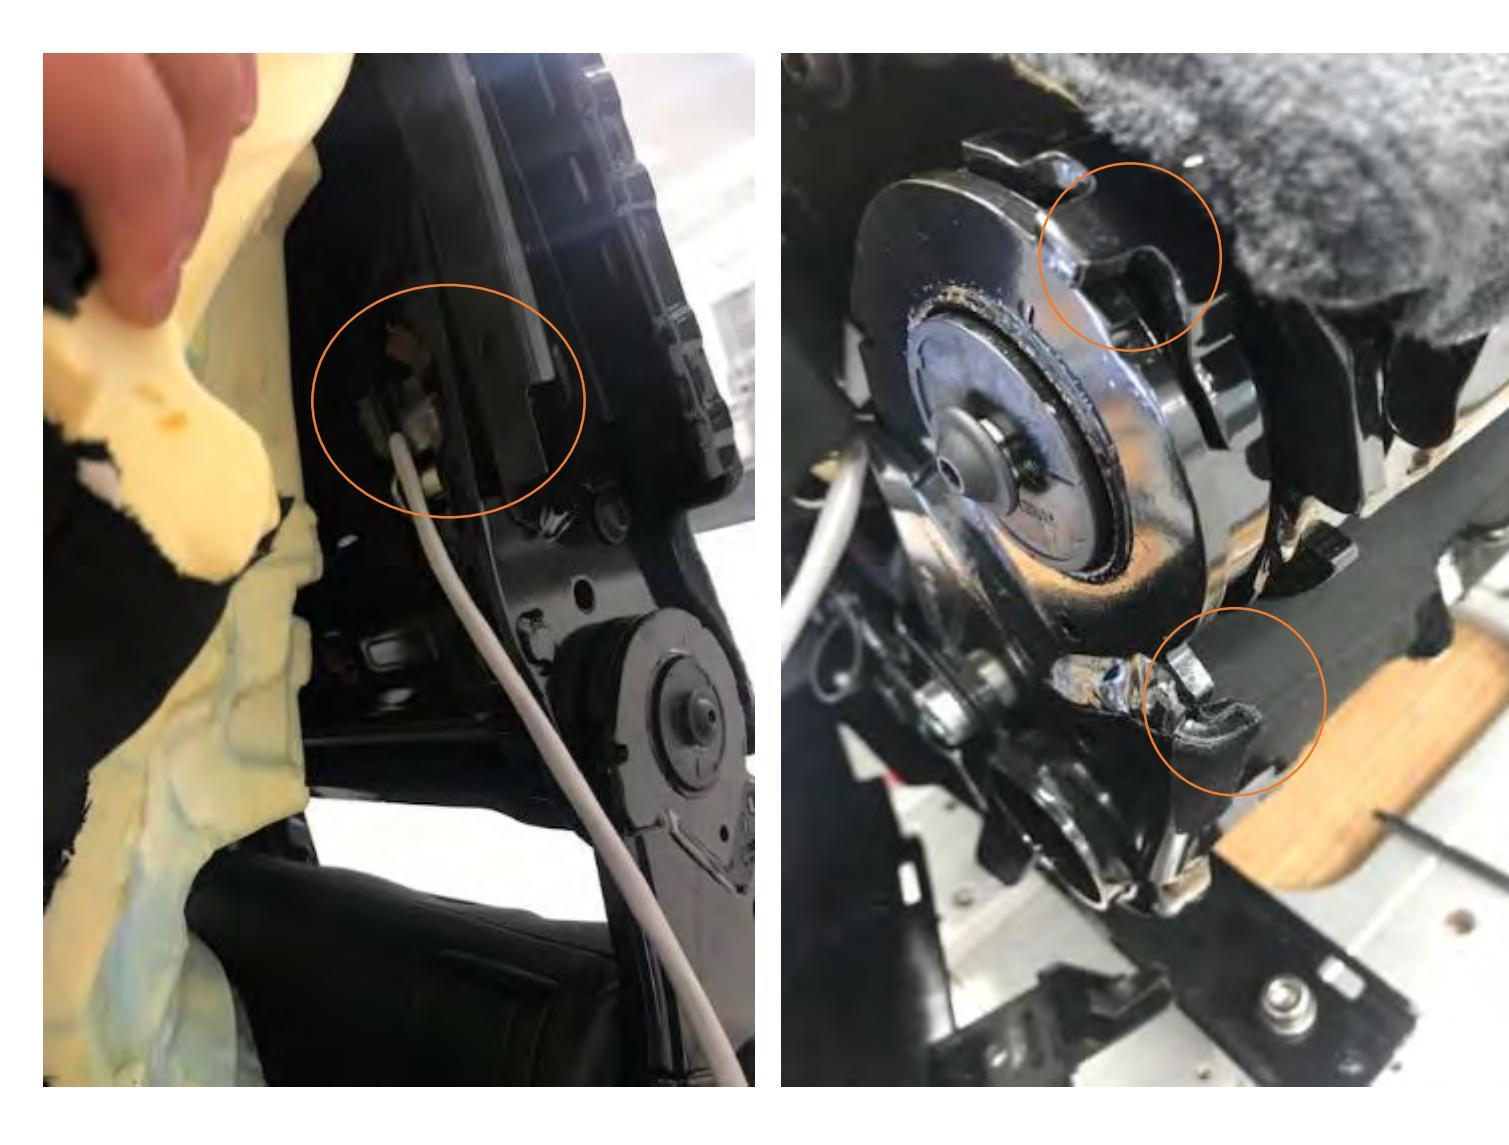
Only one end stop will be contacting, either IB or OB, this is the end stop to rework.

The seat is designed to function with only 1 end stop touching.

Plug in the 12V power source and drive seat to fold flat position, this action will move and expose the end stop to be reworked.

The amount of material to be removed is not defined, <u>small removal of material</u> and tests are required until the misalignment disappears. A maximum of 2.5 mm of material can be removed. (1mm removed at end stop is approximately 9mm movement of the backrest) This can be tested by driving the seat to the comfort position and again check the alignment. You must hook the seat up to the car and re-initialize the seat so it finds the new home position. Once you are done modifying the end stop apply a small dab of red paint to either side of the end stop so a technician in the future will know this modification has already been performed.

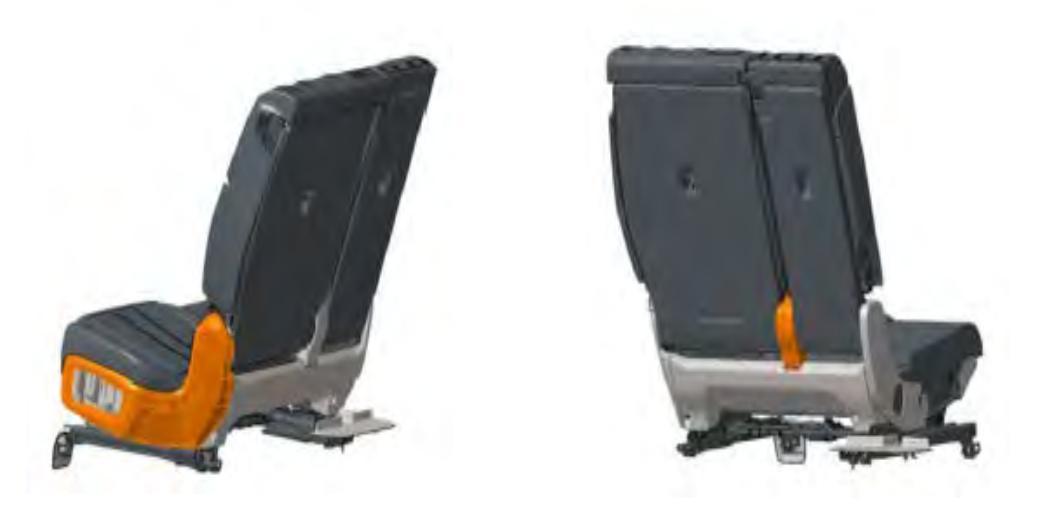
Only one end stop will be contacting, either IB or OB, this is the end stop to rework.

The seat is designed to function with only 1 end stop touching.

Remove recliner cover IB and OB OB = Out Board (side of seat closest to the door)
