UPDATE FROM WARRANTY OPERATIONS

WARRANTY OPERATIONS NEWSLETTER VOLUME 6, ISSUE 8

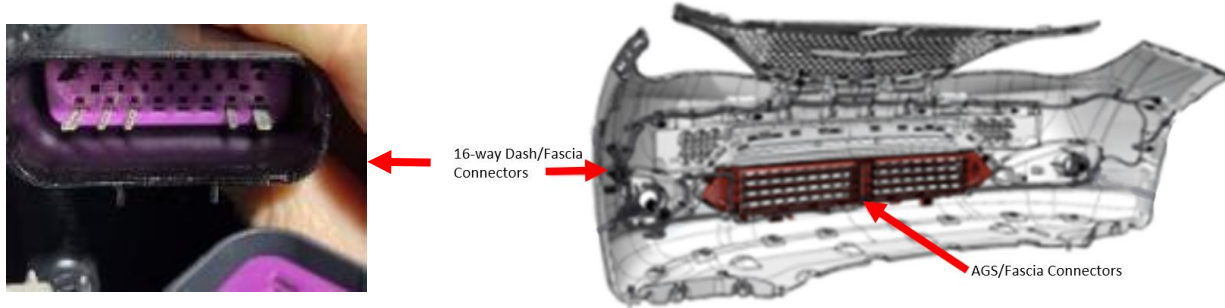
When the Malfunction Indicator Lamp (MIL) is on and AGS DTC U11E9 - Lost Communication with AGS is active or stored, do not automatically replace the AGS.

1. If the conditions below are present, use connector kit 68497543AA to repair the 16-way dash side connector and replace the fascia harness (a connector repair kit is not available).
 - Damage (nicks/cuts in the wires) at either 16-way connector. The damage may be very small and difficult to see with the naked eye.
 - Corrosion or moisture in either 16-way connector.

2. Disconnect the AGS/fascia connectors and inspect for corrosion. If corrosion is present in the fascia connector, repair it using connector kit 68396618AB or replace the harness as necessary.
3. If corrosion is present in the AGS connector, replace the AGS.
4. Do not add grease to the AGS/fascia connectors.

Verification: With scan tool, erase all DTCs. Check for the DTCs to return. If DTCs return, follow the U11E9-Lost Communication with AGS Diagnostic Procedure in Service Library.

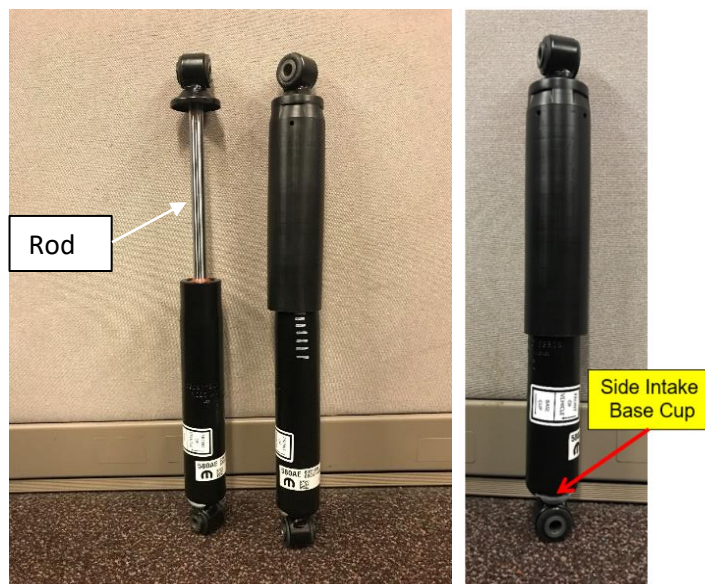
Image: Steering Dampers held in Rod Side Up Orientation.

As a reminder, the installation instructions below must be followed to properly install a new steering damper on the JL Wrangler. Failure to follow these steps can cause the steering damper to not operate as designed.

1. Before installation, hold the steering damper vertically in rod side up orientation as shown in the image below. (Base Cup should be at the bottom as indicated)

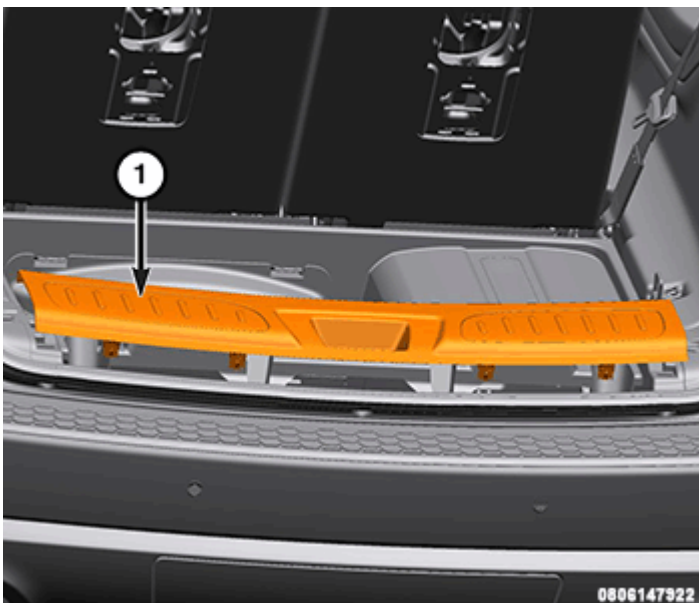
A Low Frequency (LF) Antenna is attached to the Durango and Grand Cherokee rear cargo load floor under the rear scuff plate. In order to remove the load floor, the antenna connector must be disconnected prior to pulling up on the load floor. If this is not disconnected, the LF antenna electrical connector will likely break.

CAUTION: Failure to disconnect the wire harness connector from the antenna on the rear of the cargo load floor bin, prior to removal of the load floor bin, will result in damage to the antenna, antenna mounting, or wire harness. Damage caused by failure to follow this procedure is not a warrantable repair.

Rear Cargo area scuff plate (item 1 below) must be removed to access the LF antenna connector.
