IMPORTANT UPDATE

TECHNICAL INSTRUCTIONS FOR SPECIAL SERVICE CAMPAIGN K0B MILLIMETER WAVE RADAR SENSOR

**CERTAIN:
2018 – 2019 TACOMA
2018 – 2019 TUNDRA**

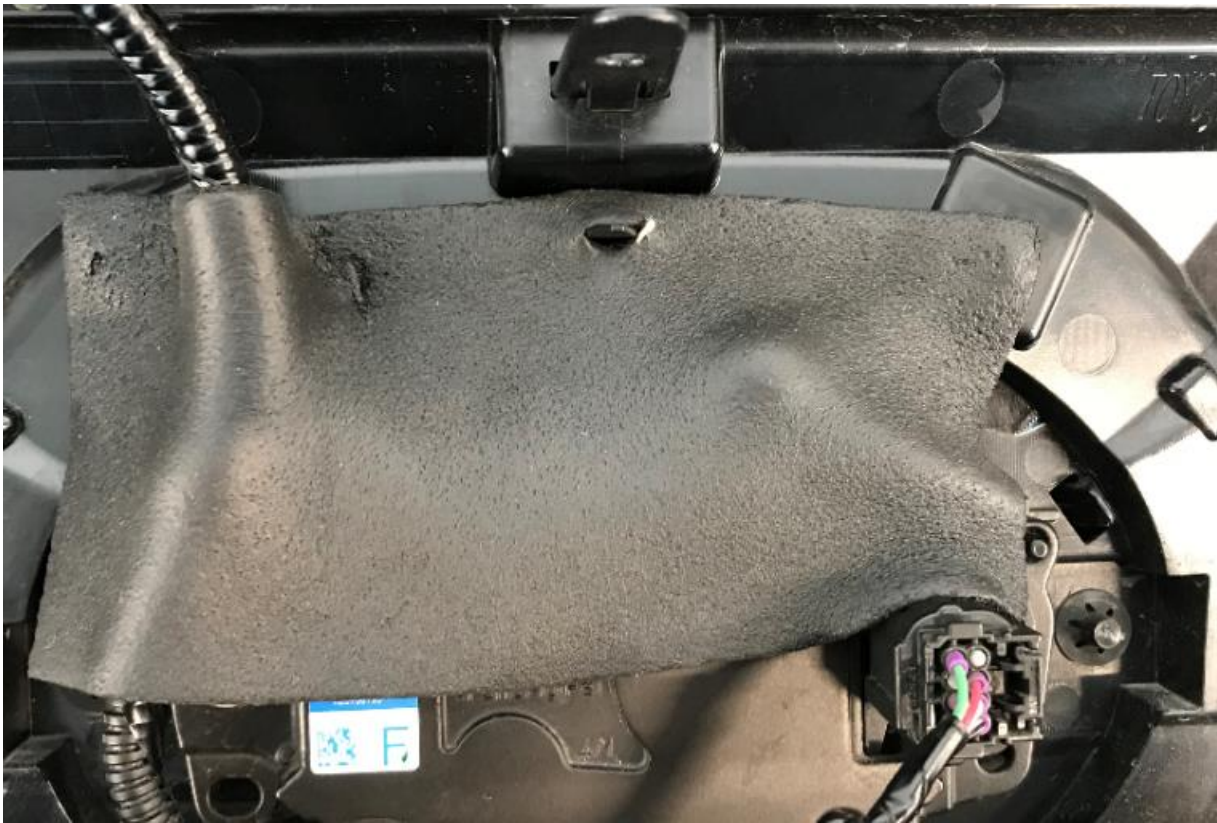
a. Apply the EPT Sealer to the back side of the MWRS in the position shown below:

- Start applying the EPT Sealer sheet to the vertical surface of the radiator grill, just above the MWRS.
- It will be necessary to push the EPT Sealer into the plastic tab at the top, creating a hole in the sealer.
- Wrap the EPT Sealer around the wire harness, as shown.
- Using heavy finger pressure, thoroughly press the entire surface of the EPT sealer to securely adhere it to all contact surfaces of the MWRS and grill.

Recommended temperature for adhesion is 50° F and above.
Keep stock at room temperature.

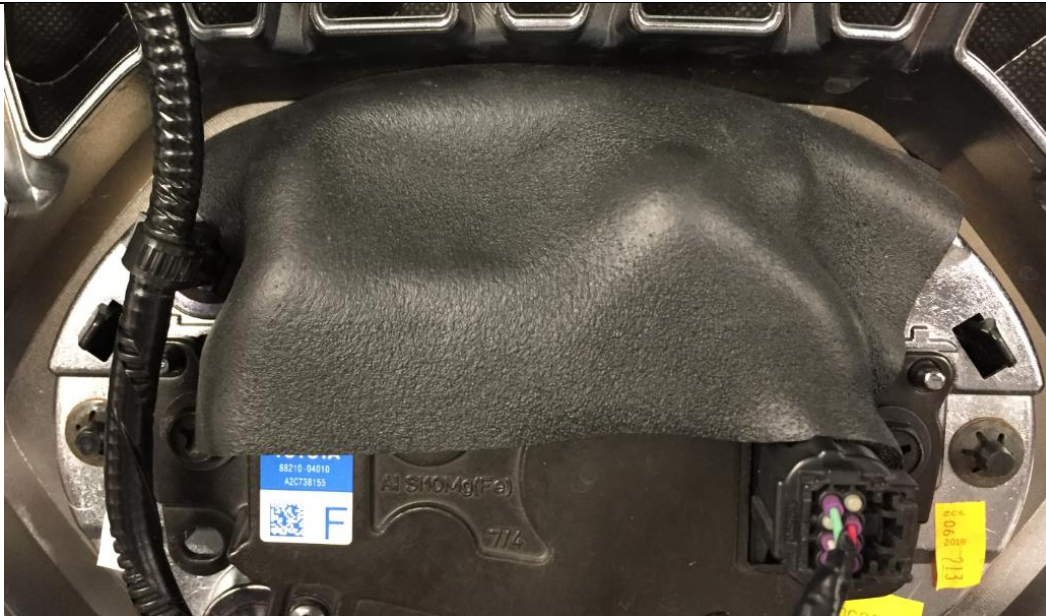
b. Apply the EPT Sealer to the back side of the MWRS in the position shown below:

- Start applying the EPT Sealer sheet to the horizontal lip of the radiator grill to create a waterproof shield over the top of the sensor.
- Using heavy finger pressure, thoroughly press the entire surface of the EPT sealer to securely adhere it to all contact surfaces of the MWRS.

Recommended temperature for adhesion is 50° F and above.
Keep stock at room temperature.

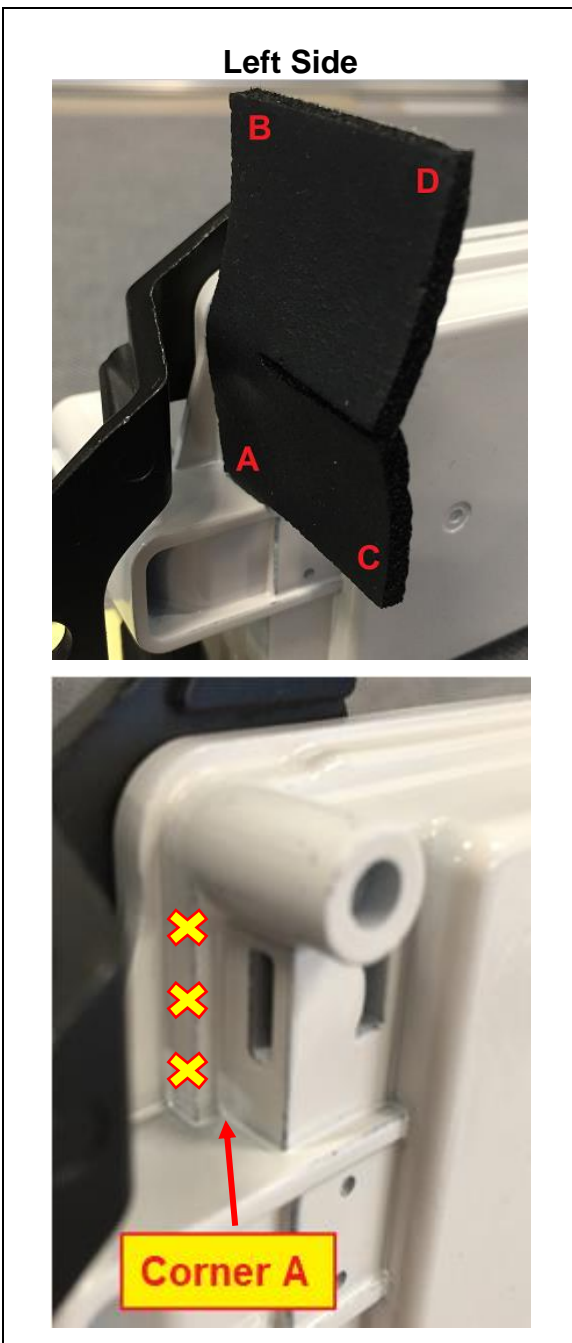
- a. Using general purpose cleaner, remove all traces of dust, dirt, and oils or grease from the application area (indicated within the red circle). Be careful not to get any liquids into the 2 vent holes.

Note: The MWRS housing has been painted white in these photos to provide more contrast in the pictures. The actual MWRS housings will be black.

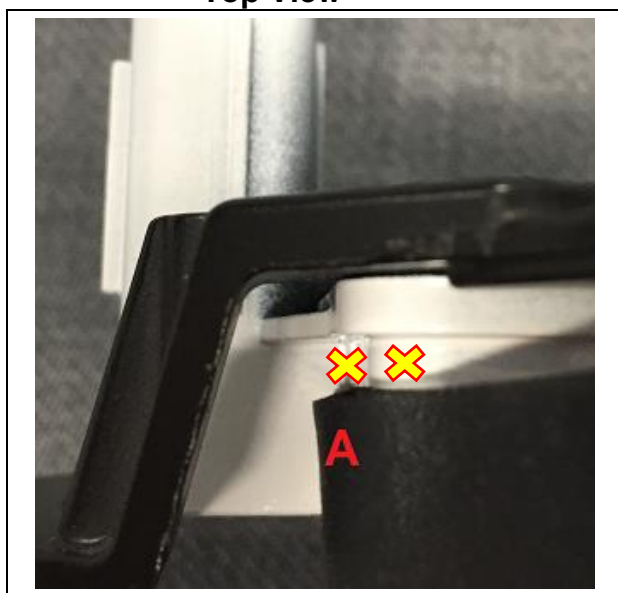
Top View

- a. Wear Nitrile Gloves to prevent adhesive contamination.
- b. Apply the EPT-Sealer to the left side of the MWRS to the following standard:
 - **Left Side View:** Corner “A” of the EPT-Sealer should be placed at the inner corner of the MWRS as indicated.
 - **Top View:** Place the EPT-Sealer on the surface of the side vent hole (it is ok to cover the side vent hole). **DO NOT place the EPT Sealer on top of the ridge**, as indicated with the yellow X’s.

- c. Press the EPT sealer firmly into place in this area to seat it thoroughly. Use a flathead screw driver or trim tool if necessary to reach the corner.

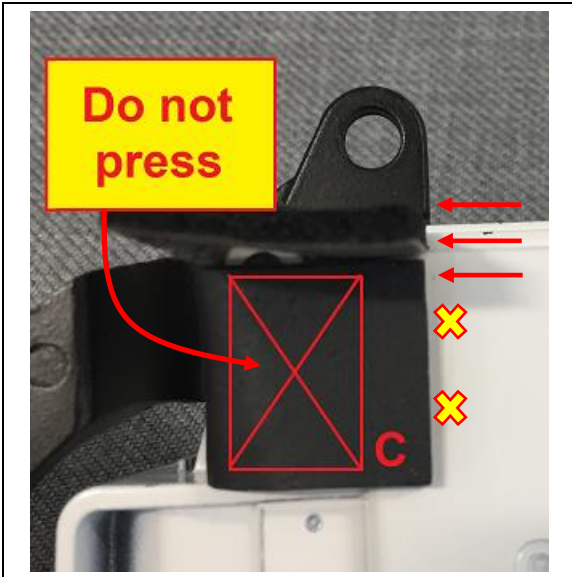
- d. Roll the EPT-Sealer Corner “B” onto the top edge of the MWRS sensor as shown, **aligning it’s edge with the end of the metal bracket. Be sure to keep the EPT-Sealer off the upper ridge.**
- e. Press the EPT sealer firmly into place in this area to seat it thoroughly.

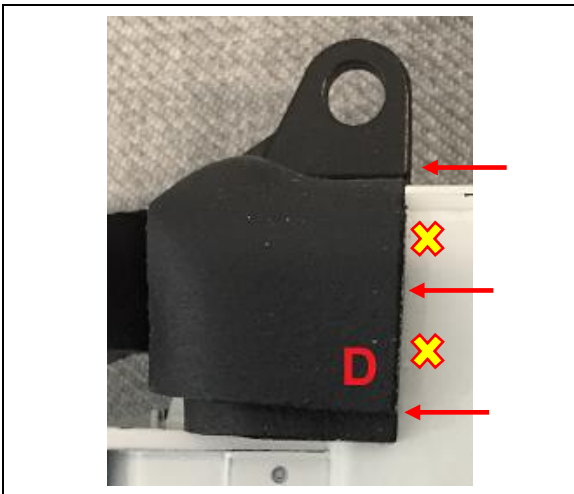
- f. Bend the lower flap (Corner “C”) onto the face of the MWRS and align the edge with the edge of the upper flap and metal bracket.
- g. Press the EPT-Sealer into the face of the MWRS to seat it firmly. **DO NOT** press in the area indicated as it’s critical there is an air gap for the vent.

<p>ONLY PRESS THE EPT-SEALER ONTO THE UPPER FACE OF THE MWRS. DO NOT press the EPT sealer into the vent hole. It’s critical that the vent hole remains open.</p>
---	---
