IMPORTANT SAFETY RECALL NOTICE

Subject: Can-Am® Ryker - Wheel nut may crack - New VINs Added in the Warranty Campaign and New Steps in the Procedure

WARRANTY BULLETIN SAFETY CAMPAIGN

Subject: **Wheel Nut May Crack**

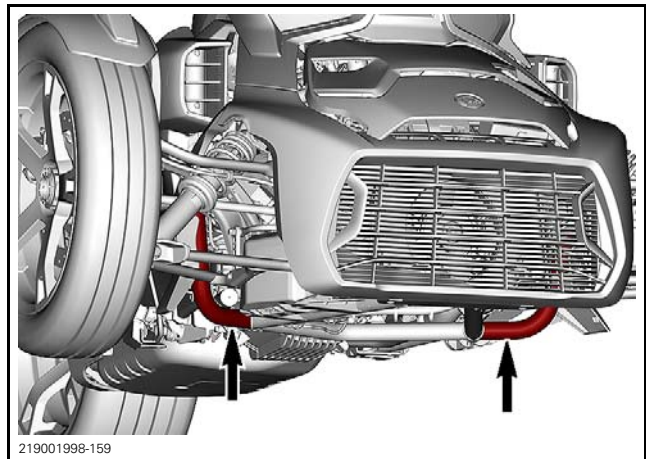
USE THESE TUBES TO LIFT OR SUPPORT THE FRONT OF THE VEHICLE

1. Place the vehicle on a level surface.
2. Lift and support the front of the vehicle.

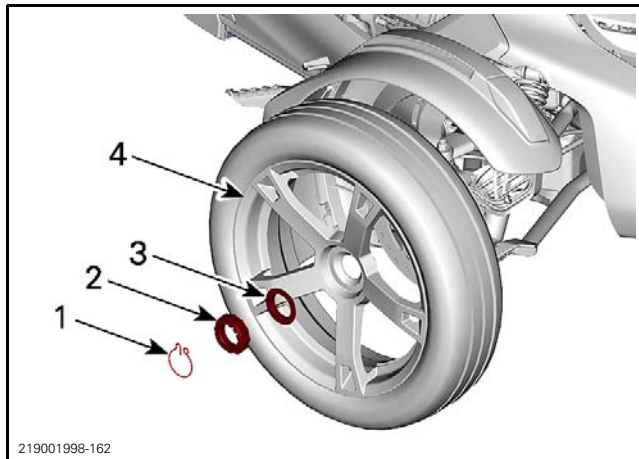
219001998-162

1. RED locking clip
2. Center lock wheel nut
3. Conical washer
4. Wheel

5. Remove and discard the center lock wheel nut.

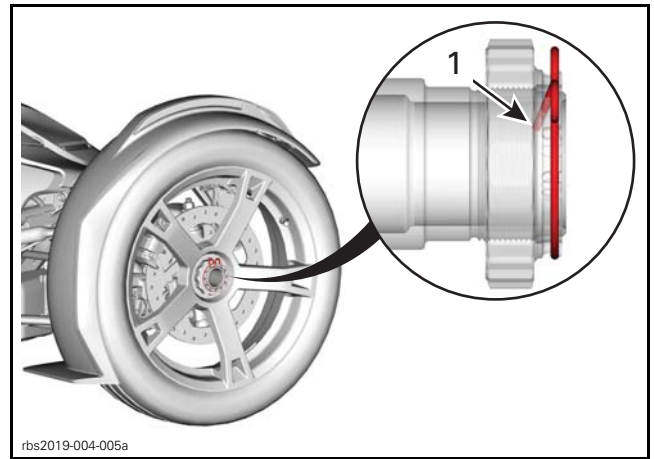
rbs2019-004-005a

Failure to install the RED locking clip may cause the loss of a wheel if the center lock wheel nut becomes loose.

1. Folded end pointing inside the drive axle

RED locking clip installation is **Mandatory**. The folded end must point inside the drive axle.

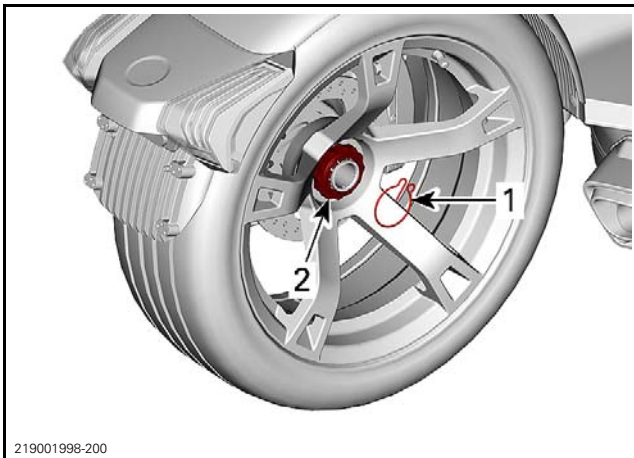
1. RED locking clip
2. Center lock wheel nut

4. Loosen the center lock wheel nut.

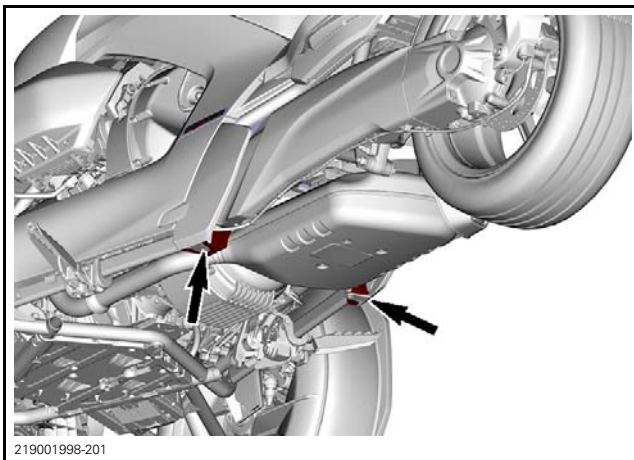
USE THESE LOCATIONS TO LIFT OR SUPPORT THE REAR OF THE VEHICLE

5. Lift and support the rear of the vehicle.

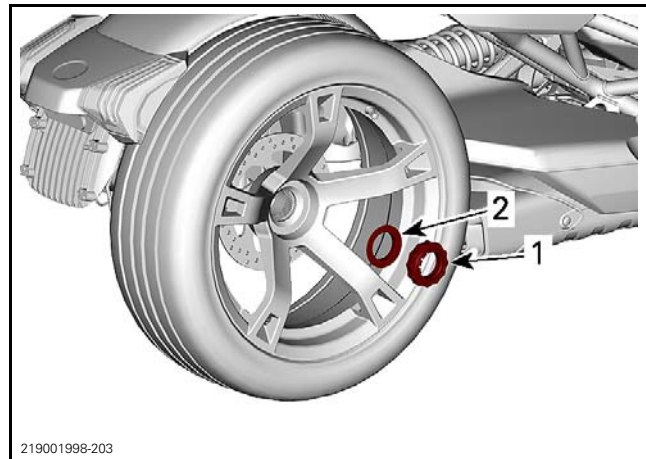
1. Center lock wheel nut
2. Conical washer

6. Remove and discard the center lock wheel nut.

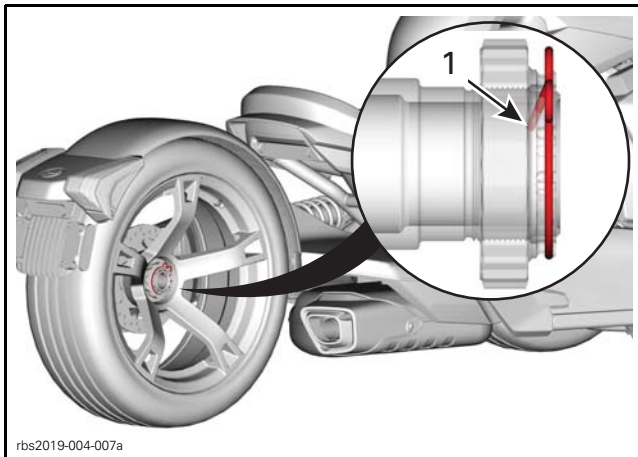
⚠ WARNING
Failure to install the RED locking clip may cause the loss of a wheel if the center lock wheel nut becomes loose.

1. Folded end pointing inside the drive axle

RED locking clip installation is **Mandatory**
The folded end must point inside the drive axle.
