MODEL  
2021MY  
K5 (DL3a)

NUMBER  
094

## TECHNICAL SERVICE BULLETIN

**SERVICE ACTION: A/C DISCHARGE HOSE AND  
SUNVISOR CLIP CONFIRMATION (SA441)**

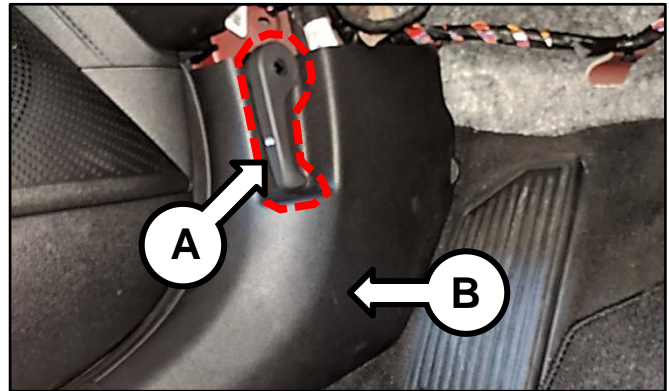
1. Pull the hood release lever (A) located on the lower left kick panel (B).

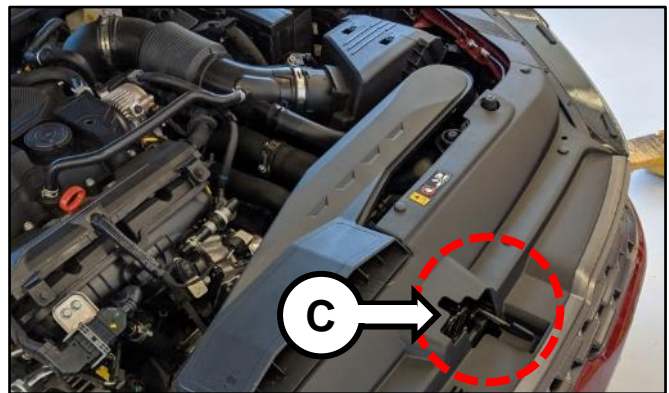
- 2a. In the front of the vehicle, locate the hood latch (C) and open the hood.

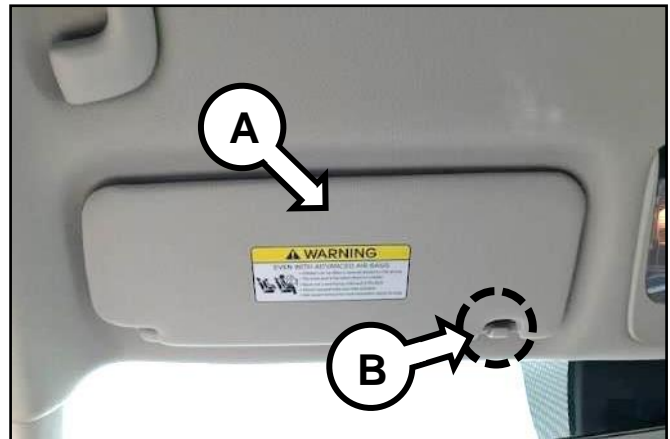
1. Inspect both driver and passenger sunvisor(s) (A) retainer clip(s) (B).

- 2a. Open and extend the sunvisor(s) and inspect the sunvisor retainer clip (B) for poor seating against the headliner.

- 2b. If the retainer clip is not seated correctly, re-install the retainer (B) to the headliner.

If the retainer clip is missing the retaining screw, install the missing screw using P/N: 85289 3V000.

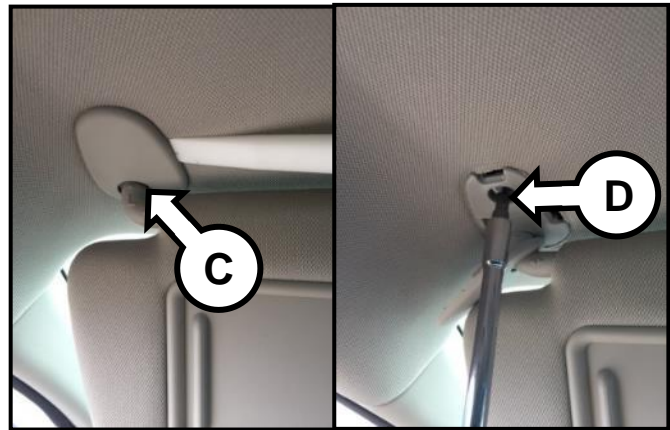
- 3a. If the sunvisor is secure, functions and appears normal, then this service action is complete.
- 3b. If an issue is found during the inspection, remove trim cover (C) from the sunvisor pivot point.
4. Remove the retaining screw (D), to remove the sunvisor.
