# Technical product information

<b>Topic</b>	New Continental GT - Wind noises
<b>Market area</b>	Bentley: worldwide (2WBE),Hongkong-Macau (5HK)
<b>Brand</b>	Bentley
<b>Transaction No.</b>	2051748/8
<b>Level</b>	EH
<b>Status</b>	Released for publishing
<b>Release date</b>	21-Oct-2020

# GT Wind noise concerns – Fix documentation

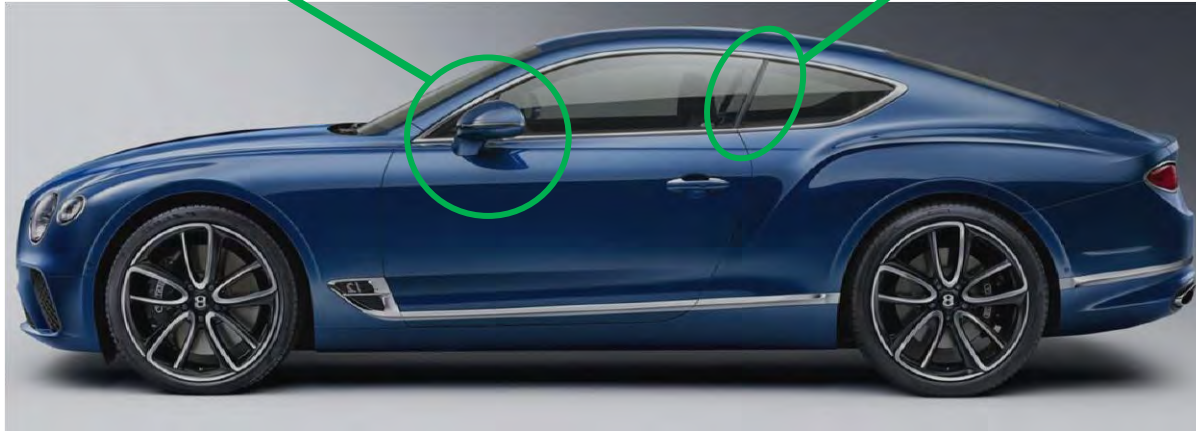
1. Front quarter glass area

2. Rear division bar area

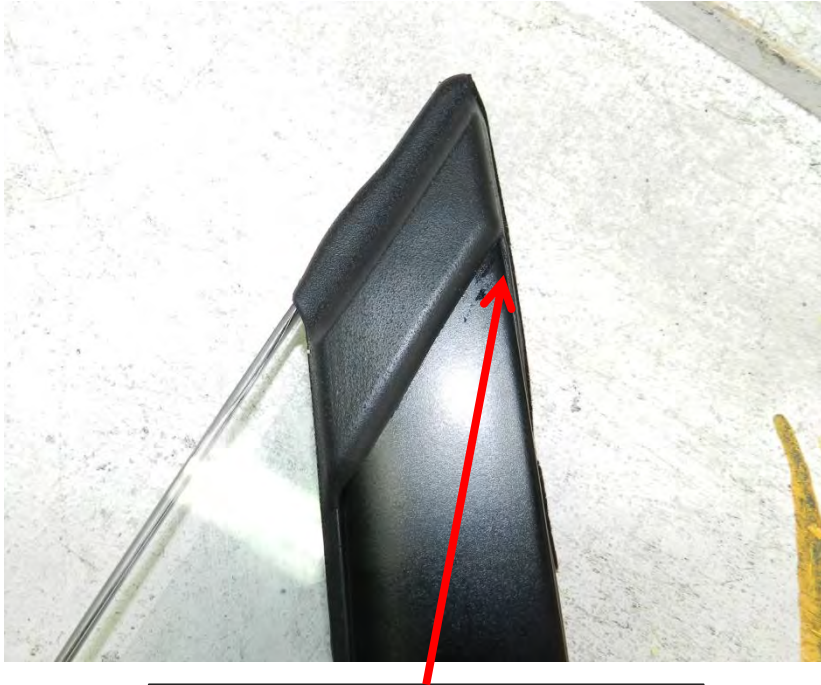
Good condition – Top corner of division bar not visible. Moulding sits lower on division bar covering top edge

Fix – Strip qtr glass & re-assemble correctly

1. See aftersales documentation to remove the front quarter glass assembly.

Refer to "Front door division bar - To remove and fit".

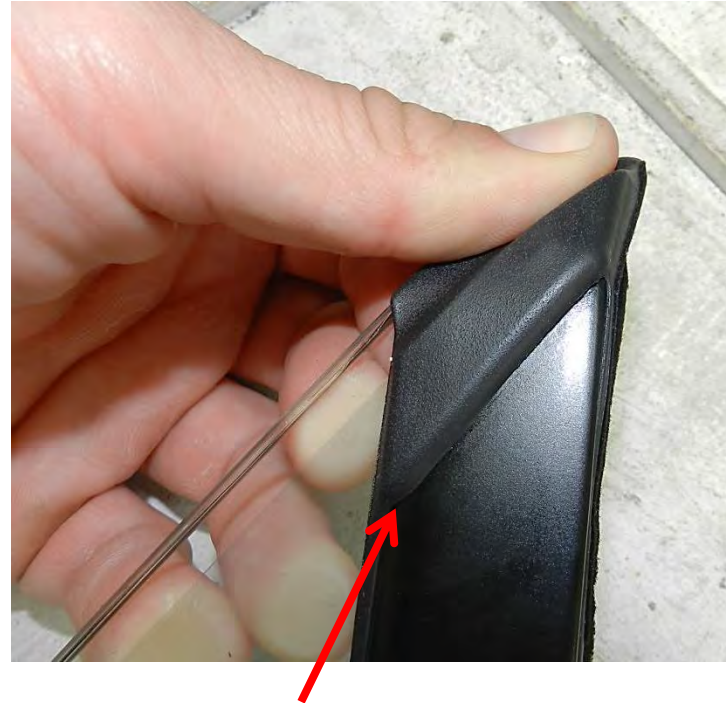
Good condition, seal not peeling up due to correct fit into div-bar retention hook.

- [A]— Guide the seal -1- onto the division bar -2- as shown.
- [B]— Apply "P80" Rubber lubricant solution to the areas shown -arrows- on the seal -1-. Push the seal -1- fully into the channel of the division bar -2-.
- [C]— Ensure that the seal -1- is fully seated into the corresponding groove -circled- in the division bar -2-.
- Ensure both sides of the seal are fully pushed in and the rubber bulb latches into the division bar grooves as shown -circled-.

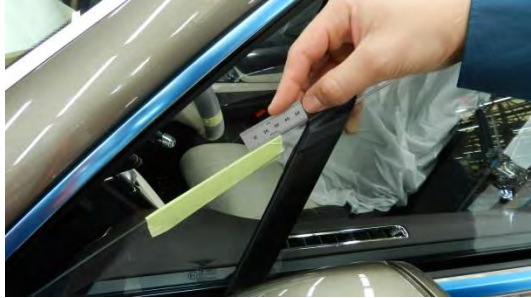
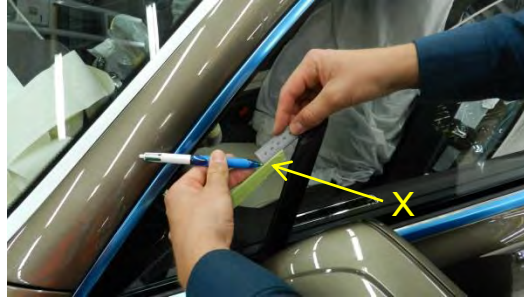
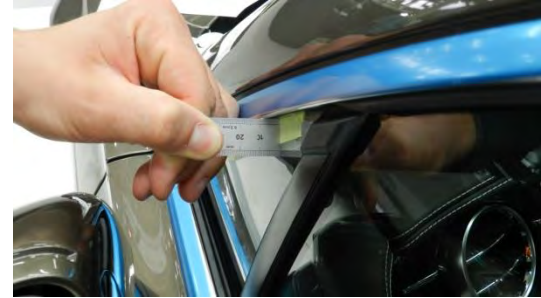
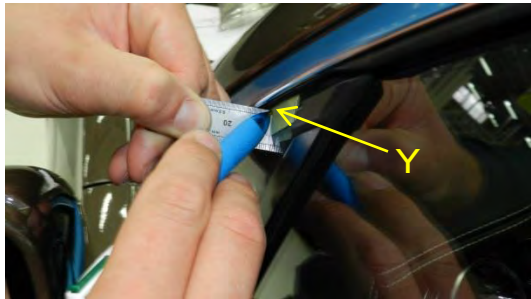
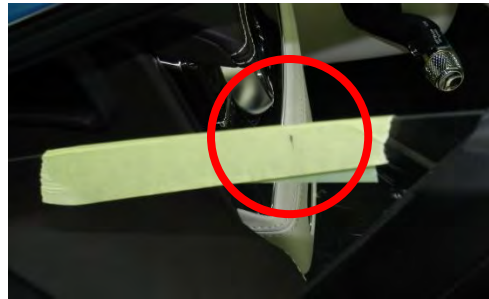
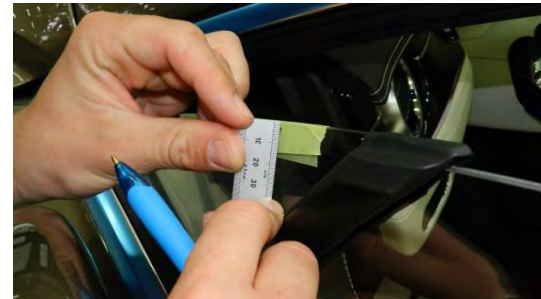
Apply masking tape to glass edge that provides coverage 50mm down from Front Quarter div-bar

Mark point-X on tape 50mm down from front quarter div-bar

Align rule with 50mm point and edge of cantrail seal with rule edge perpendicular to glass surface.

Mark a point-Y on the tape aligned to the top corner of the rule.

Point-Y marked on the tape.

Check distance from point-Y to the top edge of glass. Distance should measure 2mm on glass set in the correct position

Fix – Remove door pad & adjust quarter glass assembly upwards

See aftersales documentation to re-set qtr glass

Refer to “Side glass - To set”. → Rep. Gr.64

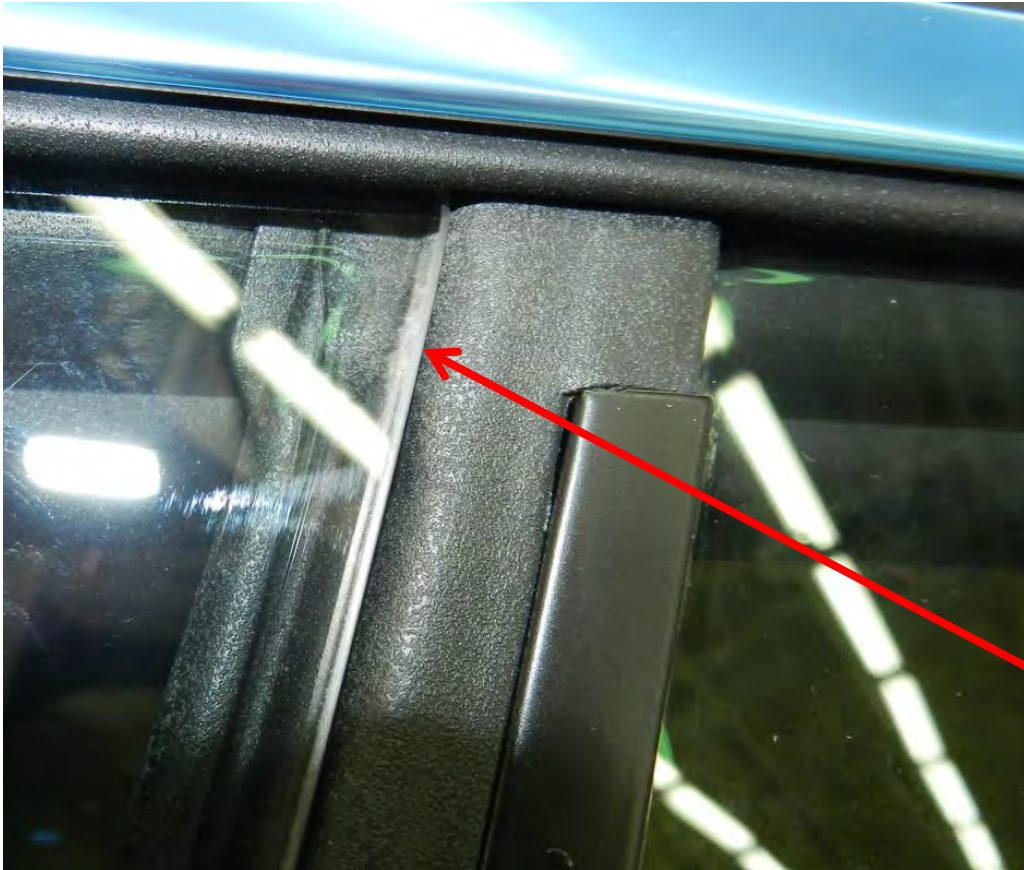
Good condition - seal not folding and sits behind the door glass.

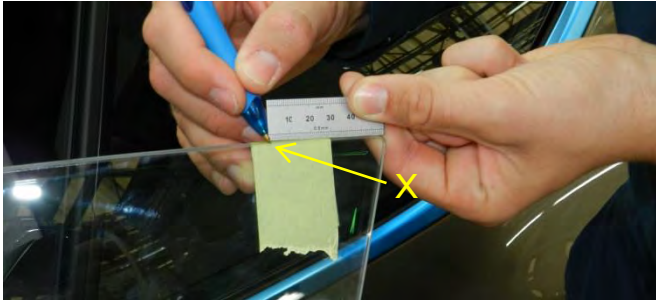
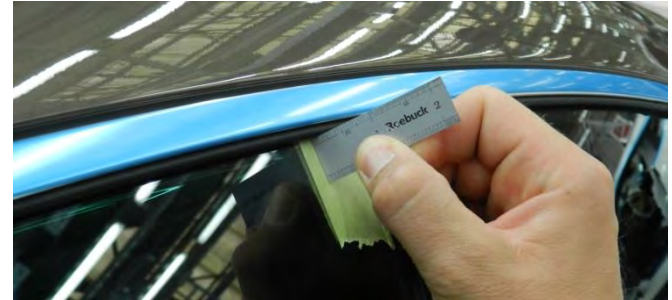
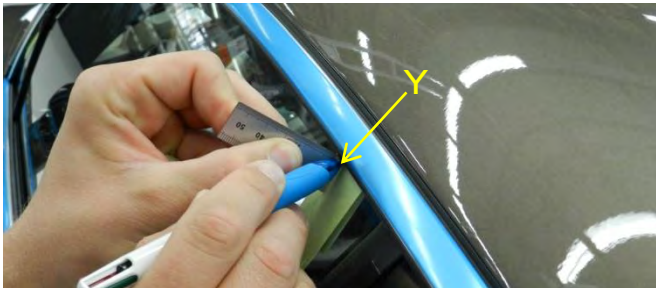
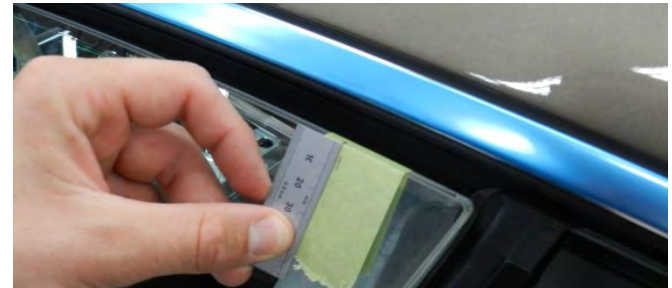
1. Apply masking tape to glass edge that provides coverage 50mm down from Front Quarter div-bar and mark point-X 50mm along from corner of glass.

2. Align rule with 50mm point and edge of cantrail seal with rule edge perpendicular to glass surface.

3. Mark a point-Y on the tape aligned to the top corner of the rule.

4. Check distance from point-Y to the top edge of glass. Distance should measure 5mm on glass set in the correct position.

Fix – Set door glass level or 1mm lower than rear quarter glass

Re-set glass as per aftersales document in Z-axis.

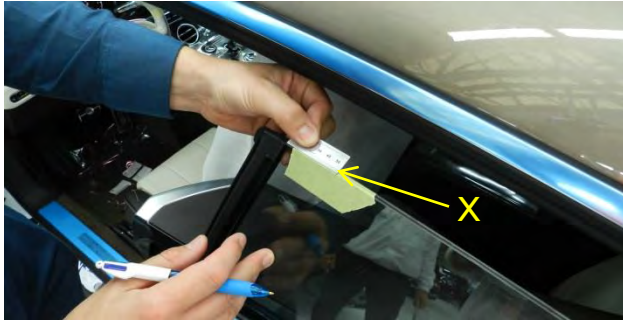
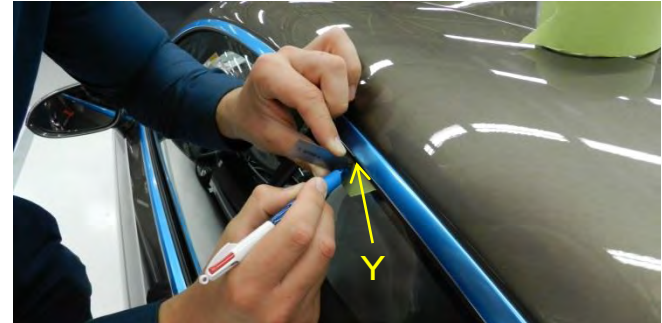
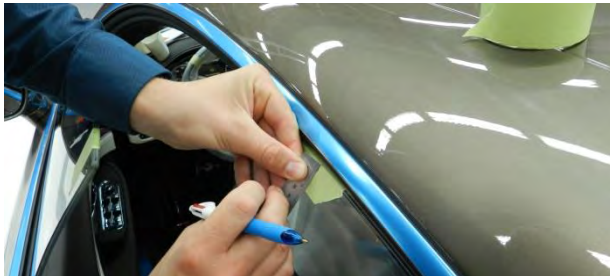
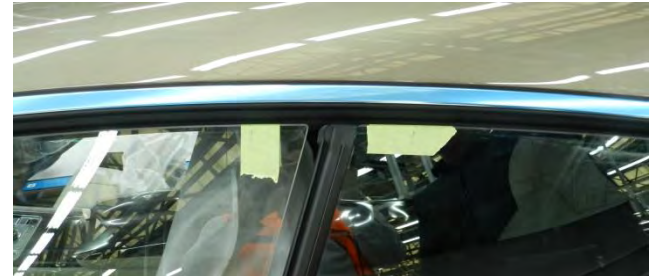
5. Apply masking tape to glass edge that provides coverage 50mm along from Front Quarter div-bar and mark point-X 50mm along from edge of div-bar.

6. Align rule with 50mm point and edge of cantrail seal with rule edge perpendicular to glass surface. Mark a point-Y on the tape aligned to the top corner of the rule.

7. Check distance from point-Y to the top edge of glass. Distance should measure 5mm on glass set in the correct position.

8. For best results both door and rear quarter glass should be set to the 5mm interlock dimension to ensure correct div-bar seal to door glass fit.
