<b>HYUNDAI</b> <b>Technical Service Bulletin</b>	GROUP <b>HVAC</b>	NUMBER <b>20-HA-003H</b>
	DATE <b>OCTOBER, 2020</b>	MODEL(S) <b>Sonata (DN8)</b>
<b>SUBJECT: A/C INOPERATIVE - ENGINE ROOM JUNCTION BOX REPAIR</b>

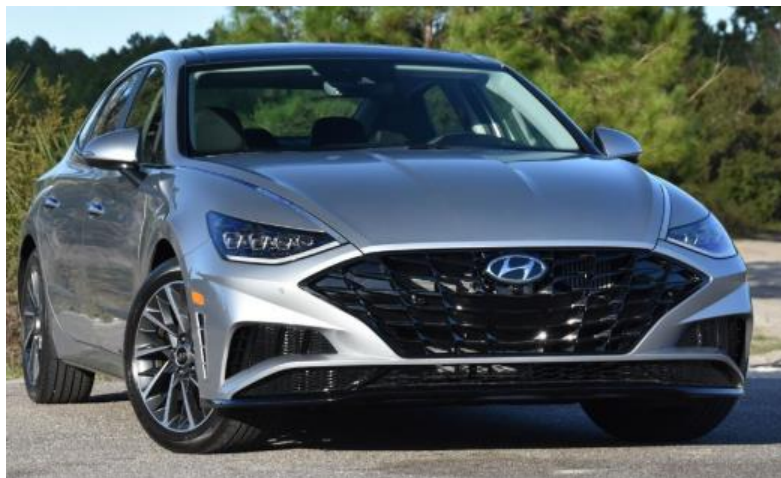
**Description:** Certain 2020MY Sonata vehicles (DN8A) may experience an inoperative air conditioning system with cold air not blowing from the vents. This condition may be caused by an electrical terminal connection in the engine room junction box. Follow the procedure in this bulletin to inspect and if necessary, repair the terminal in the engine room junction box.

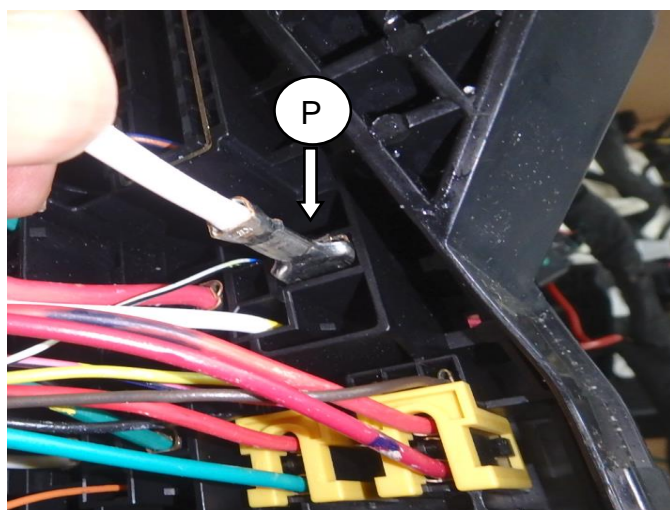
**Vehicles from the affected production range will not have a secondary lock on the wiring.**

13. Reassemble vehicle in reverse order.
- Reprogram all radio presets noted in Step 1.
