Technical Journal

Panoramic sunroof, roller shade/blind hanging loose

REF NO: TJ 35583.1.1	ISSUING DEPARTMENT: Technical Service	CAR MARKET: United States and Canada	
PARTNER: 3 US 7510 Volvo Car USA		ISSUE DATE: 2020-10-21	STATUS DATE: 2020-10-26
FUNC GROUP: 8369	FUNC DESC: Miscellaneous	Page 1 of 4

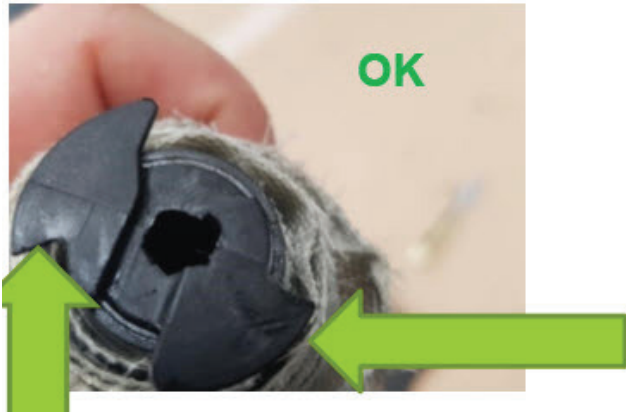
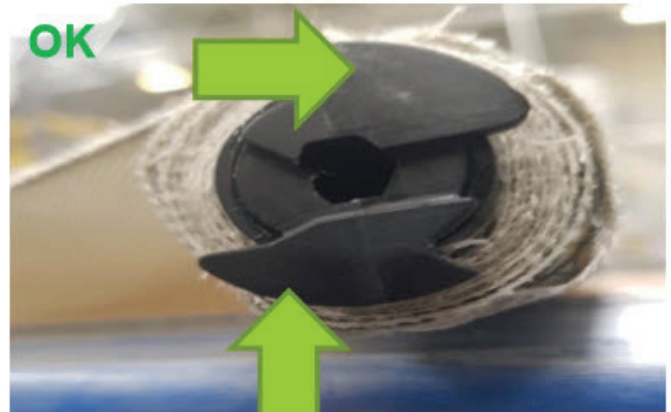
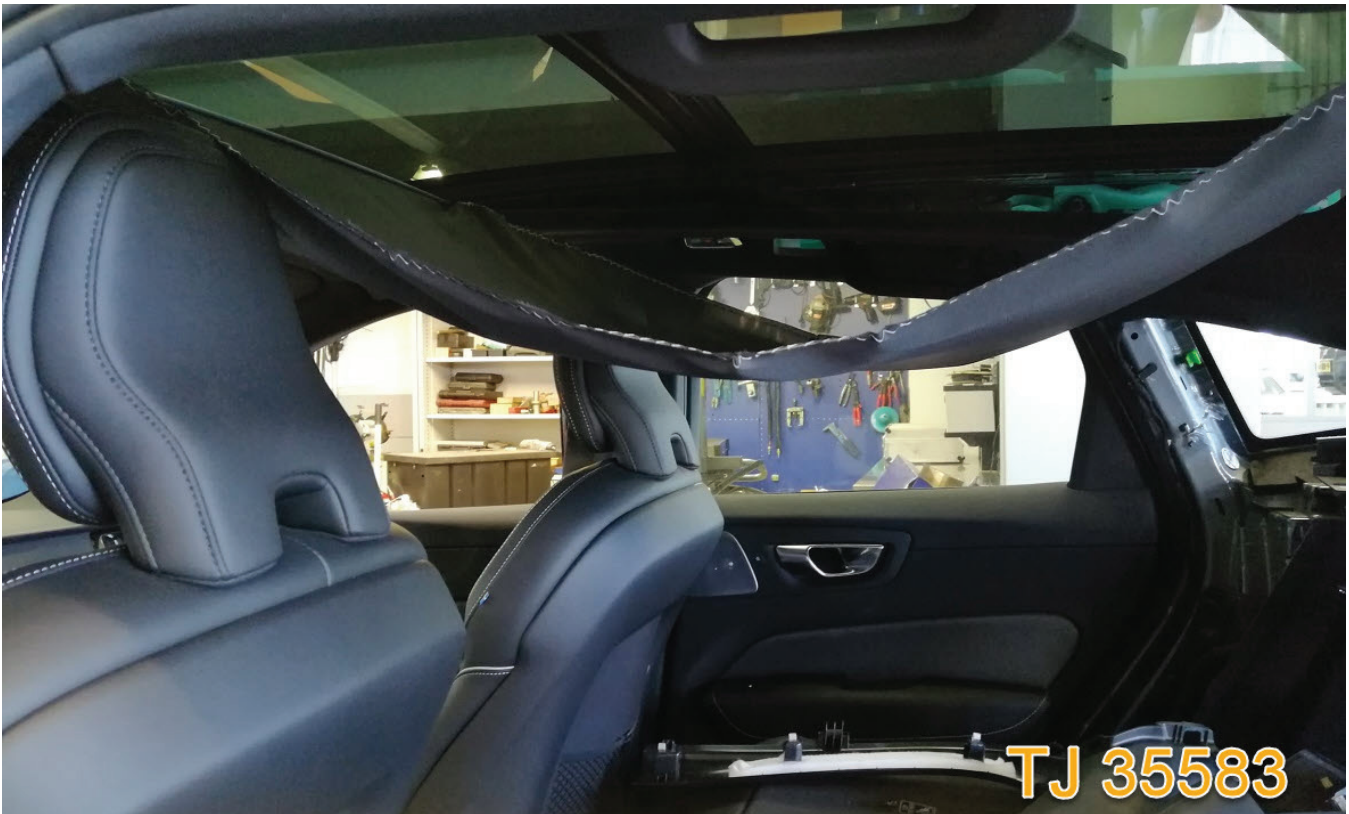
Before repairs, check the roller blind to see if there are any abnormalities in the following areas as shown in photos A, B and C:

- A. Rollo tube pinching. There should be 6 separated pinchings in the tube, check each pinch that the depth is good. If possible, measure the depth using a caliper.
- B. Socket for rollo fixator. Check if any cracks or imperfections in the plastic.
- C. Roller blind fixator. Check the wings to see if there are any cracks or imperfections in the plastic.

If any problems are found, please replace the roller blind according to VIDA method (search for VCC ID: VCC-371003-6) and send a Vehicle Report with the findings including some photos.

If no abnormalities / damages could be found, repair the car by rolling back the roller blind to the correct position.
