# AfterSales Diagnostic Sheet

## MAS002310 (BOL 20-11)

### Turbocharger anomalies

**Models:** M157/M156/M161 (Gasoline engines)

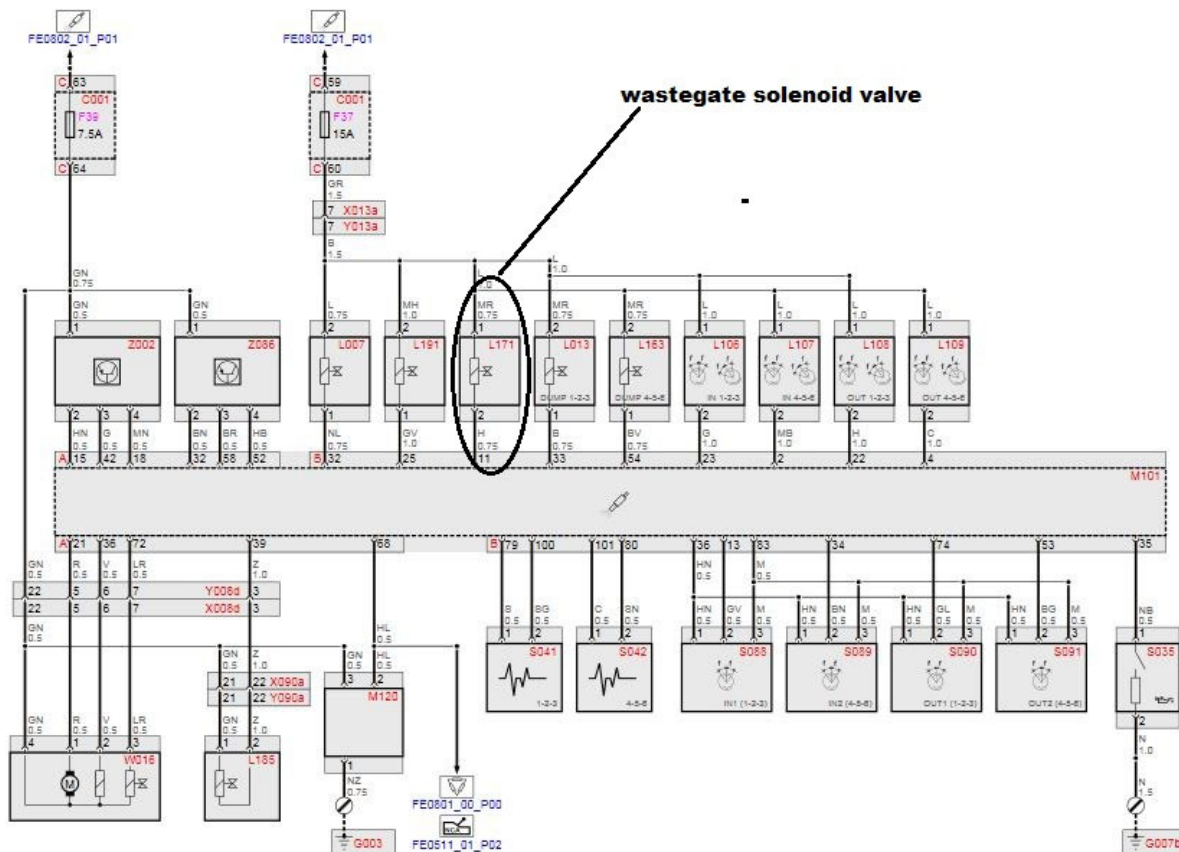
Figure 1 - FE0802 – wiring diagramEngines Fuel electronic management

- 1) Is the customer complaint confirmed?
- 2) Attach to the BOL the DTC and parameters report from the ECM
- 3) Check the wiring harness integrity (continuity, absence of short circuits to ground or battery, absence of loose pins) of the wastegate valve and on MAF sensors (Figs. 1 and 2)
