MODEL  
2020-2021MY  
Telluride (ON)

NUMBER  
213 (Rev 1, 11/12/2020)

## TECHNICAL SERVICE BULLETIN

**SVM/AVM CAMERA DISPLAY IMAGE QUALITY  
AND TPMS LIGHT ON**

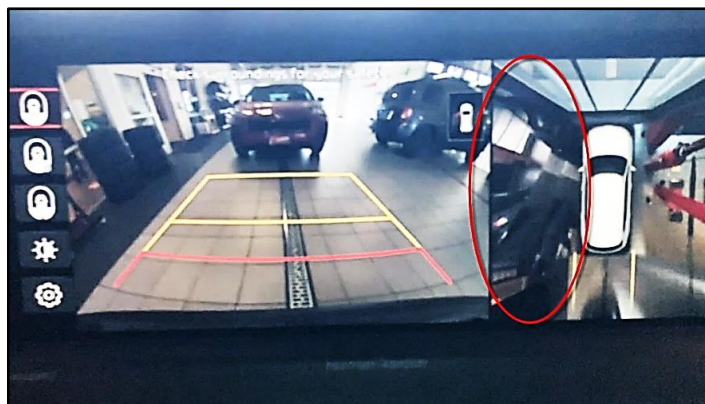
This bulletin provides the procedure to repair, the female coaxial cable terminals located in the respective locations as shown below on some 2020-2021MY Telluride (ON) vehicles produced June 1, 2020 to September 2, 2020, equipped with Side View Monitor or (SVM) or Around View Monitor (AVM) systems, which may exhibit intermittent issues with camera images flickering, displaying lines on the display, or intermittent TPMS communication failures resulting in error messages on the cluster.

**Based on the complaint location, repairs should be made to one (1) or more of the four (4) locations listed below:**

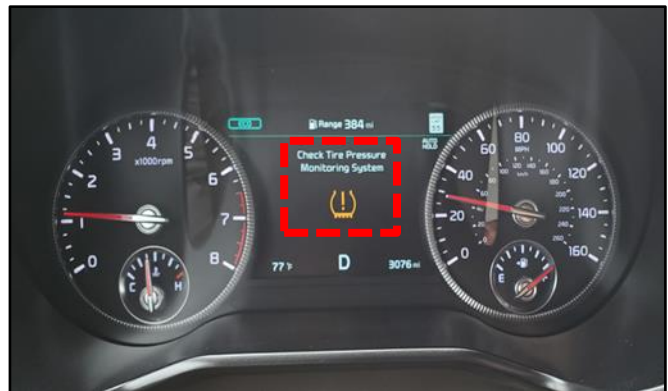
**Note:** This Issue is an intermittent failure, if customer complains of TPMS lamp 'ON' and an issue does not present itself test drive vehicle for roughly 30 minutes to confirm failure.

1. Turn vehicle on and confirm failure mode.

Using KDS, monitor communication status of TPMS sensors as needed.
