ABS trailer code 520216 31 P4 New Cascadia Jul 2, 2020 9:36 PM

We have been receiving multiple ABS complaints on newer P4 new Cascadia's for trailer ABS. The re-occurring code that every truck is having is 520216 31, ESC function is reduced (trailer ABS not OK) condition exists. Wabco info is short and sweet, saying faulty ABS functionality. Trucks have ranged from 19k, 41k miles etc and upwards. Operators that pull multiple/different trailers have come in, not specific to a truck with same route/trailer. Two trucks in question, also present with the 629-11 code, are really new P4's too, (19,805 miles) and these two units happen to have a seven way cord that does not ground to the cab back wall. Instead routes under the headache rack, under the left side cab and grounds to a frame stud. Ground load tests from the seven way cord end have always been successful, and no other problems like dirty frame connections. This 520216 does not effect truck ABS but the display does not tell the driver that, they perceive that they have a truck ABS problem instead, often times dropping the current trailer and bringing to the shop.

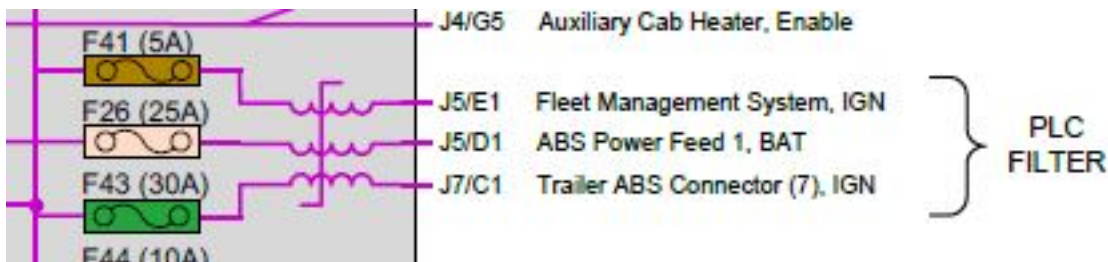
You probably already seen [HAVE A 2020 P4 COMPLAINT IS THAT TRACTION CONTROL LIGHT COMES ON , WHEELS GET STUCK HAVE TO CYCLE KEY TO GET WHEELS TO MOVE](#) It's mainly others agreeing on the ground issue.

If not the ground then the circuit that the PLC signal piggybacks on? A serial number would help define that circuit. I want to say it is 45?

The trucks ABS ECU talks to the trailers ECU through the PLC filter that is built into the VPDM. I'm not sure how to test a PLC but you could check the terminals for proper crimping and drag tension.
