# MOTORHOME VIN # LJ4372.

**MOTORHOME VIN # LJ4372.** Sep 16, 2020 7:44 PM

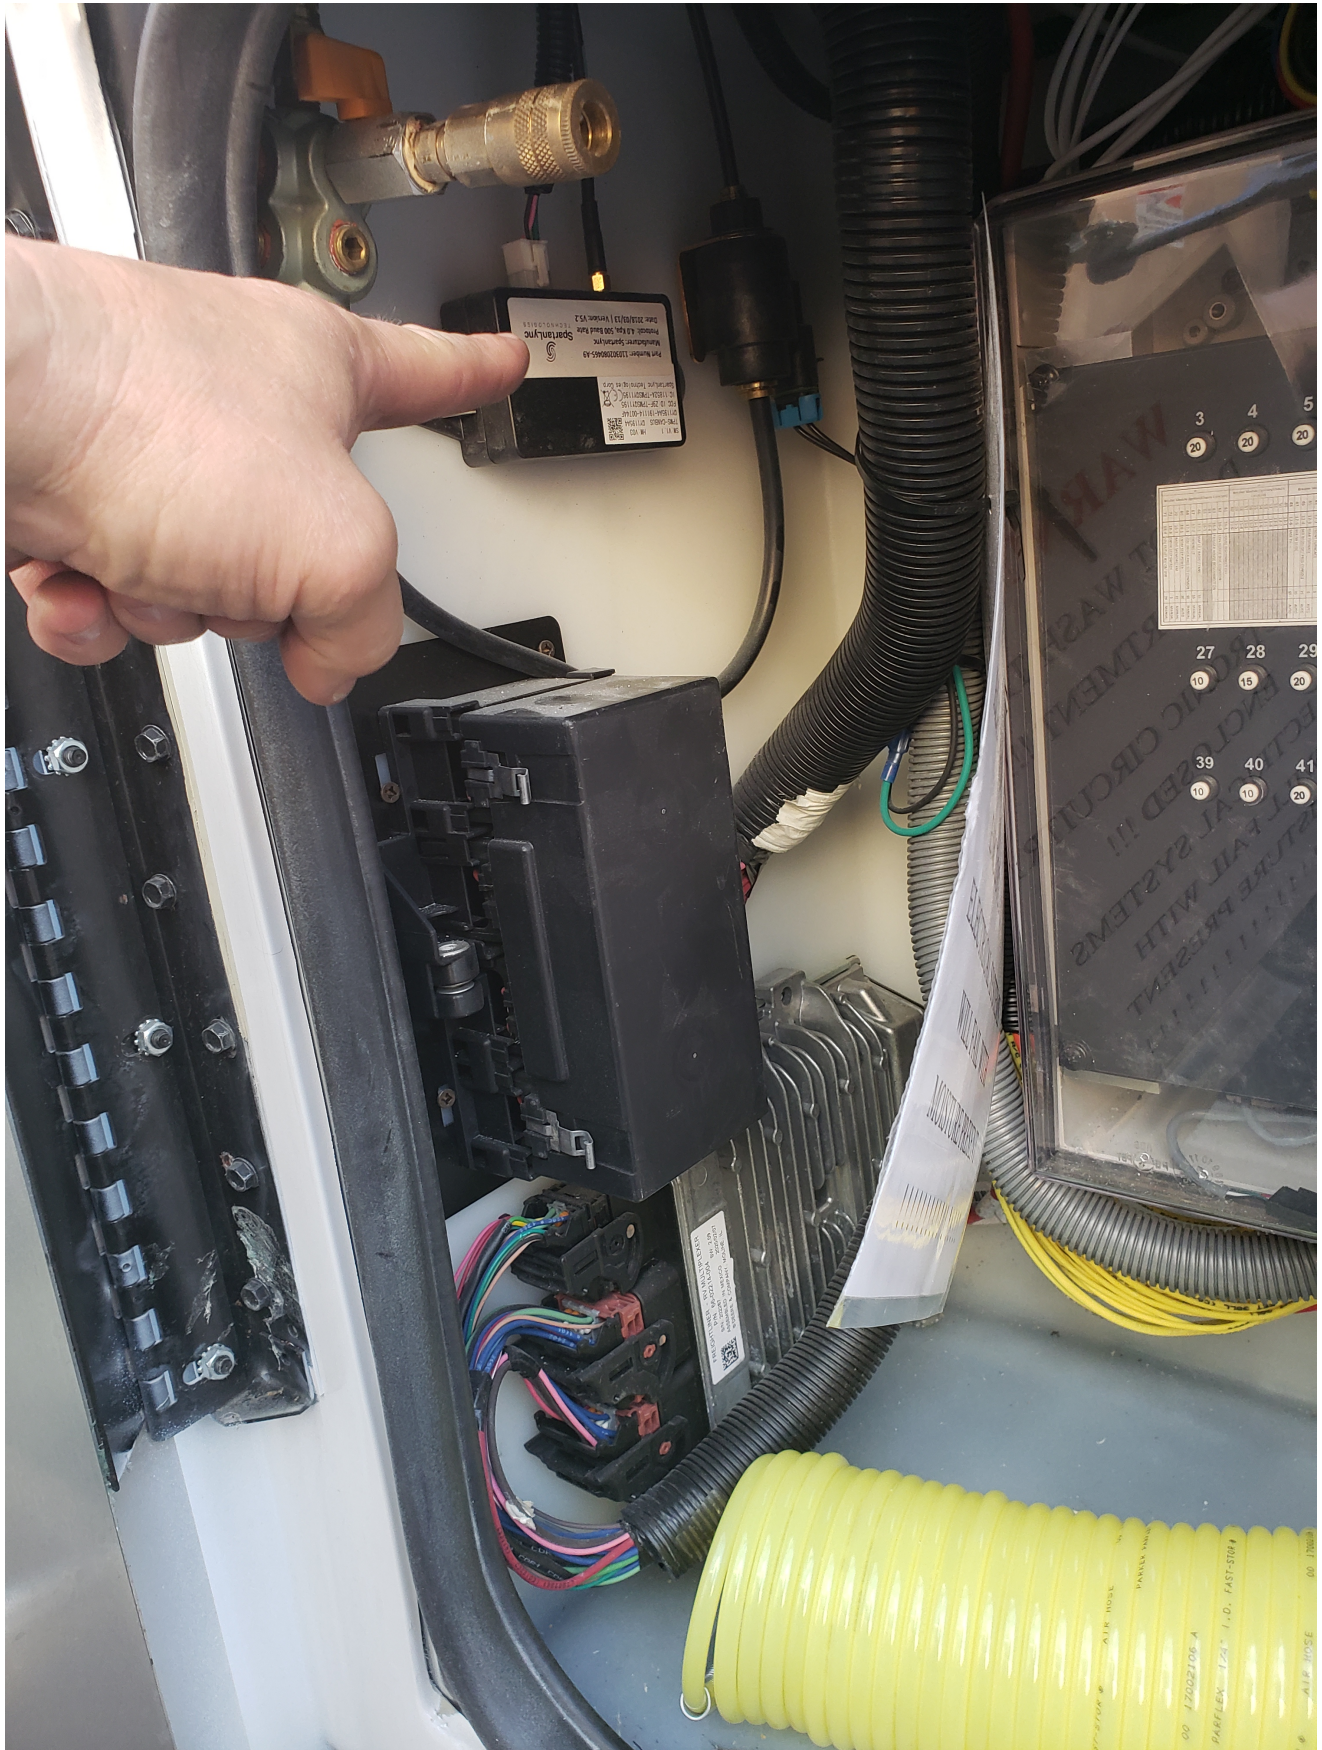
I scrolled through the dash to retrieve the active TPMS faults. I looked at TS1033423 for J1939 fault identifier. The SA is correct. source address 51 is TPMS. But the SPN and FMI are not found. I even stumped Google with the search. Bottom line is we have to purchase the tool
