Service Alert

CX-30 SERVICE CAUTIONS FOR NEW AND REVISED FEATURES

Service Alert No.: SA-013/20

2020-2021CX-30

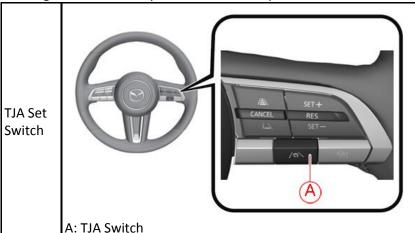
Traffic Jam Assist (TJA)* (2021 CX-30 only)

When lane lines are detected, the function assists the driver in keeping the vehicle within the lane lines. If lane lines are not detected, the function provides the driver driving assistance in keeping the vehicle along the motion path with the vehicle ahead. Steering assist function operates below 35 mph.

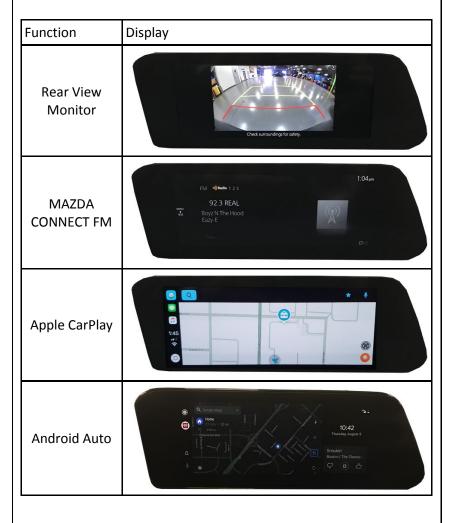
MAZDA CONNECT Center Display View

The rear-view monitor does not utilize all of the center display space.
