Service Alert

Subject: CONNECTED VEHICLE SYMPTOM TROUBLESHOOTING	Service Alert No.: SA-031/20
	Last Issued: 11/06/2020

2019-2021 Mazda3
2020-2021 CX-30
2021 CX-5
2021 CX-9

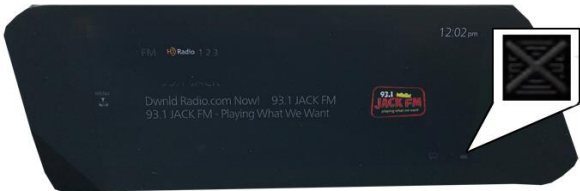
Customer Complaint	Action
<ol style="list-style-type: none"> 1. Vehicle Center Display does not provide the Authorization Code during the MyMazda App Connected Vehicle enrollment. 2. Remote function(s) inoperative. <ol style="list-style-type: none"> 1. Engine Start / Stop 2. Door Lock / Unlock 3. Lights ON / OFF 	Go to Step 2.
<ol style="list-style-type: none"> 1. 2019 Mazda3 only <ol style="list-style-type: none"> 1. The customer is not able to activate Connected Services via the MyMazda app after CSP06 completion. 2. MAZDA CONNECT connected vehicle reception strength icon is missing or shows unsubscribed after CSP06 completion.

Go to CSP07 Repair instructions

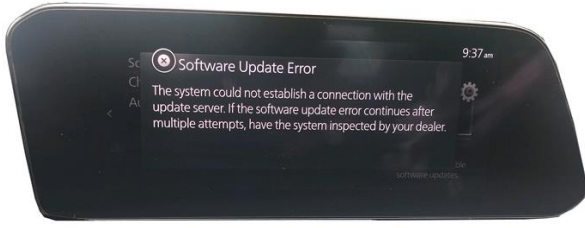
1. 2020 Mazda3 only
 1. Infotainment center display does not provide Authorization Code during the MyMazda App Connected Vehicle enrollment and infotainment Software Update Error message.

Go to [SSPC1](#).
