# SERVICE BULLETIN

EC17-033c

NTB17-113c

## 2017-2020 ROGUE SPORT; WHEN COLD, LONG CRANK TIME / ENGINE TURNS OFF / HESITATION / ROUGH IDLE / MISFIRE

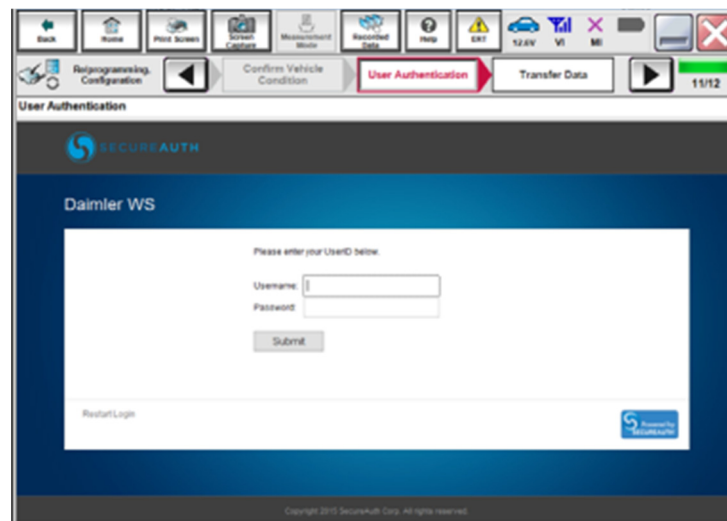
Figure 4

- Before reprogramming will start, you will be required to enter your **Username** and **Password**.
  - The CONSULT PC must be connected to the Internet (Wi-Fi or cable).
  - If you do not know your **Username** and **Password**, contact your service manager.
