Service Bulletin

Bulletin No.: 19-NA-055

Subject: Accessory Front Floor Liner Warped, Bent Inward

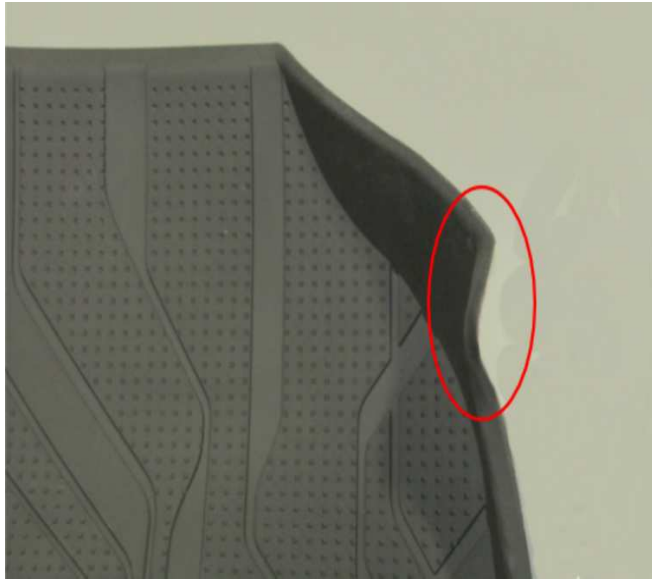
5280118

- If the outboard corner, remains warped or has taken a set, the trimming repair will not improve the condition and it would be necessary to replace the floor liner.
