Service Bulletin

Bulletin No.: 20-NA-071

Subject: Service Engine Soon Lamp Illuminated and/or Service Power Brake Assist Message Displayed, with DTCs P0557 or P0558 Stored

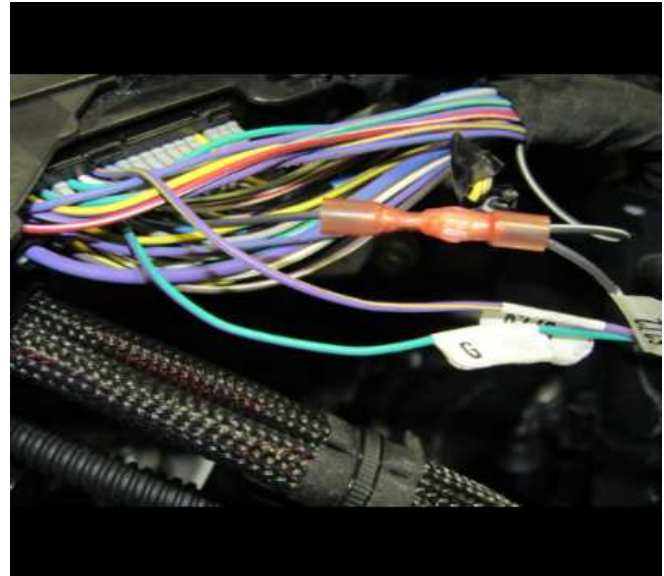
5549631

Important: There are multiple ground circuits tied to ECM ground circuit #2151 and the existing vehicle harness wire **MUST** be spliced into the new harness.

19. Cut the new harness wire labeled #6272 approximately 7.6 cm (3.0 in) from the ECM connector body.
20. Cut the engine harness ground circuit #2151 approximately 7.6 cm (3.0 in) from the ECM connector body.

21. Strip the end of all three of these wires, leaving enough length to make a splice in the butt connector.
22. Twist the engine harness side of circuit #2151 with the new harness #6272 and insert in the butt connector and crimp.
23. Insert circuit #2151 wire from the ECM connector into the butt connector and crimp.
24. Apply heat to shrink and seal the butt connector to complete the splice. Refer to *Wire to Wire Repair*, in SI.
