## Warranty Extension: 2012-15 Civic Hybrid IMA Motor Power Inverter (MPI)

### AFFECTED VEHICLES

Year	Model	Trim Level	VIN Range
2012-15	Civic Hybrid	ALL	Check the iN VIN status for eligibility.

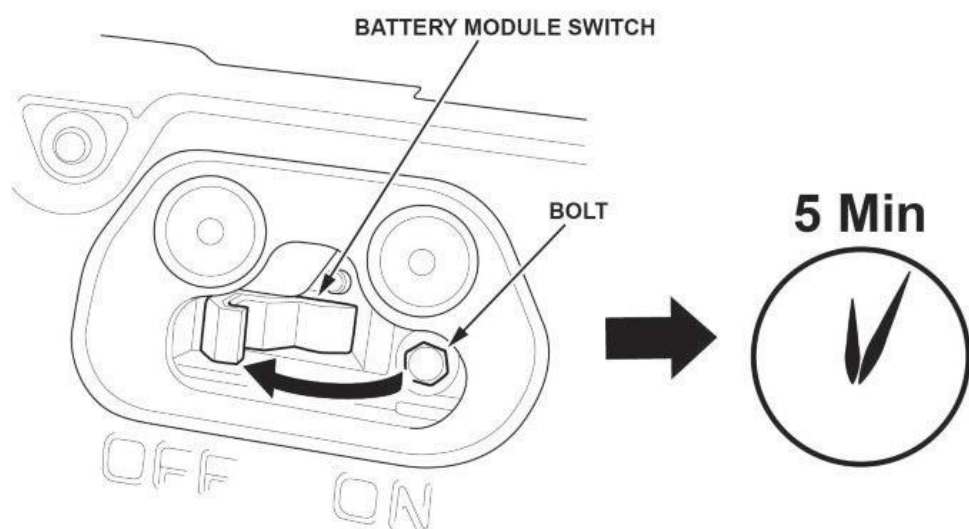
11. Turn the battery module switch to OFF, make sure you can see the bolt, then wait at least **5 minutes** to let the PDU capacitors discharge.

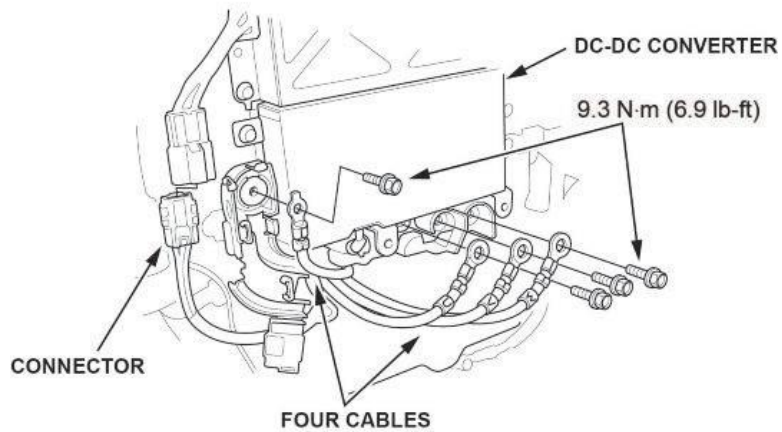
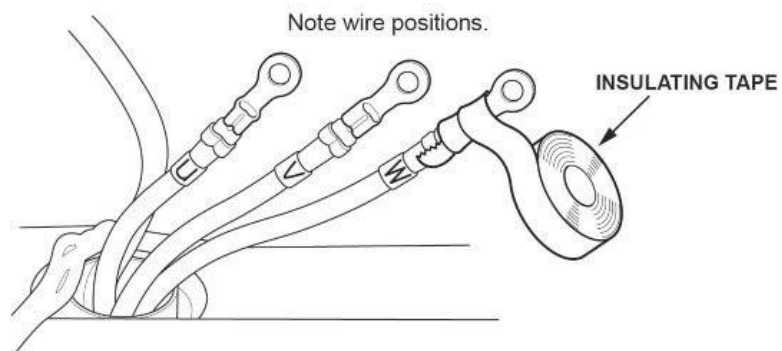
14. Disconnect the connector, then the four cables from the DC-DC converter, and wrap the end of the cables with insulating tape.

Check the position of the U, V, and W phase cables and label them before disconnecting them.

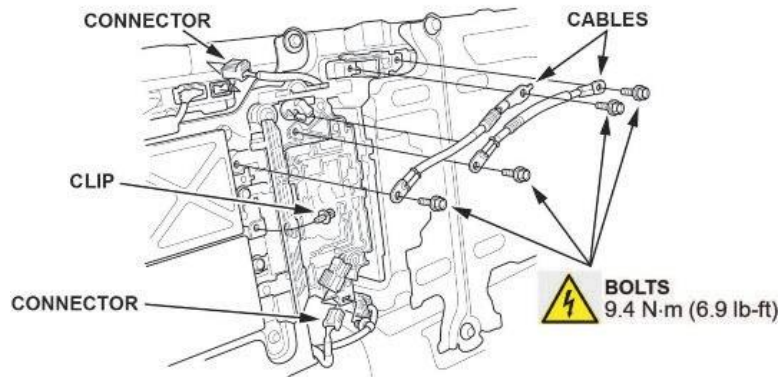
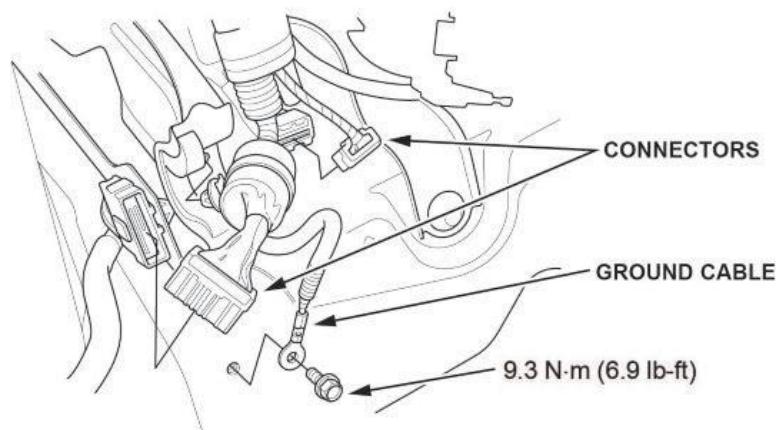
15. Remove the clip, ground cable, cables, and connectors from the PCU as shown.

Use insulated tools for this procedure.

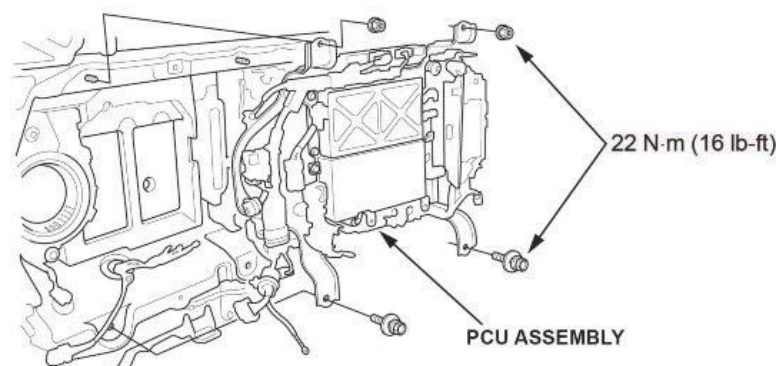
16. Remove the PCU assembly.

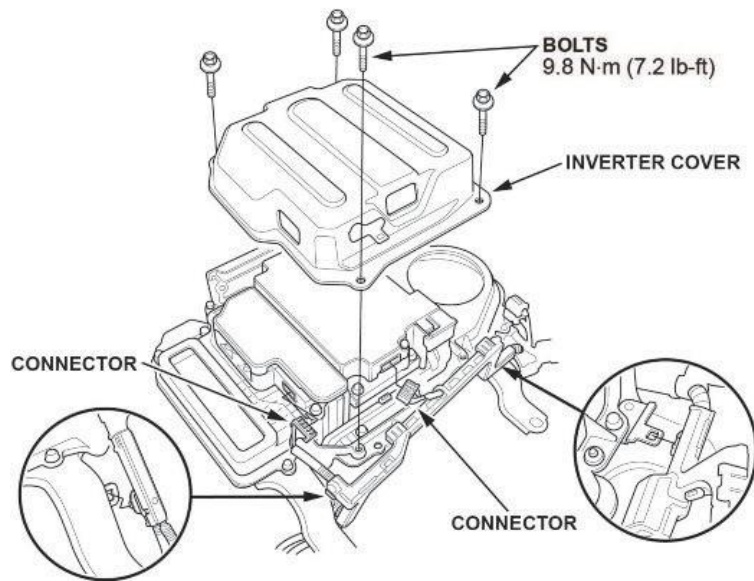
19. Disconnect the connectors, then remove the IMA inverter cover.

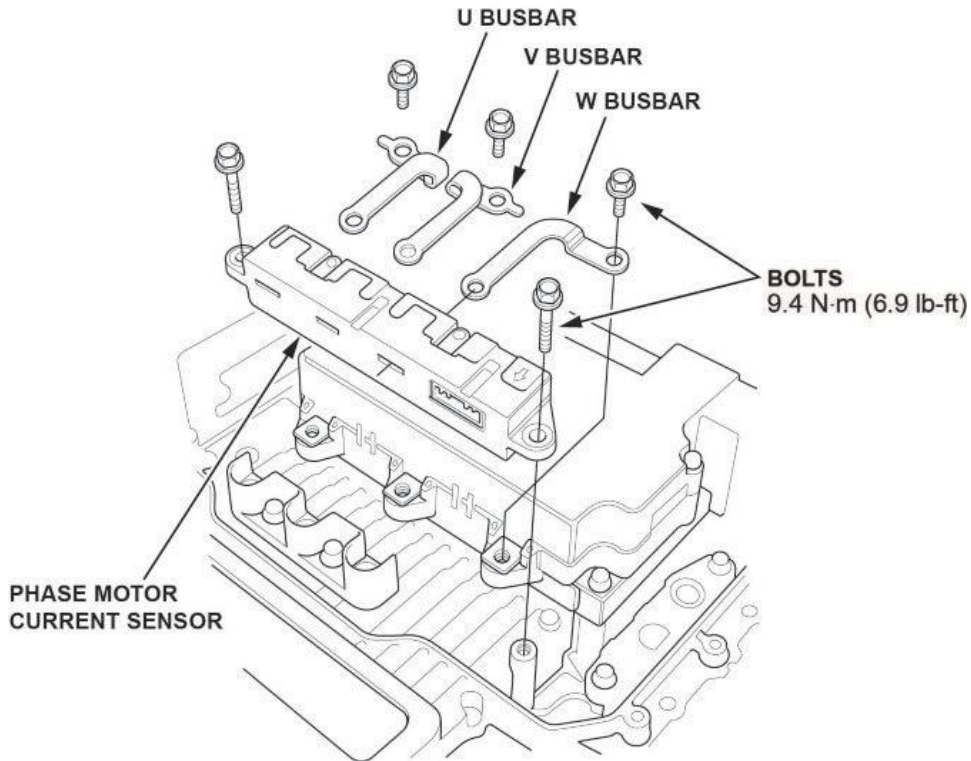
22. Remove the phase motor current sensor and the U, V, and W busbars.
