Applies To: **2009–11 Civic** – ALL VINs Beginning With 2HG

## Gap Between the A-Pillar Trim and the Headliner

(Supersedes 11-064, dated February 3, 2012, to revise the information marked by the black bars)

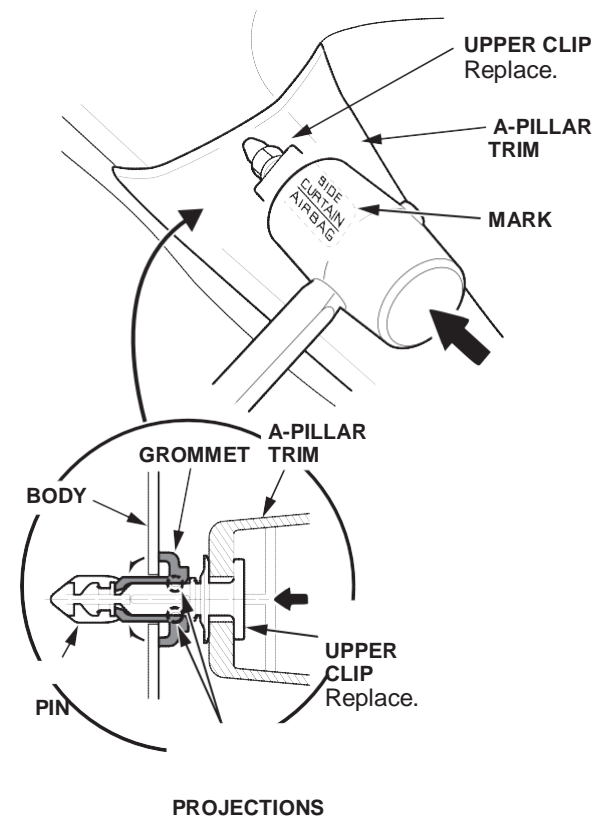
- Hit the upper clip in the A-pillar trim with a rubber mallet. The clip is under the "SIDE CURTAIN AIRBAG" mark. Hitting the clip breaks the projections on the pin and pushes it into the grommet on the body.

NOTE: The upper clip must be replaced with a new one when the A-pillar trim is reinstalled.

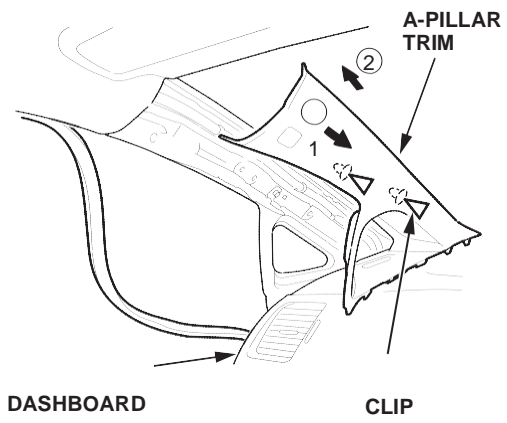
11. Pull out the A-pillar trim by hand to detach the clips. Pull up the trim from the dashboard, then remove the trim.
