Technical Service Bulletin

| Subject: DTC U2050:55 STORED AFTER REPLACING OR REPROGRAMMING TCU | Bulletin No.: 09-013/20 |

2019 Mazda3 vehicles (Japan built) with VINS lower than JM1BP*****147656 (produced before June 29, 2019)

2019 Mazda3 vehicles (Mexico built) with VINS lower than 3MZBP*****115095 (produced before June 29, 2019)

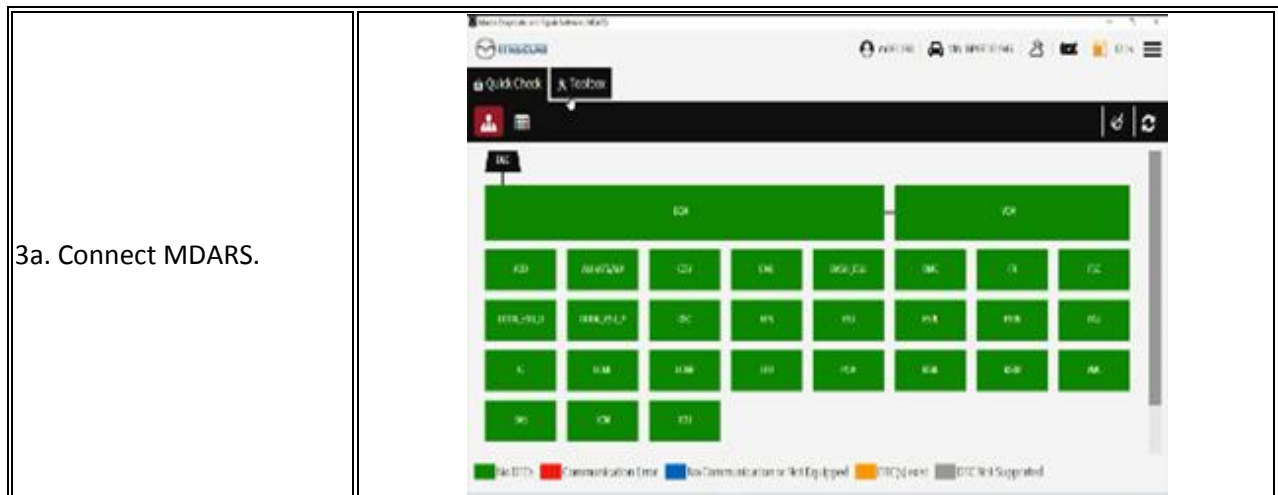
3. Perform "Activation Remote Control by Smart Phone"

NOTE: If this is not performed, DTC U2050:55-TCU and/or U2050:55-BCM will be stored.
