Service Alert

CX-30 SERVICE CAUTIONS FOR NEW AND REVISED FEATURES

Service Alert No.: SA-013/20

2020-2021CX-30

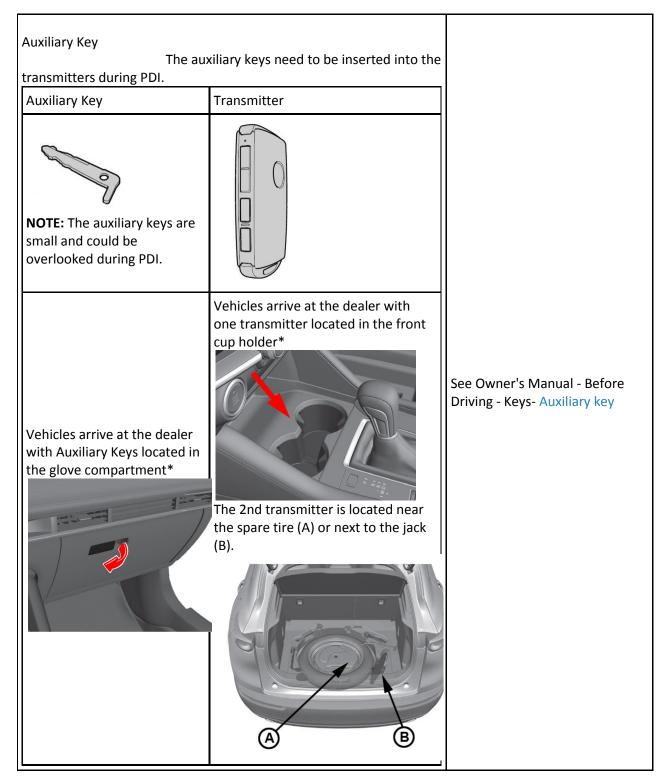
*Vehicles that arrive at the dealer after business hours, one transmitter and auxiliary keys are located in the dealer's early bird key drop box.

Insert the auxiliary key into the transmitter.

Remove the transmitter lower cover by sliding the knob in the direction shown and then sliding the cover in the opposite direction.

Insert the auxiliary key.

Install the transmitter lower cover by inserting the tabs of the lower cover into the slots of the transmitter.

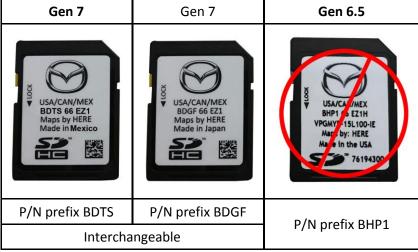
NOTE 1: Gen 6.5 Navi SD card with part number prefix BHP1 (CX-3) installed in the Gen 7 2020 CX-30 will not function.
