**SERVICE BULLETIN**

**APPLICABILITY:** 2017-18MY Impreza  
 2018MY Crosstrek  
 2018MY Legacy and Outback  
 2018MY BRZ\*

**NUMBER:** 15-211-17R  
**DATE:** 06/13/17  
**REVISED:** 12/18/20

**SUBJECT:** Reprogramming File Availability for Additional Optimization of Harman Gen 3 Audio and Navigation Head Units

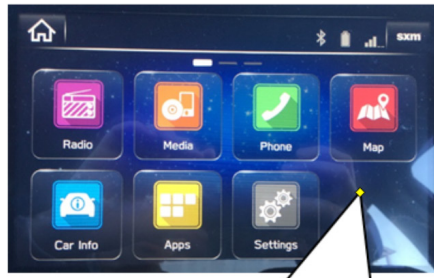
Normal HOME screen with icons

- On 2018MY Legacy / Outback models with Navigation (High) head units, the update corrects a condition where the head unit remains powered even after the ignition is OFF and the driver door is opened.
- Update for a condition where the SXM presets become lost and only “Initializing” appears as shown below.
- Update for condition where only the star field background is displayed (without icons) after the HOME button is pressed.
